APPENDIX A

APPENDIX B

Photo Log

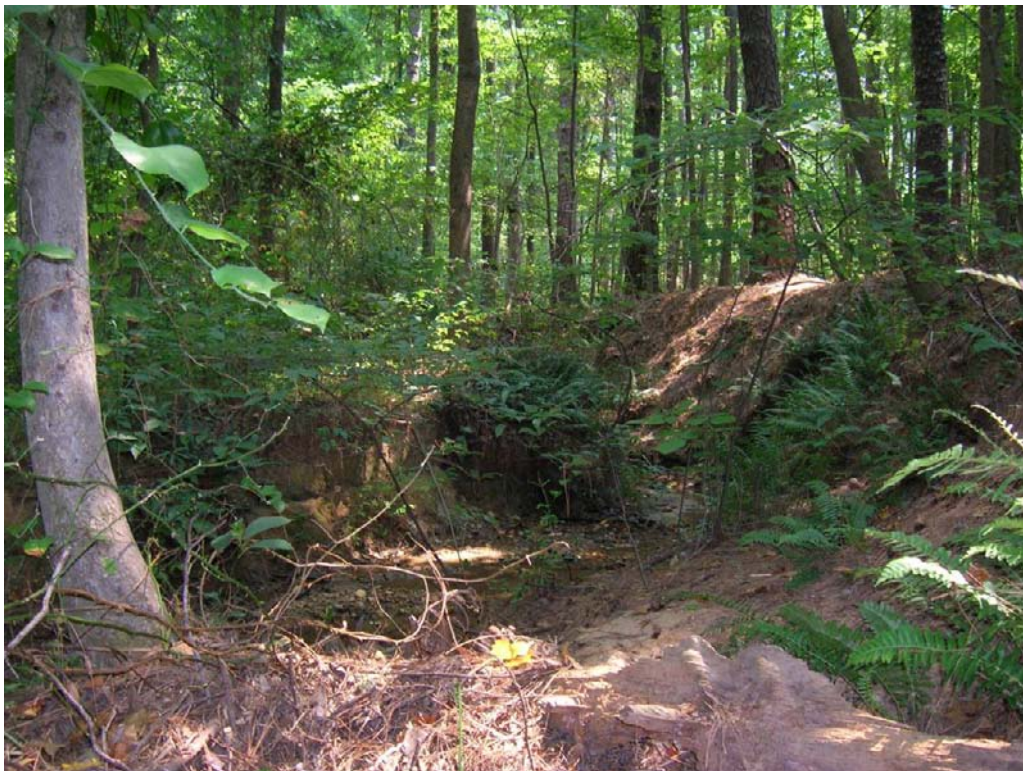
Facing downstream where the ditch from the dissipating structure meets the stream. Note the eroding, partially caused by the flow discharging from the ditch.

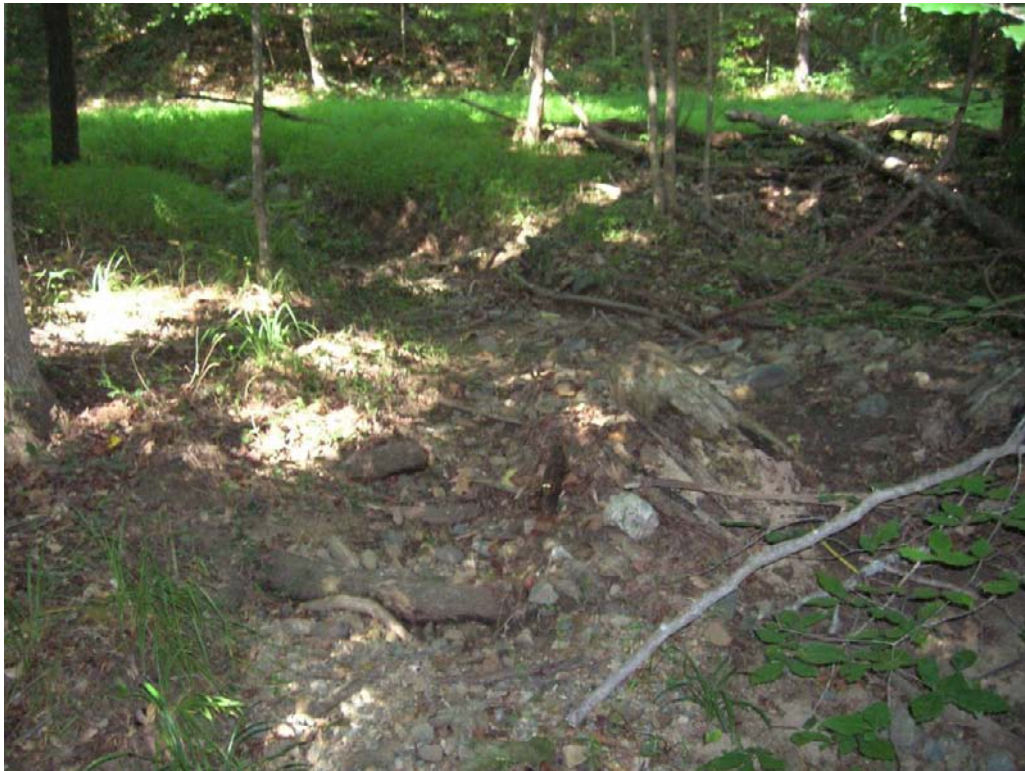
What was observed to be an ephemeral stream at Site 28. This could serve as the location for a bio-retention area.

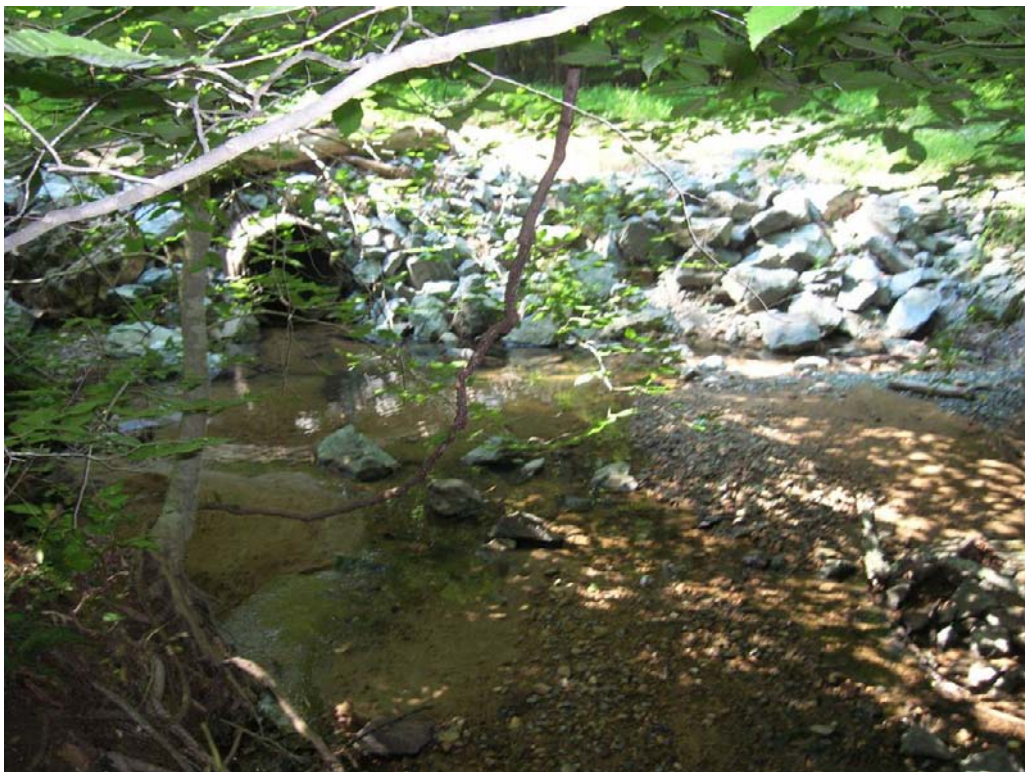
A utility crossing near Site 28 has caused mass wasting on the stream banks.

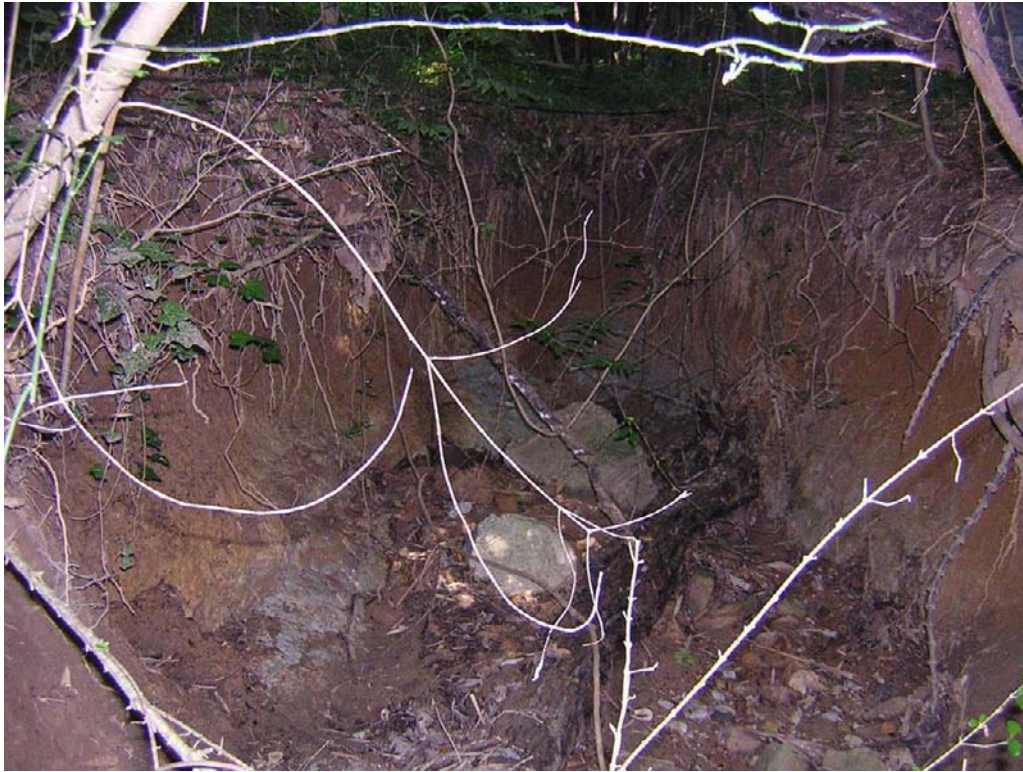
Site 29

One of the headcuts present at Site 29. Looking upstream.
