BOLIN CREEK WATERSHED

Geomorphic Analysis and Potential Site Identification for Stormwater Structures and Retrofits

TOWN OF CARRBORO
NORTH CAROLINA

November 2007

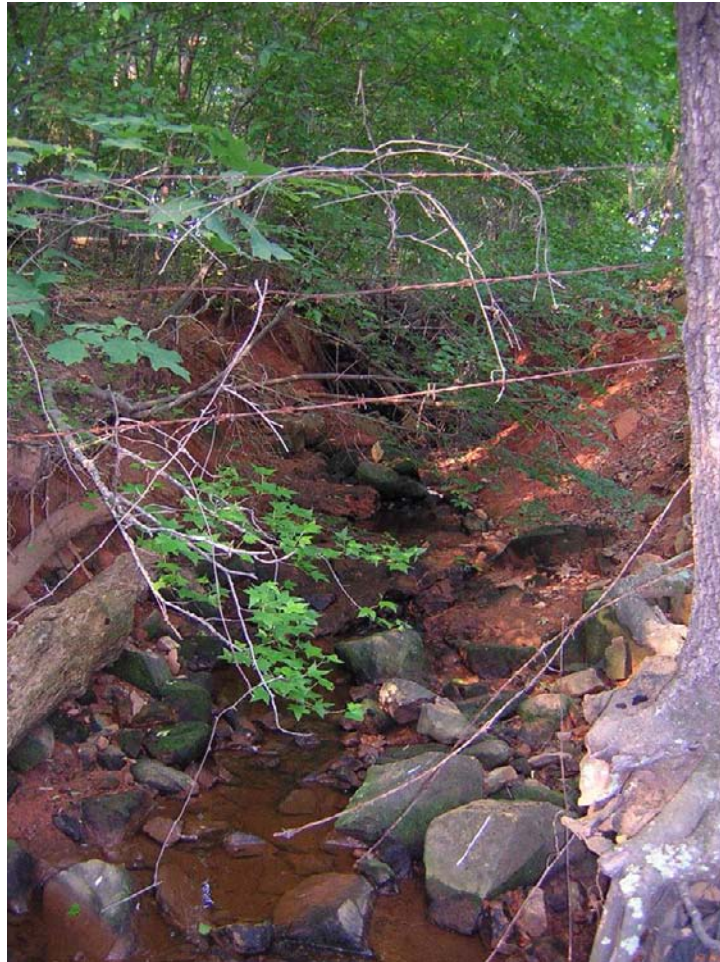
Site 1 consists of an actively eroding, deeply incised pond spillway outlet situated on Bolin Creek. The outlet channel is approximately 250 feet in length, and has dimensions of approximately 8 feet wide by 6 feet deep. This spillway is improperly constructed and serves as the only outlet for the relatively large lake on Bolin Creek. The slope of the spillway channel is approximately 4% which is too steep to serve as a constant flow channel of native soils with no hardening of the channel. The spillway invert has down-cut approximately 3 feet over the years and a beaver dam now sets the headwater elevation for the lake, which his approximately 2 feet above the invert

The chief problem with this site is the significant amount of sediment that is estimated to be exported by the site, due to the instability of the spillway channel. During site visits, Earth Tech consistently observed that the channel downstream of the lake was covered in a fine, red clay sediment. As the lake itself is a significant barrier to suspended sediment, the downstream siltation is an indicator of the massive sediment loading that is occurring to Bolin Creek due to this relatively short reach. Using a modified BANCs model for predicting streambank erosion rates (Rosgen, 2006), a total bank erosion rate of 1444.4 tons/year was estimated for this site, as shown in **Table 1.1**.

A degraded and eroding spillway on Bolin Creek just below the pond dam. Facing upstream towards the dam.

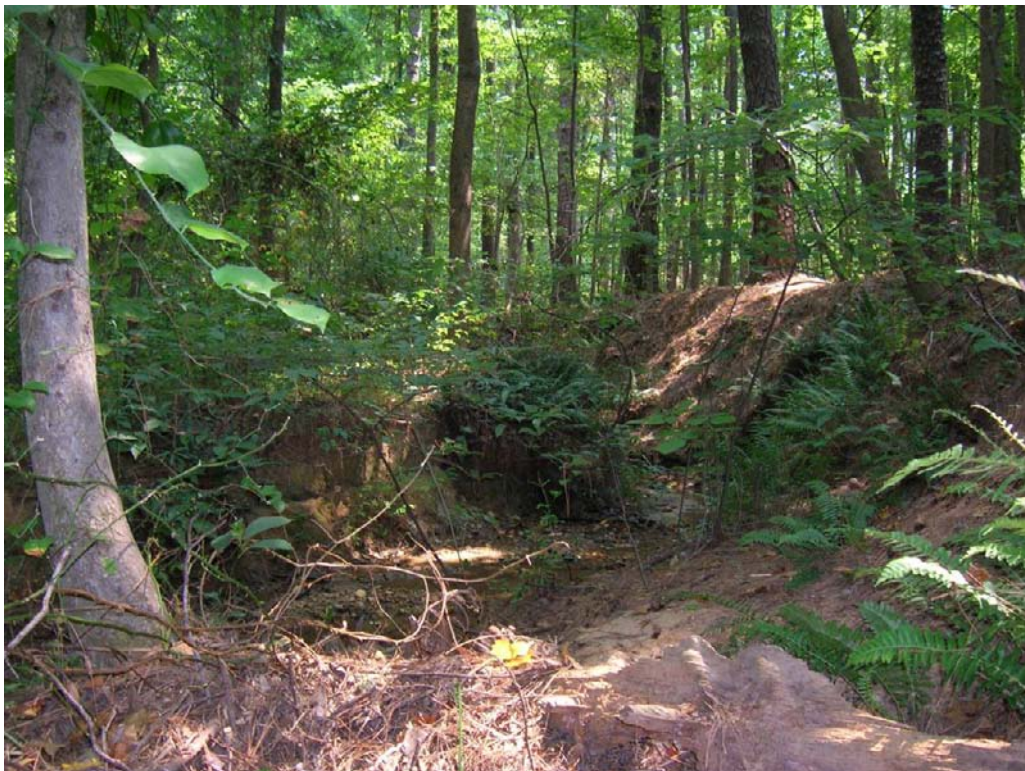
Facing downstream where the ditch from the dissipating structure meets the stream. Note the eroding, partially caused by the flow discharging from the ditch.

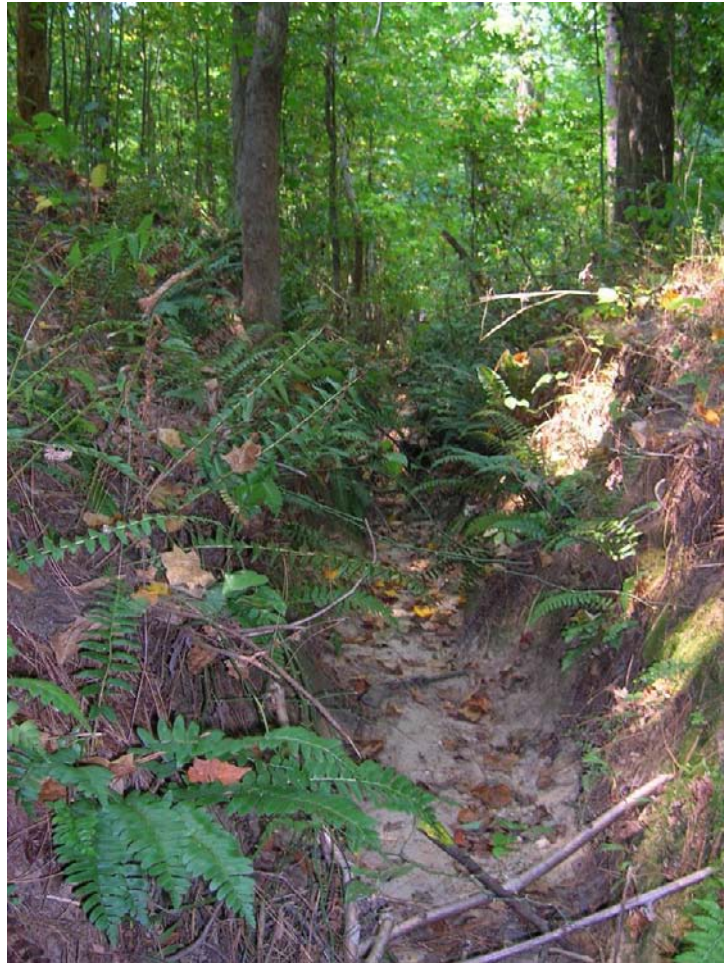
Looking upstream at the ditch.

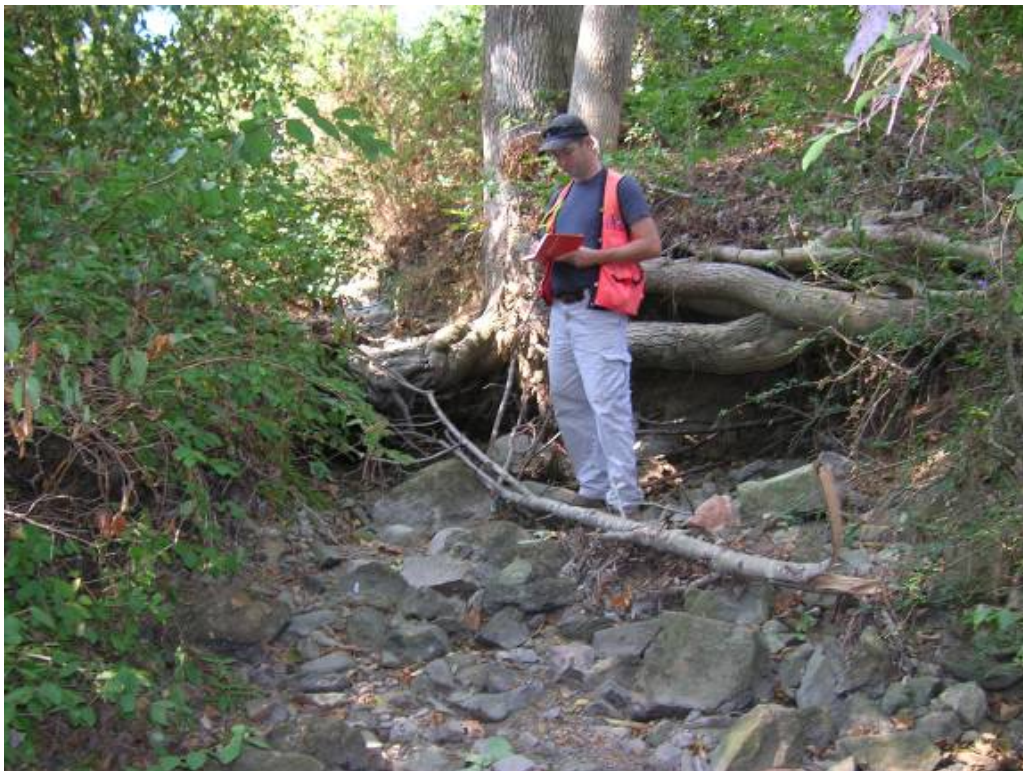
The stream is severely incised, and has degraded below the roots of several large trees. Facing upstream.

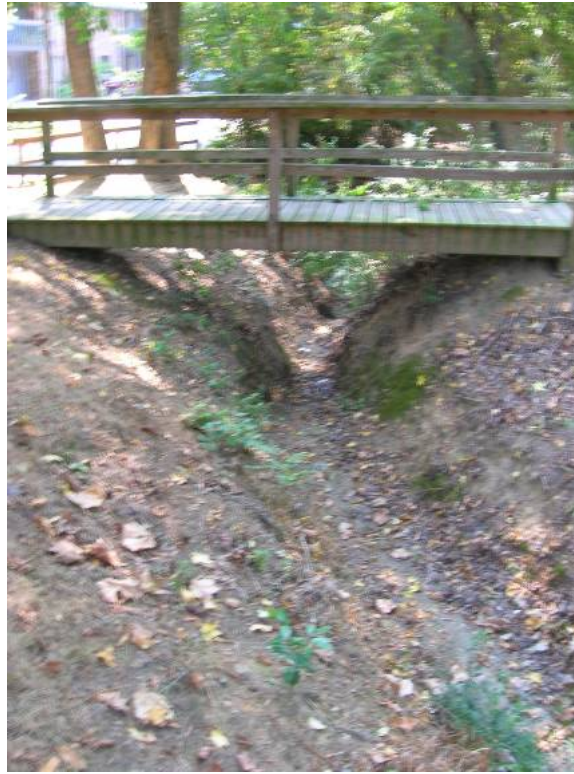
What was observed to be an ephemeral stream joins the main channel after flowing under Estes Drive Ext.
Facing downstream.

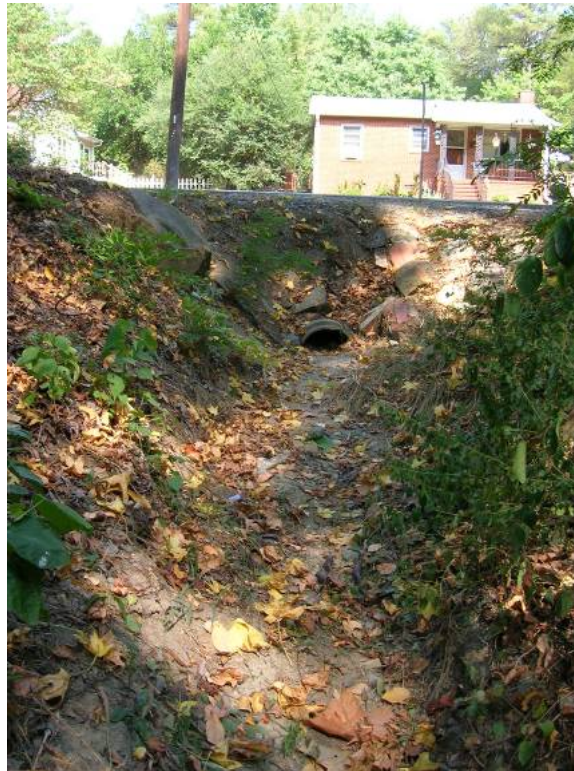
The ephemeral tributary facing upstream towards Estes Drive Ext.

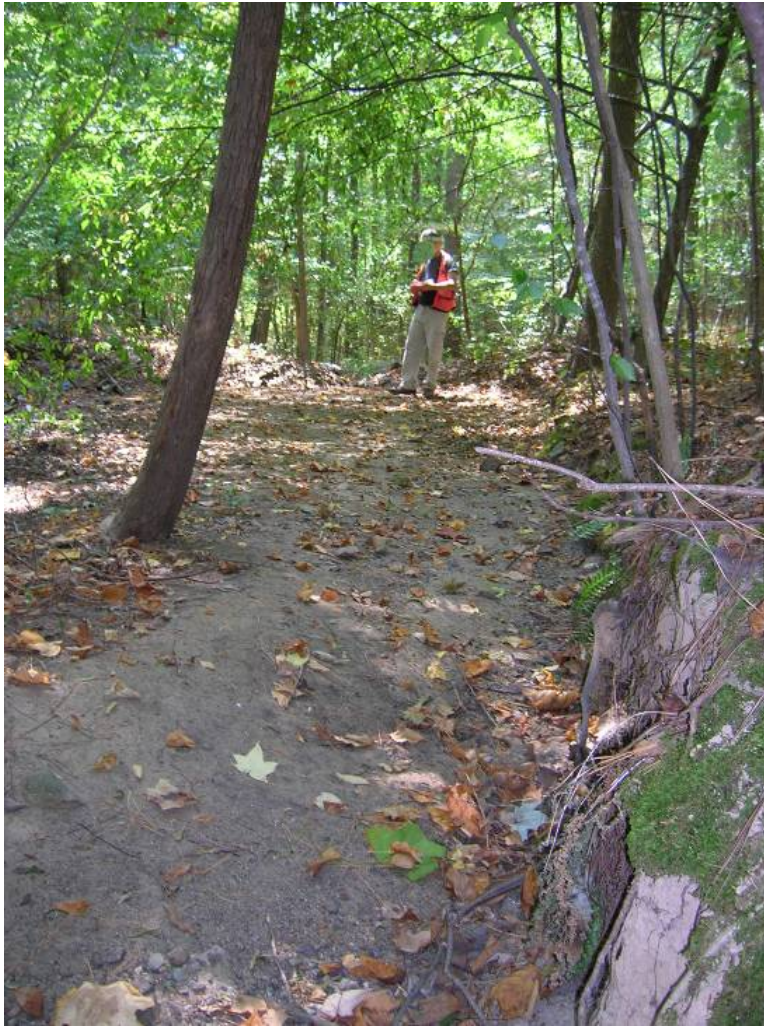
Site 23

An existing sediment basin in-line with what was observed to be an ephemeral channel. The basin has filled with sediment and trees have become established. Facing south and downstream.

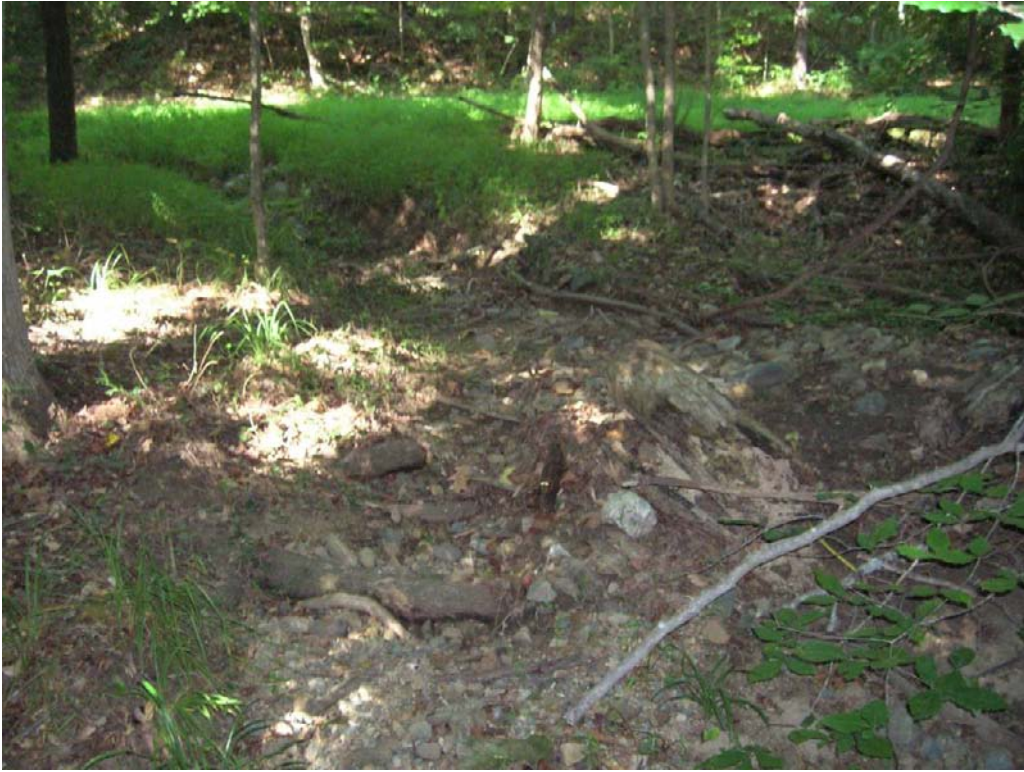
What was observed to be an ephemeral stream at Site 28. This could serve as the location for a bio-retention area.

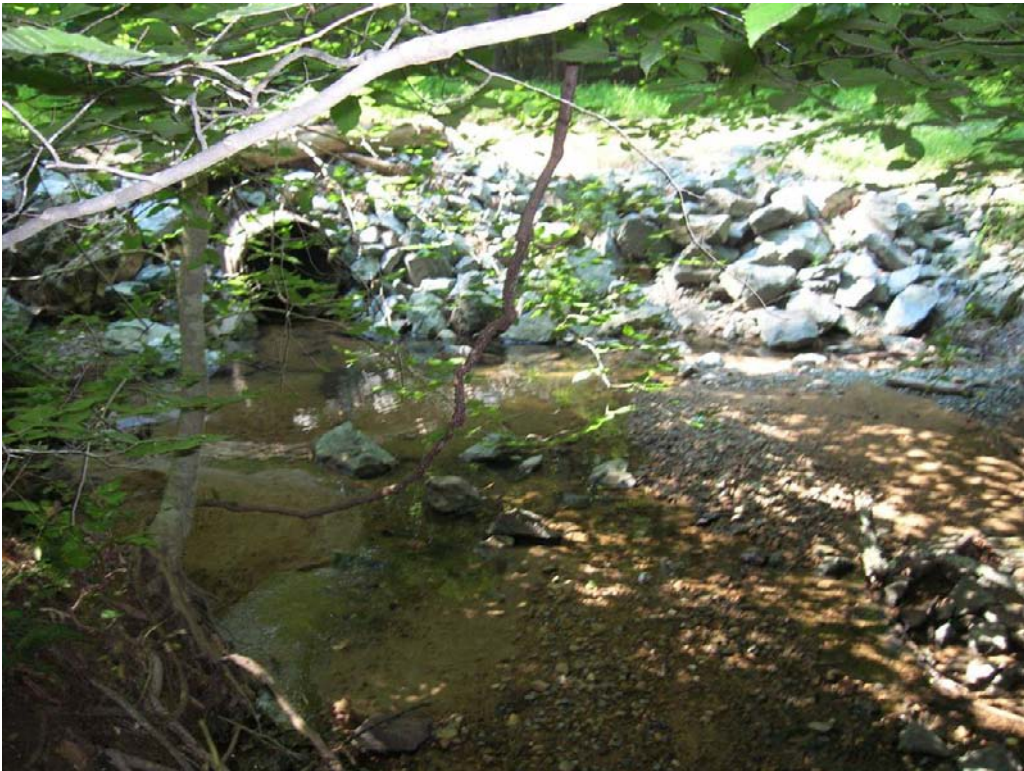
A utility crossing near Site 28 has caused mass wasting on the stream banks.

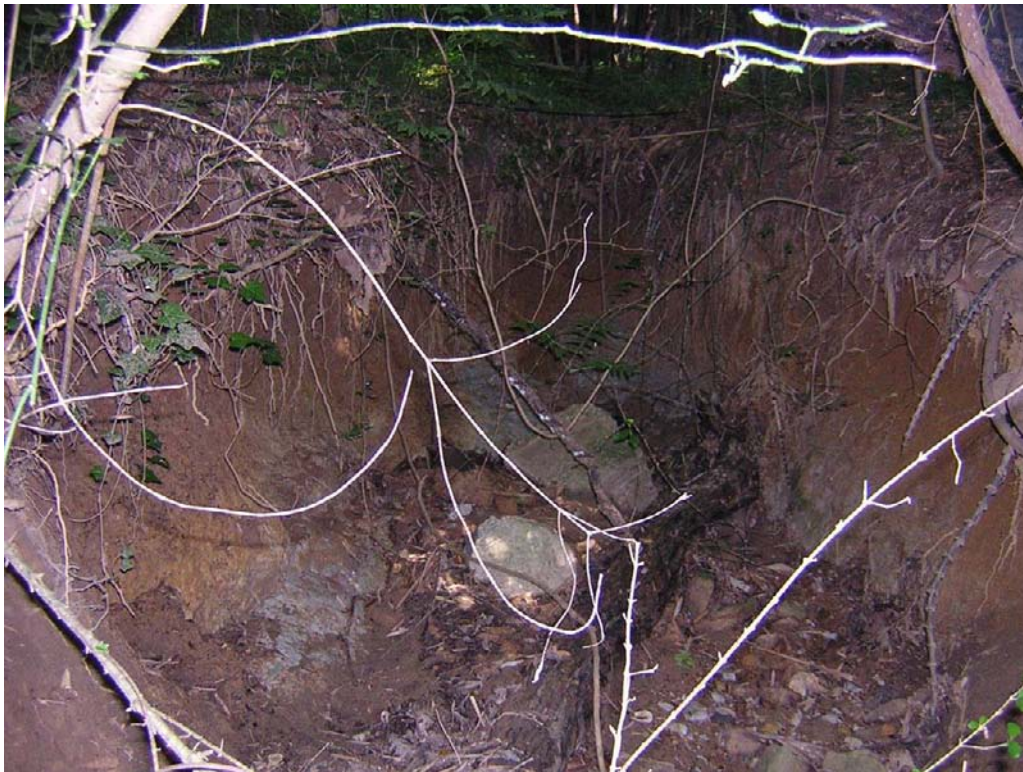
Site 29

One of the headcuts present at Site 29. Looking upstream.
