October 29, 2007

Re: Traffic Issues on Sedgefield Drive – No sidewalks, No traffic calming, No slowing down

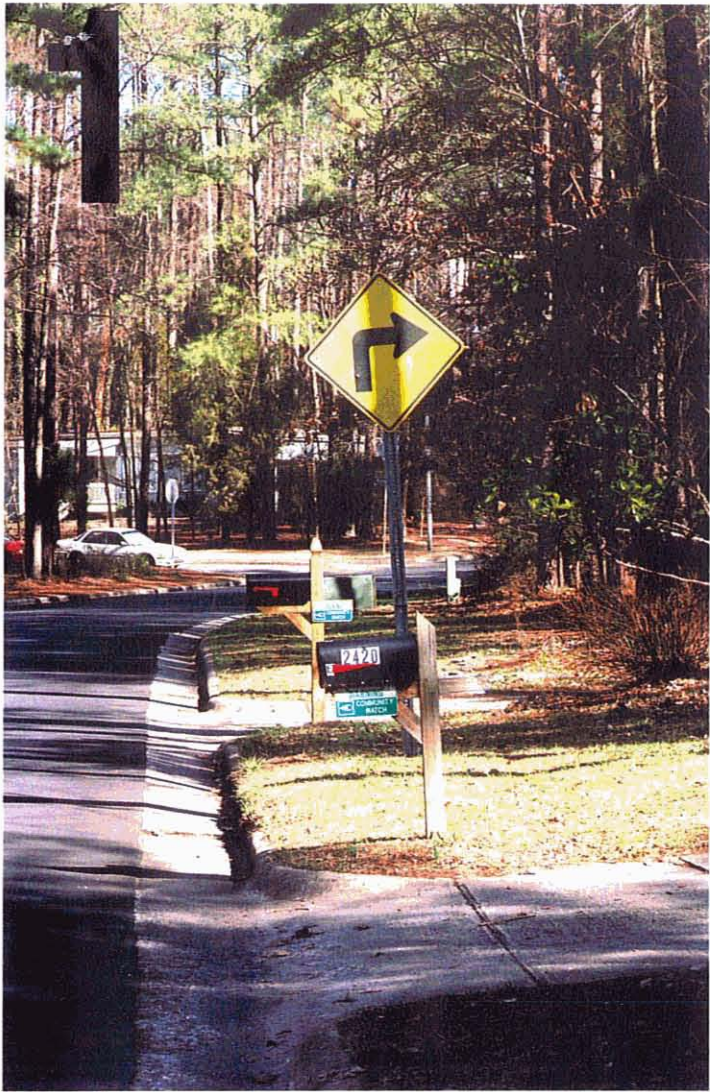
- 1.) A street sign is missing. I have enclosed a photo of the directional sign that was in place at #2420 Sedgefield Drive, but is no longer. I'd like to suggest that the Town take the opportunity to provide more information to drivers with its replacement sign, such as; 'Limited Sight Distance', 'Dangerous Curve', 'Hill Blocks View' or 'Our Kids' Safety is in Your Hands'. See photo # 1.
- 2.) Measure the pace of traffic on Sedgefield Drive. I have made this request in the past, without success. Police Department officials showed interest, but the Sharpe Unit turned out to be inoperative. Recently, I have seen the Sharpe Unit deployed in the Lake Forest neighborhood. Once the speed of vehicles is measured and analyzed, I believe you will have data showing some impressive numbers, in the wrong direction. See photo #2.

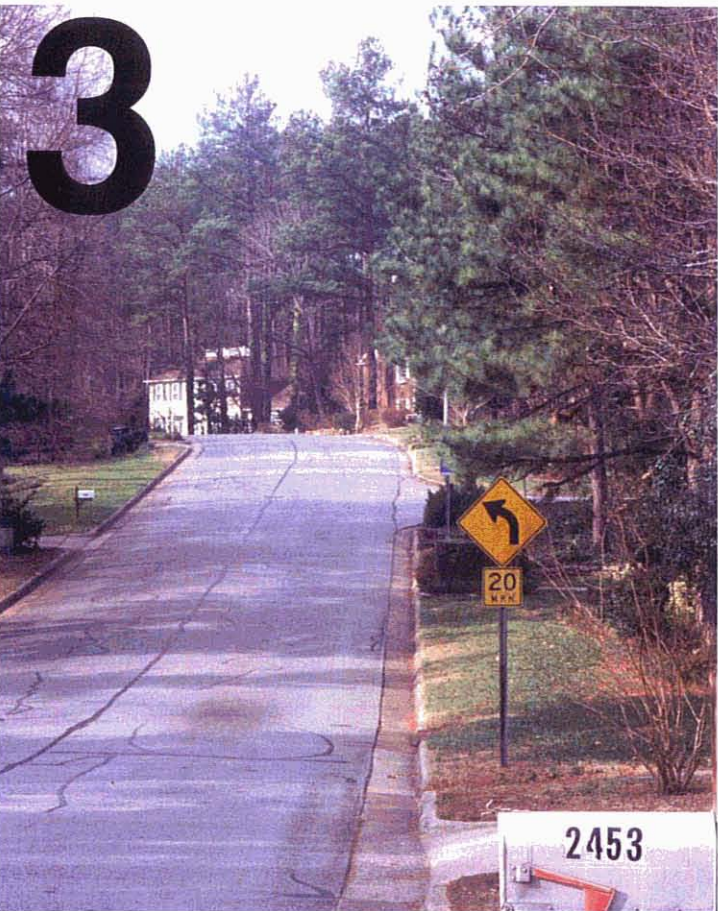
Review the safety of the walk zone found between #s 2451 & 2453 Sedgefield Drive. This walking path connects Sedgefield Drive and Weaver Dairy Road (near the entrance to Arcadia Lane). East Chapel Hill High School students walking to and from school use this path frequently. Bicyclists, pet walkers, runners and others also use it. The path deposits those using it directly into Sedgefield Drive, precisely at a point where drivers coming into the neighborhood are gaining speed on their first downhill run. There are no sidewalks on this street. See photo # 3.
