Appendix A-1: Streetscape Details

Franklin Street, Chapel Hill, NC Inventory and Management Plan, 2007

Franklin Street Tree Inventory 2007

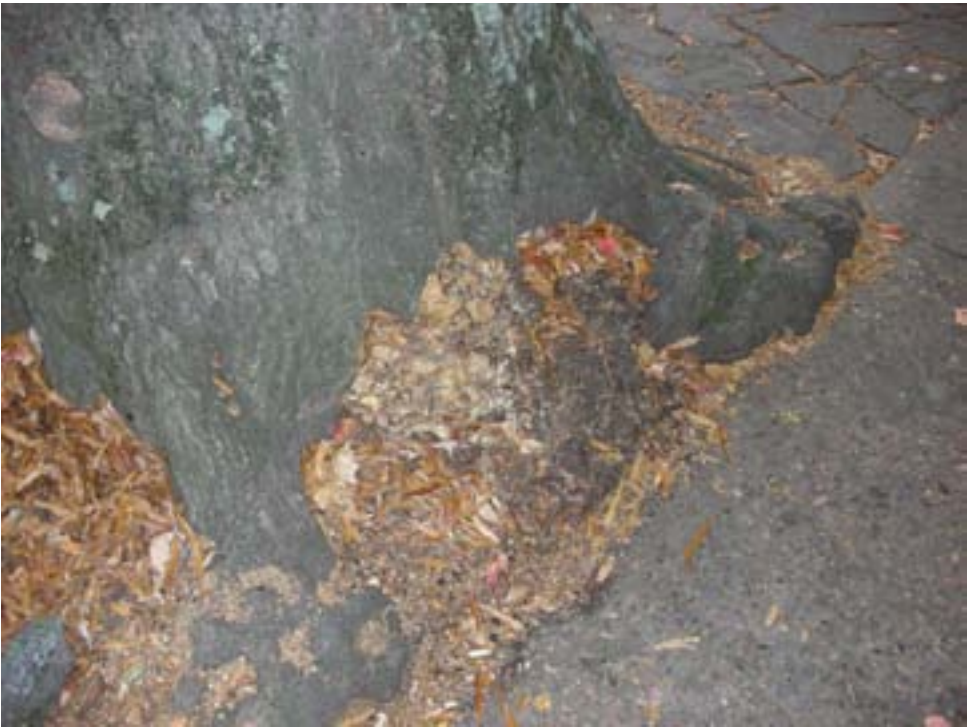
Figure 1. Conk on base of Tree # 11.

Tree #	Common	Diameter	Pest	Notes
11	willow oak	52	conk	
24	willow oak	47	seam/ stem	
78	pin oak	7	wounds/ stem	
87	Siberian elm	26	cavities/ crown	
90	American elm (non-resistant)	40	storm damage	broken branch
92	willow oak	27	cavities/ stem	
92	willow oak	27	conk	
93	willow oak	44	lean	
93	willow oak	44	cavities/ root collar	
93	willow oak	44	cavities/ crown	
94	willow oak	45	cavities/ crown	
98	American elm (non-resistant)	19	wounds/ stem	
102	Siberian elm	19	cavities/ crown	
119	American elm (non-resistant)	33	cavities/ root collar	
120	pin oak	4	wounds/ stem	
127	red maple	14	wounds/ stem	
135	sugar maple	13	wounds/ crown	
139	flowering dogwood	6	wounds/ crown	
147	green ash	55	cavities/ crown	hanger
159	American elm (non-resistant)	28	wounds/ crown	
171	little leaf Linden	12	cavities/ stem	hanger
177	little leaf Linden	10	girdiling roots suspected	
182	callery pear Bradford	17	wounds/ stem	
182	callery pear Bradford	17	storm damage

Tree #	Common	Diameter	Evaluation Type
9	willow oak	56	Climbing/Inspect
11	willow oak	52	Climbing/Inspect
11	willow oak	52	Drill Root Flare
24	willow oak	47	Climbing/Inspect
24	willow oak	47	Drill Stem
87	Siberian elm	26	Climbing/Inspect
92	willow oak	27	Drill Root Flare
93	willow oak	44	Drill Stem
93	willow oak	44	Climbing/Inspect
93	willow oak	44	Drill Root Flare
94	willow oak	45	Climbing/Inspect
102	Siberian elm	19	Climbing/Inspect
119	American elm (non-resistant)	33	Drill Root Flare
147	green ash	55	Drill Stem
147	green ash	55	Climbing/Inspect
171	little leaf Linden	12	Drill Stem
185	willow oak	36	Climbing/Inspect

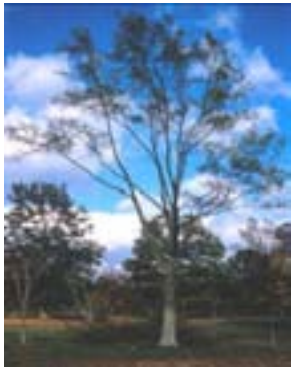
- Lion tailing – Pruning that removes interior branches along the stem and scaffold branches
- Topping – Reduction of tree’s size by using heading cuts that shorten branches to a predetermined size.

Figure 14. Lion tailed tree (unacceptable pruning practice)

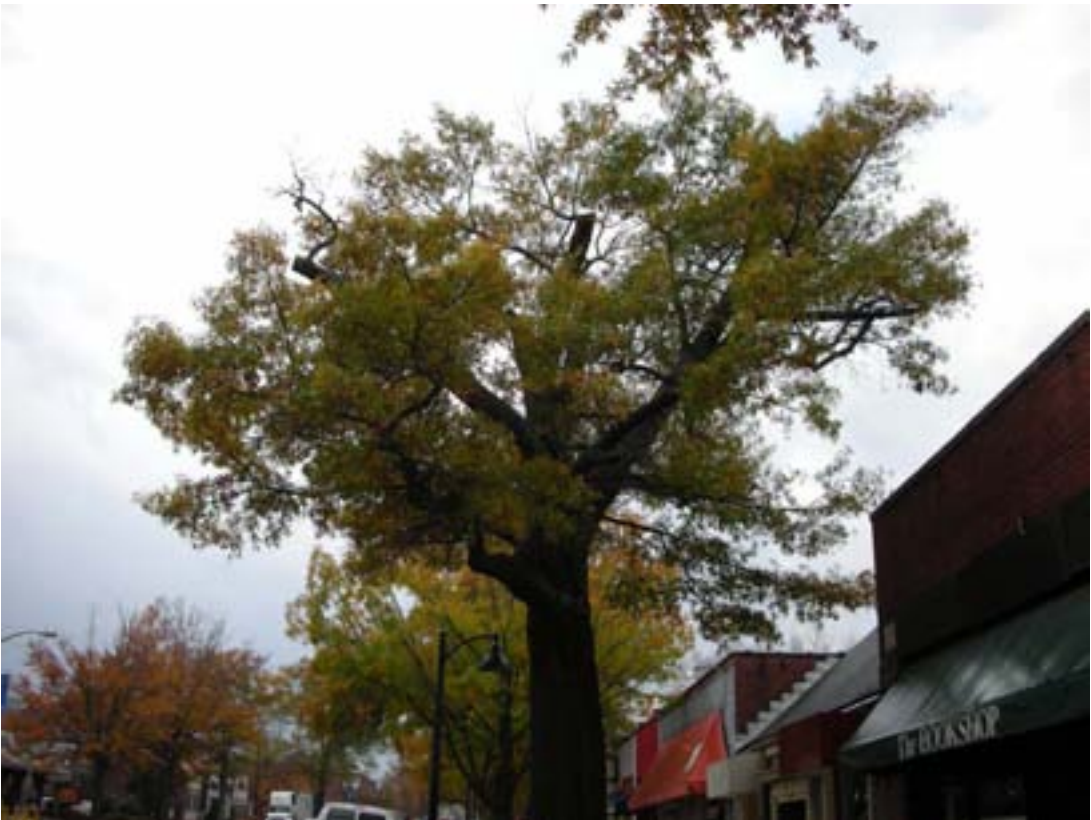
Figure 11. Tree # 24

The following trees are showing signs of decline. Trees listed as 1 Priority contain potentially hazardous deadwood. In an attempt to maintain the mature tree population along Franklin Street pruning these trees may promote health, and will improve aesthetics. However, these trees are showing signs of decline. Removal of these trees may be considered a due course of action.

Tree #	Common	Dia	GTW Type	GTW Pri	Location
24	willow oak	47	REMOVAL or CLEAN	1 Priority	17th east of N Roberson
118	American elm (non-resistant)	30	REMOVAL or CLEAN	1 Priority	20th west of Raleigh
119	American elm (non-resistant)	33	REMOVAL or CLEAN	1 Priority	21st west of Raleigh
127	red maple	14	REMOVAL or CLEAN	1 Priority	20th east of S Columbia
168	willow oak	17	REMOVAL or CLEAN	1 Priority	15th east of S Roberson
169	willow oak	21	REMOVAL or CLEAN	1 Priority	14th east of S Roberson
184	willow oak	24	REMOVAL or CLEAN	1 Priority	2nd east of S Merritt Mill

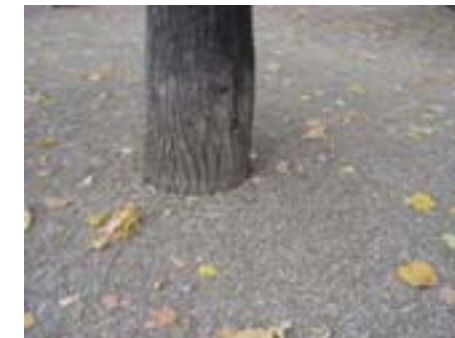
Root collar excavations are recommended for those trees whose buttress roots are covered by excess soil or mulch. Buried root collars can contribute to a number of tree health problems including: development of girdling roots, basal cankers, and masking root and lower stem decay. (Refer to *Root Collar Disorder* Technical Report)

Figure 16. Example of buried root collar
