**NC 86/Airport Road Pedestrian and Bicycle Safety and Mobility Study:
Chapel Hill Community Mobility and Health Initiative**

**Final Report
prepared for the
Town of Chapel Hill, North Carolina**

**The Highway Safety Research Center
Of the University of North Carolina
Chapel Hill, North Carolina**

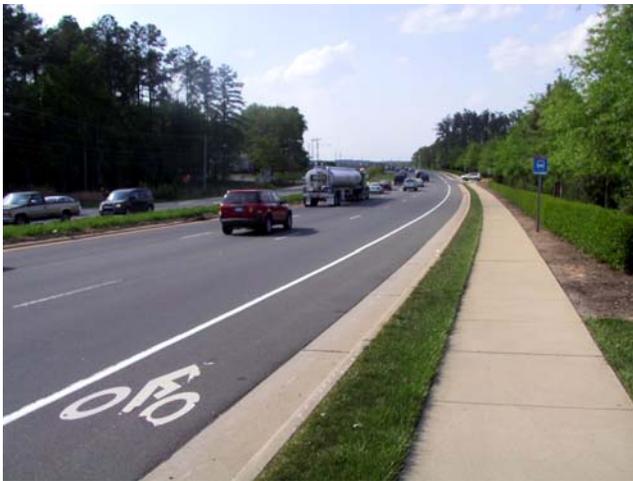
- From I – 40 south to Homestead Road, Airport Road is a raised-median divided four-lane, consisting of two through lanes in each direction, with bike lanes on each side. There are curbs, approximately 4’ grass-only buffer strips, and sidewalks on both sides, with dedicated turn lanes added at intersections.

The roadway itself has three major cross-sectional areas (shown in fig. 2):

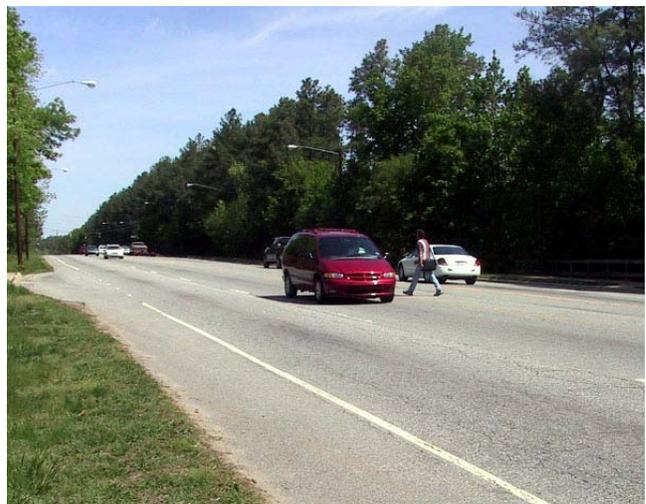
Airport Road area with paved shoulders, TWLTL

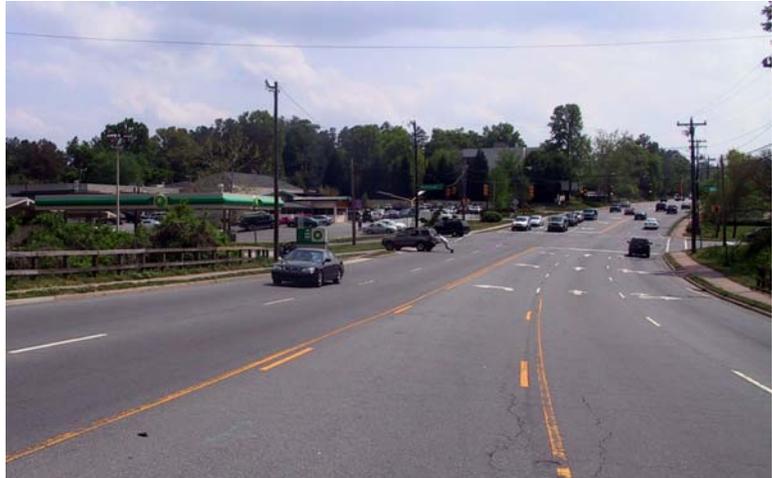
- Estes Road south to North Street continues the 5 lanes with TWLTL, but with wide outside lanes instead of paved

Segment of Airport Road with wide outside lanes, TWLTL

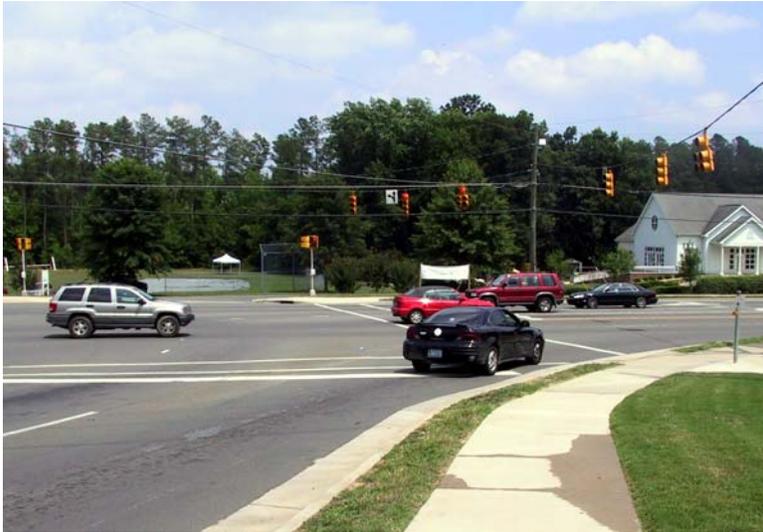
Wide curb radius and right-turn-on-red at Homestead Road

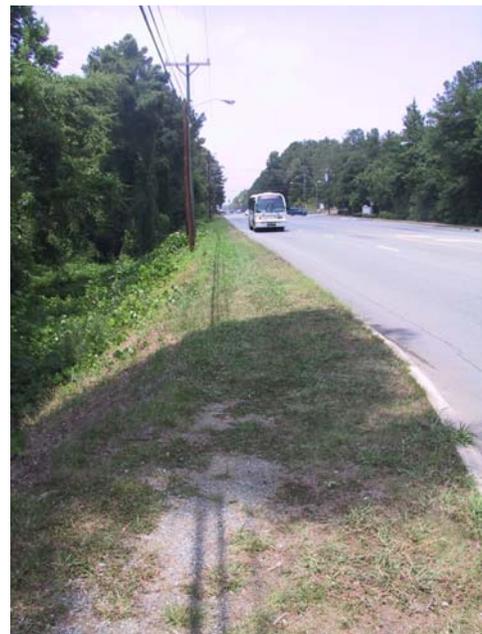
No sidewalk access on west side of Airport Road leading to YMCA stop

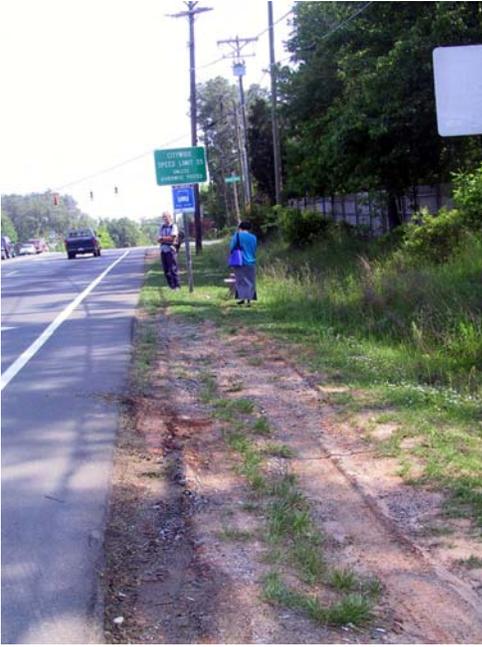
No sidewalk leading to bus stop between Northwoods Drive and Weaver Dairy Road

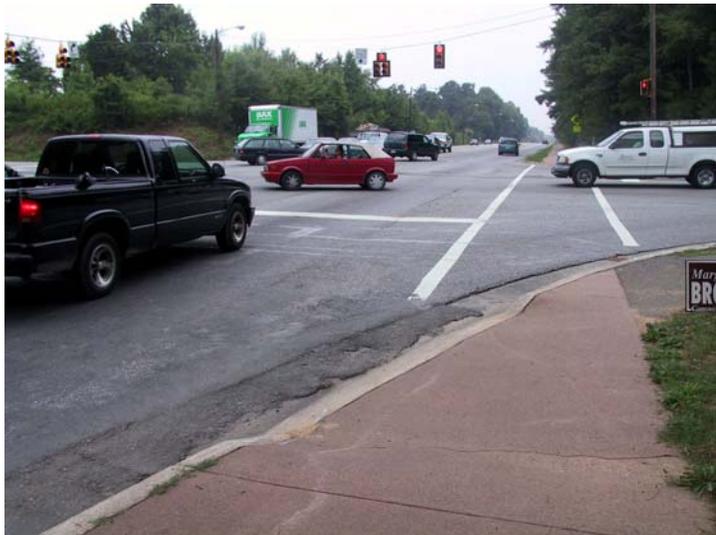
Single corner curb cut is misaligned with crosswalk at Estes Drive.

- *Add proper curb cuts to all pedestrian crossing locations - two curb cuts per corner, aligned with crosswalks / crossing areas.*
- *Add curb cuts and median pockets where needed, including at midblock transit stops.*

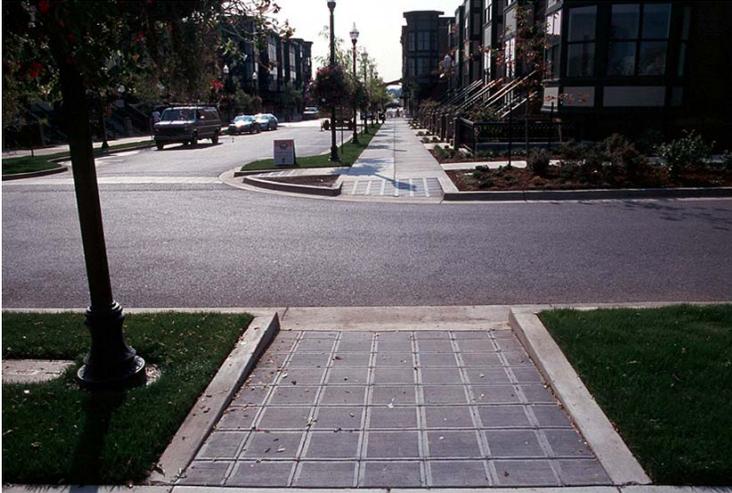
Well-designed curb cuts in line with sidewalk and crossing and recently-planted street trees, Hillsboro, OR (D. Burden)

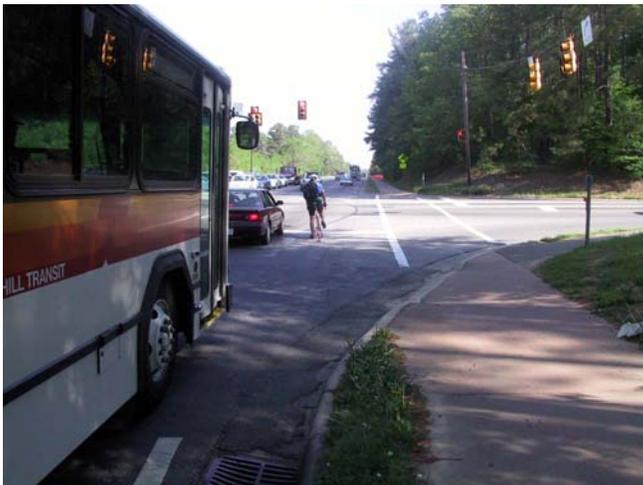
Estes Drive intersection with Airport Road is a hazardous one for bicyclists.

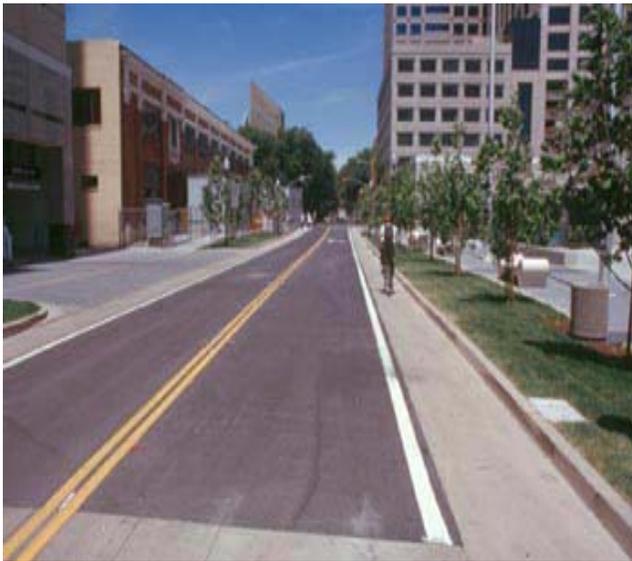
Different paving treatments such as this concrete bike lane may enhance conspicuity of bicyclists and visually narrow the roadway. (Photo, D. Burden)

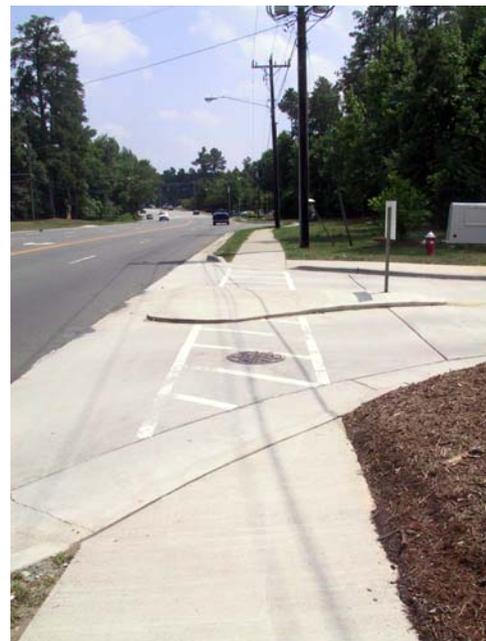
Diverter intended to restrict left turns at this driveway lacks curb cuts and creates an obstacle for pedestrians.

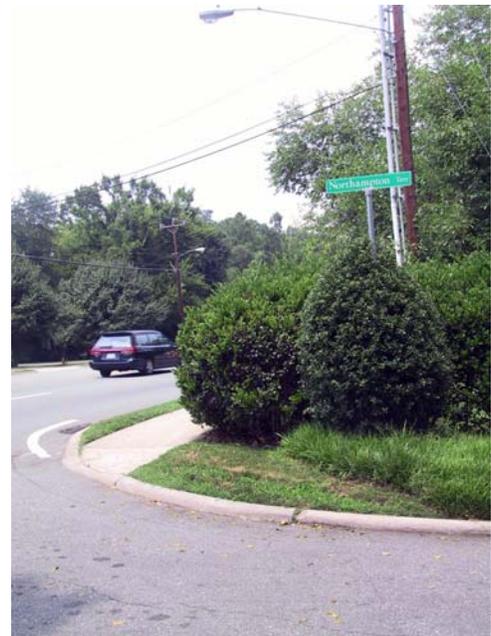
Sight distance is an issue at many side streets and driveways.

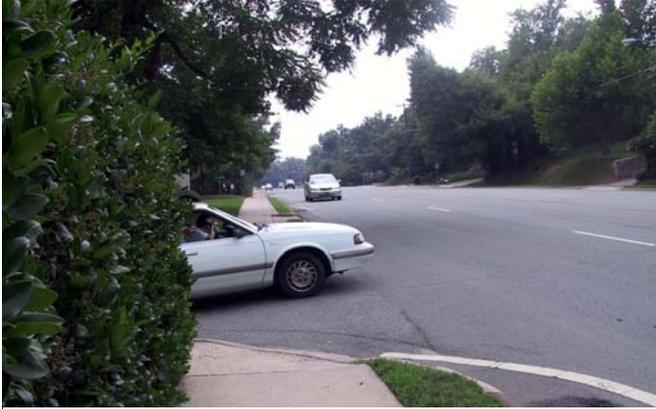
Motorists must pull across the walkway crossing area to view either pedestrians or oncoming traffic.

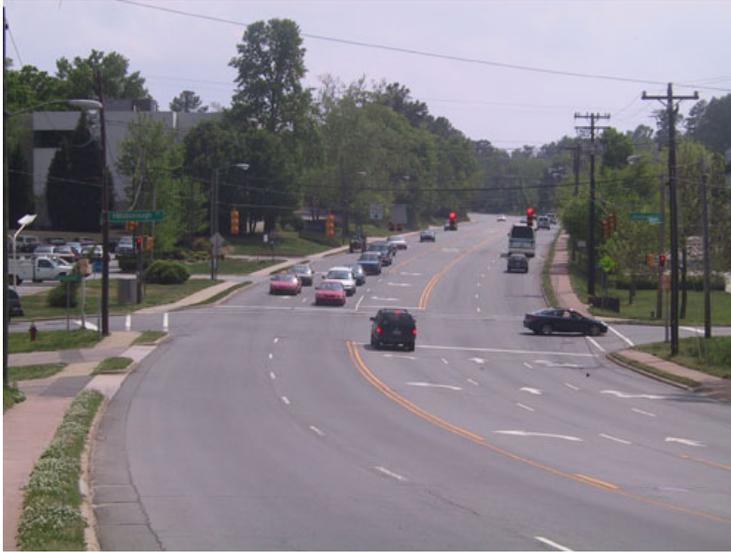
Hillsborough Road area - steep grades, poor sight distance, and multiple driveways create hazardous conditions for bicyclists and pedestrians.

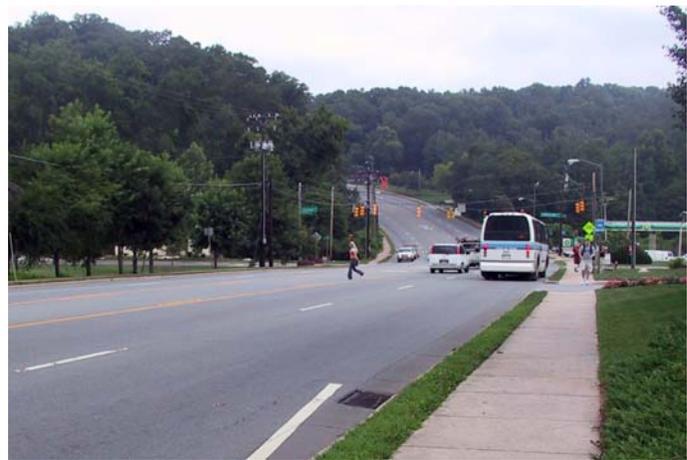
Bus stop midblock dash (Note the hazardous drainage grates that reduce usable bicyclist space.)

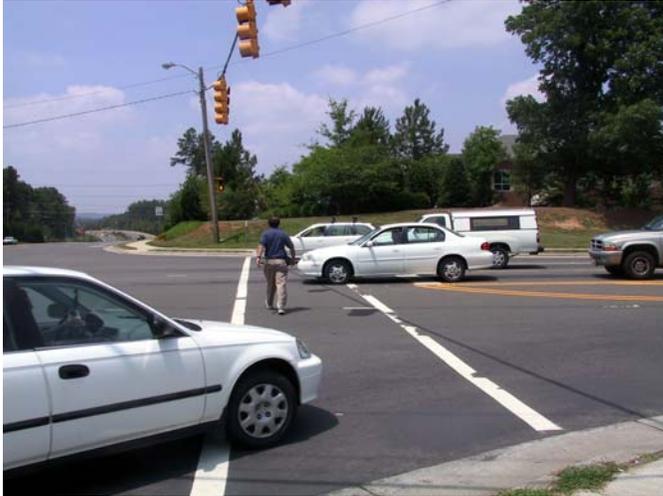
Crossing a wide Weaver Dairy intersection with turning cars and cars encroaching into crosswalk

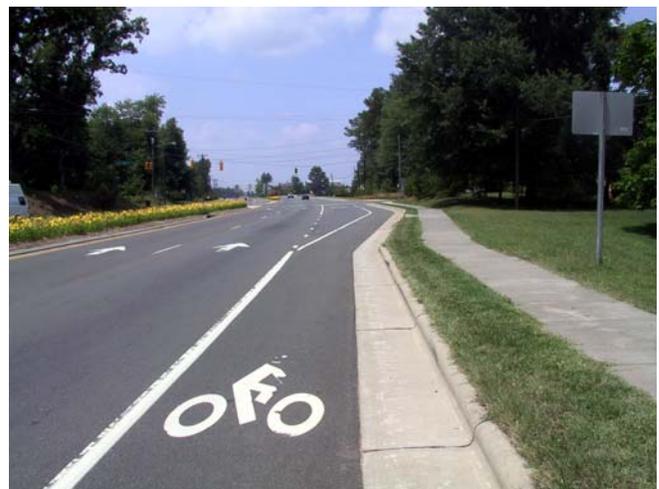
Bike pockets for through bicyclists should be striped to the left of right-turn only lanes.

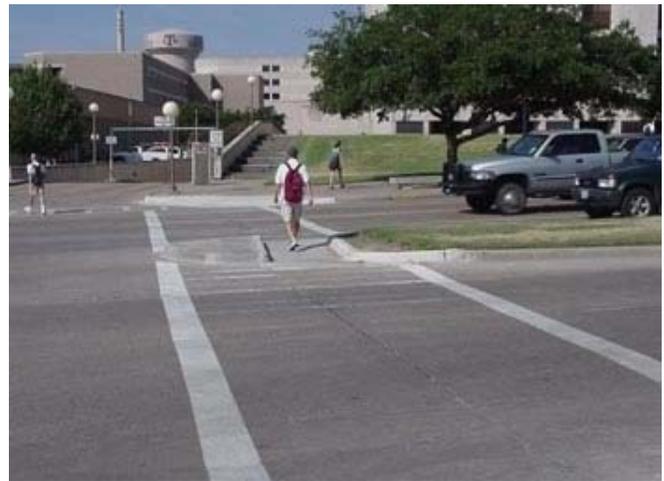
Median may be extended to create a refuge at intersections. (photo, ITE Pedestrian and Bicycle Council)

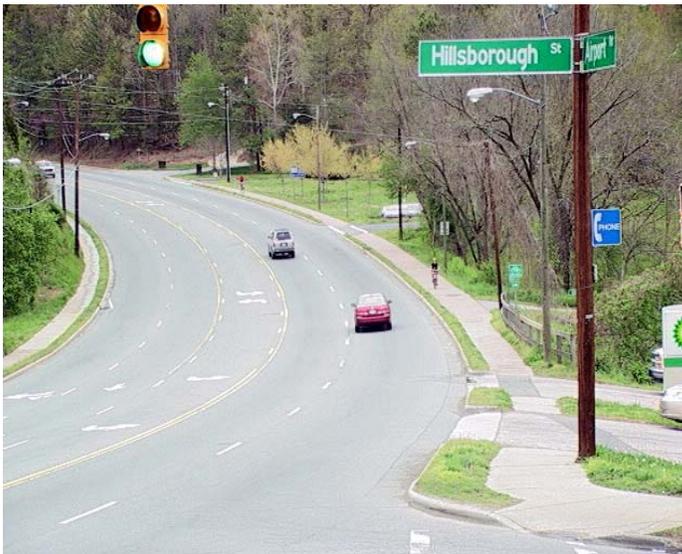
Currently, east side only access to the Bolin Creek trail from Airport Road contributes to sidewalk / wrong-way riding.

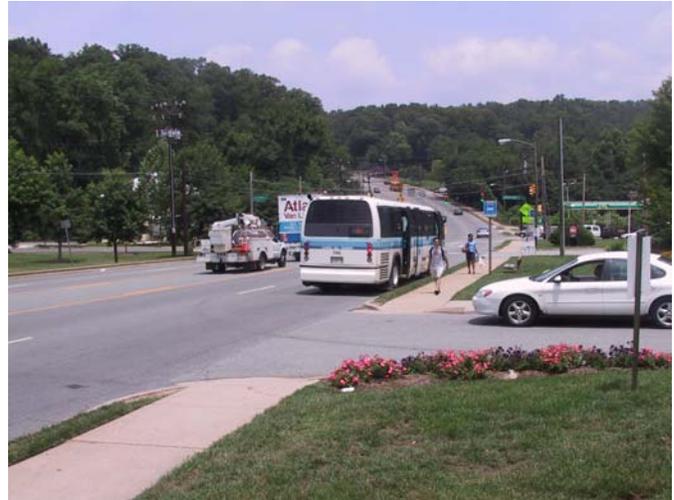
Alighting pedestrians may face conflicts with vehicles turning in and out of commercial driveways.
