Chapel Hill Parks & Trails Assessment

December 2008

Susan Hatchell
Landscape Architecture, PLLC

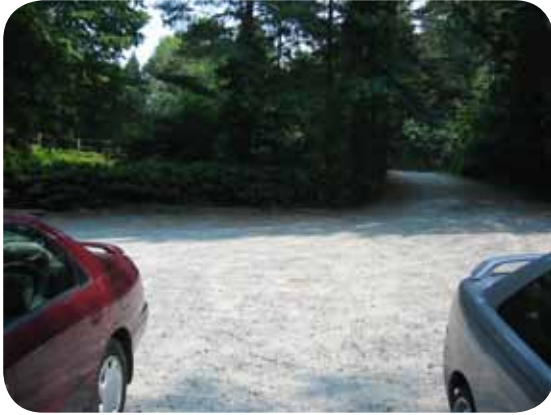
1 The existing parking lot and entrance drive are gravel with wooden edging along the perimeter. The gravel needs to be replenished and the parking lot needs to be enlarged to accommodate new ADA accessible parking.

The gravel parking lot needs to have new gravel installed with metal edging or it needs to be paved. The parking lot should be enlarged to accommodate eight standard parking spaces.

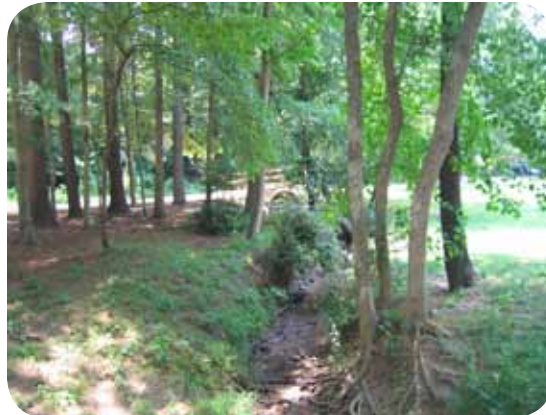
2 The stream is in need of restoration work since the stream banks are unstable and debris is clogging the natural channel.

3. Complete a stream restoration project to restore the creek. It is recommended that the Town discuss the restoration with the North Carolina Department of Natural Resources (NCDENR), the Orange County Stormwater Management Division of Water Quality, or another restoration program such as the Ecosystem Enhancement Program.

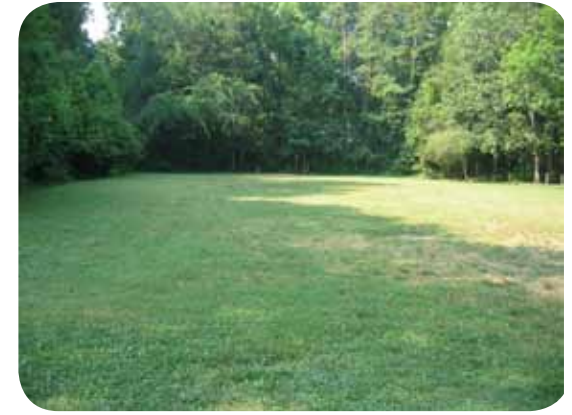
3 The open field has bare areas in the lawn and needs to be aerated and reseeded.

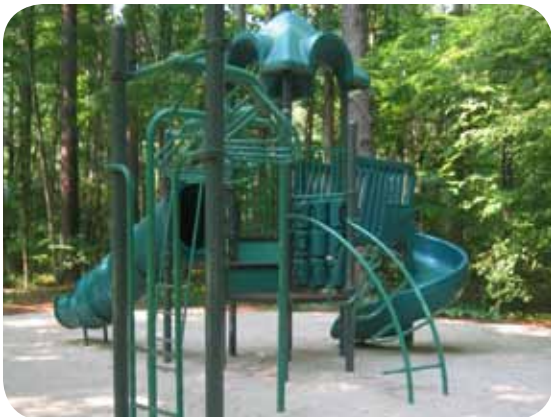
4 The main playground area is divided into two spaces. The area shown above is newer and includes a composite play structure. The playground surfacing needs to be replaced and edging needs to be installed to define the area and contain the safety surfacing.

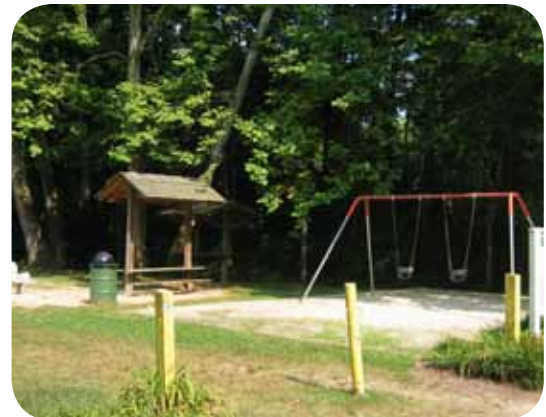
5 The older playground area has dated equipment with inadequate fall zones and safety surfacing. There are no ADA accessible routes to either play area.

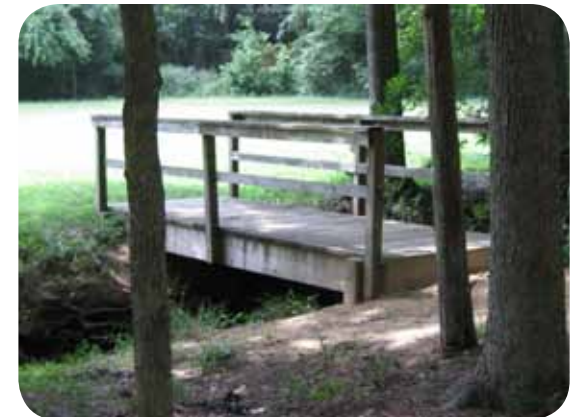
6 The wooden bridges on the site should be replaced. The wood decking is splitting and rotting in some areas and the concrete supports are crumbling.

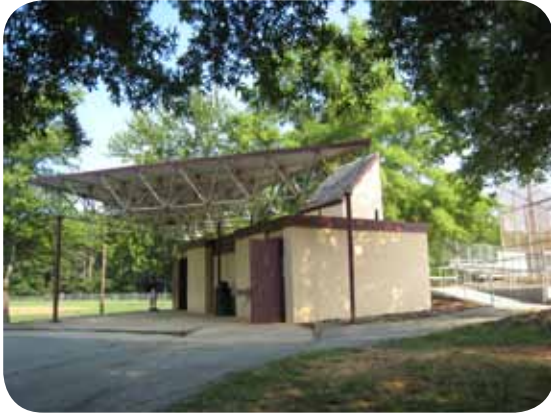
The restroom building is not ADA compliant for several reasons. The building is located more than 200 feet away from the ADA accessible parking. The route to the building exceeds 5% in slope and so it is not ADA accessible. The position and locations of the plumbing fixtures and accessories in both bathrooms are not ADA compliant. Also, the only water fountain is not ADA accessible because it is not a high/low model.

The roof drains and gutters are clogged and structural materials are rotting or rusting. The finished grade behind the building adjacent to the new ADA accessible ramp is not allowing water to drain away from the building's foundation. Mulch is covering a portion of the buildings exterior wall, which will continue to retain moisture against the wooden surface.

The Restroom Building has various Electrical Code and ordinance violations including broken or disconnected conduit, non compliant receptacles, and misaligned occupancy sensors.

1 The restroom building has definite value and potential for public use, but requires renovations for compliance with ADA accessibility, Electrical Code, Mechanical Code, and Town ordinances. The building also requires increased maintenance.

At the restroom building, install an ADA accessible water fountain and patch and paint the CMU wall. Widen the bathroom stalls and remove one stall in the women's bathroom to accommodate the required clear floor area for ADA accessibility. Add grab bars in each stall and reinstall the hand blowers to be ADA compliant. Replace the urinal in the men's bathroom.

Rework the dislodged or loose conduit and cap uncapped openings in the electrical boxes at the restroom building. Also, replace quadruplex receptacles with in-use types.

At the restroom building, replace toilet and faucet in the women's bathroom and the urinal and faucet in the men's bathroom. Replace fluorescent light fixtures and realign the occupancy sensor in the men's bathroom. Unclog the roof drains and install protective covers over the baskets. Repair the wood framed wall around the mechanical room entrance and replace the metal door. Replace the rotten wood stud framing and T-111 siding. Replace the rotting plywood sheathing and recover the roof with tar and gravel roofing. Paint steel base plate and steel bearings.

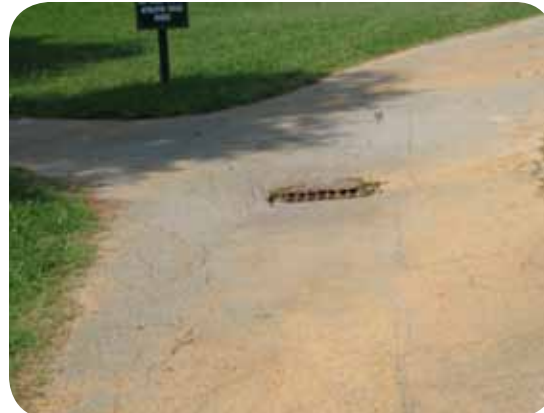
The major paved asphalt trails are crumbling along the edges and around the seams and where they abut with other paved areas. All of the trails have vegetation growing over the edges as well as coming up through cracks. This vegetation will compromise the structural integrity of the trail over time.

2 Paved trails throughout the park are not ADA accessible. The entire storm drainage system at Cedar Falls Park needs to be evaluated and most likely renovated.

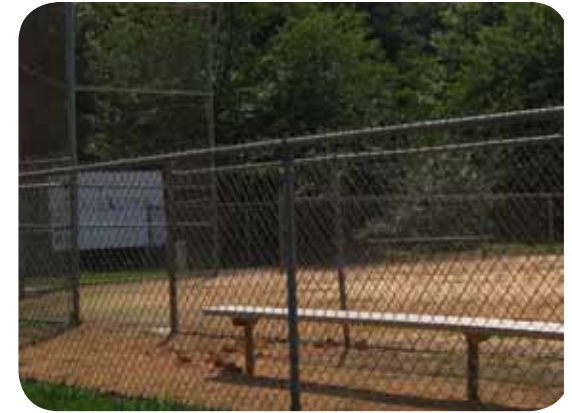
3 At each of the four ballfields, the adjacent players benches need to be reset at the correct height. The galvanized chain-link fence fabric should be replaced at the backstops, and all of the scoreboards need to be replaced.

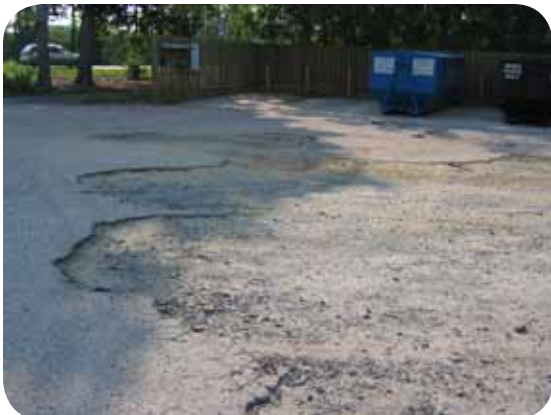
4 The parking lot is made up of concrete, asphalt, and gravel surfacing. The entire parking lot should be demolished and redesigned to accommodate vehicular traffic for the park and the recycling center.

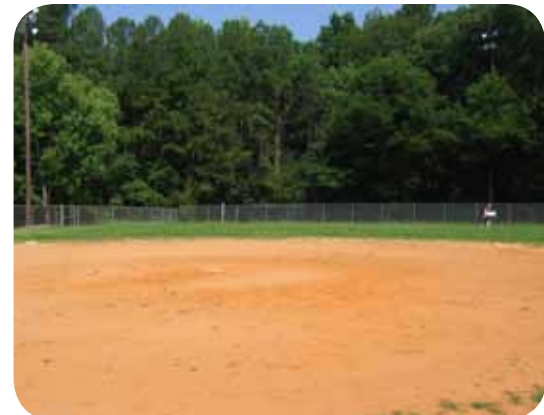
5 The ballfields need to be regraded to allow water to drain off of the infield and not towards home plate.

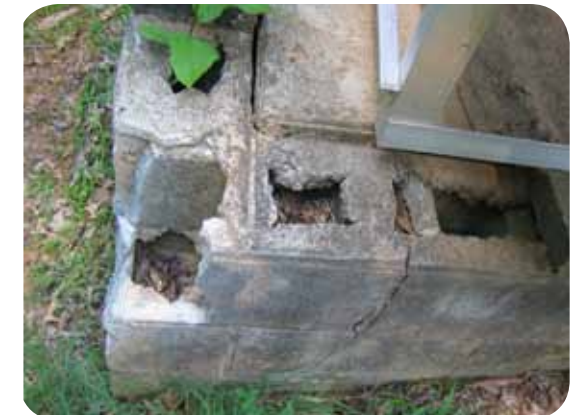
6 The concrete block walls supporting the bleachers at each of the ballfields are in need of replacement. The existing concrete pad for the bleachers is not adequately sized for pedestrian circulation and it does not accommodate an ADA accessible route or seating area adjacent to the bleachers.

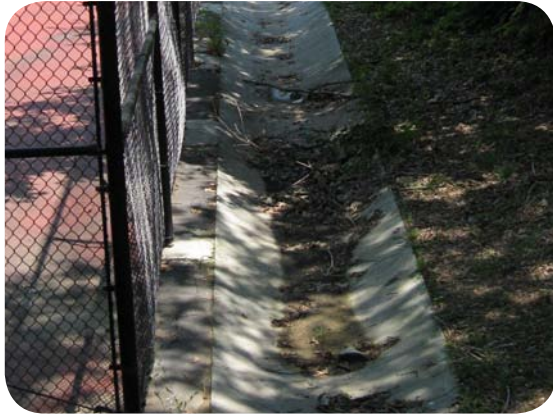
1 The swales adjacent to the tennis court need to be maintained on a regular basis. Shallow depth to bedrock prevents the swales from being replaced. The adjacent court is being undermined by the water caused by the build-up of debris.

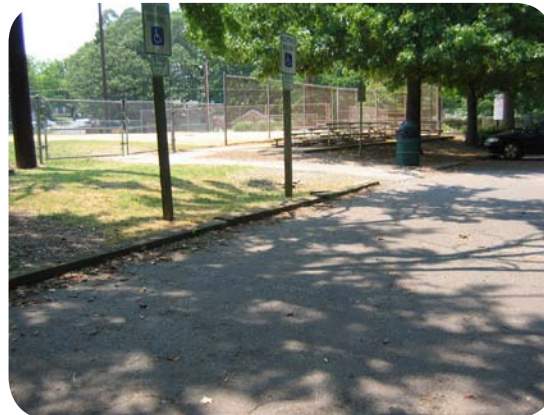
2 The four parking lots throughout the park need to be repaved, restriped, and reorganized to accommodate the correct number and size of the required ADA accessible spaces. Parking lot #4, shown above, needs ADA accessible van parking.

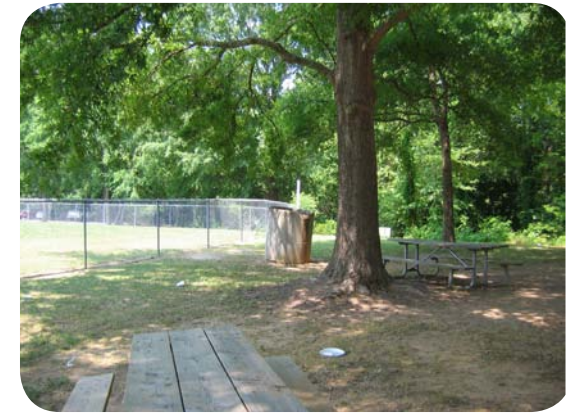
3 The picnic area adjacent to the ballfield does not have an ADA accessible route or ADA accessible site furnishings. An ADA accessible route needs to be installed from the ADA accessible parking at parking lot #4 to the picnic area, with access to the basketball court and the gymnasium entrance.

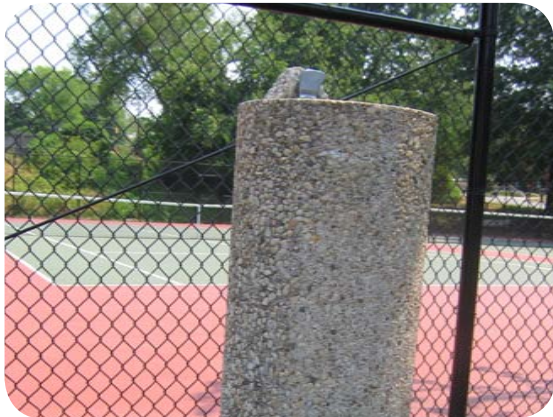
4 The water fountain at the tennis courts needs to be replaced with an ADA accessible high/low model. The fountain also needs to be located along an ADA accessible walkway from parking lot #1 to the tennis courts. Currently, the route is not accessible because the slope exceeds 5%.

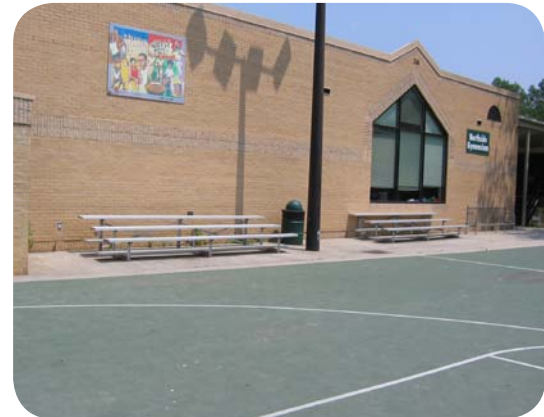
5 The basketball court will need to be resurfaced and restriped in the next few years. To reduce the amount of hardscape in this area and make the basketball court more climate friendly, shade trees should be installed between parking lot #3 and the basketball court.

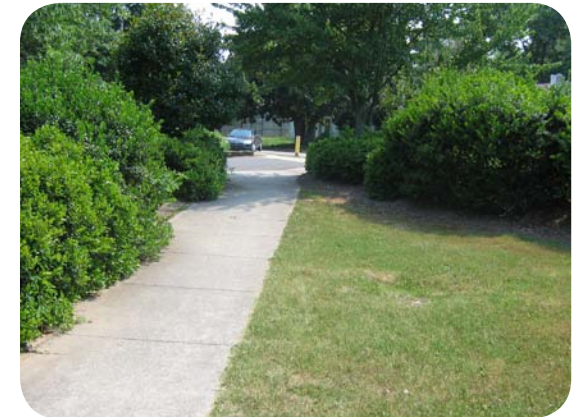
The park contains a variety of planting for slope stabilization and foundation plantings. Most of the existing vegetation is overgrown and presents a safety and security concern. The planted area in front of the Community Center does not have adequate lighting and obscures sections of the sidewalk. The planting along the steep banks adjacent to parking lot #4 is overgrown and weedy. Park users have been walking up this slope to enter the park from the bus stop in a more direct route that has become a worn earthen trail. Other areas throughout the park such as the area in front of parking lot #2 contain weedy lawn areas that need to be maintained.

6 The existing landscaping throughout the park is overgrown and needs to be removed. A planting plan should be prepared for the area in front of the Community Center, shown above, and for the steep slopes surrounding the park.

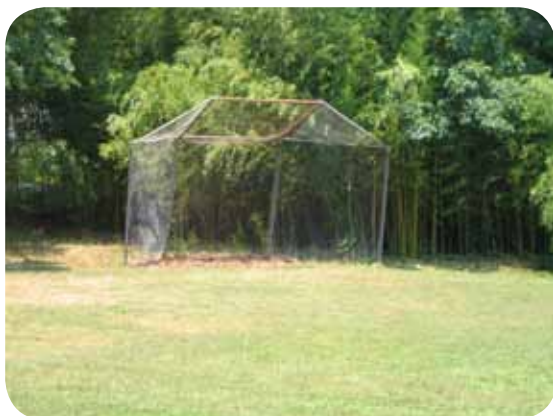
1 The existing open play field needs to be regraded with a swale added to divert water from the center of the field.

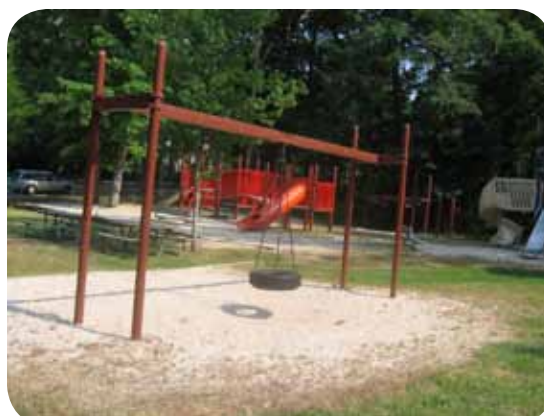
2 The playground equipment is dated and should be replaced. A new playground should be designed for this space with the possible addition of a picnic shelter.

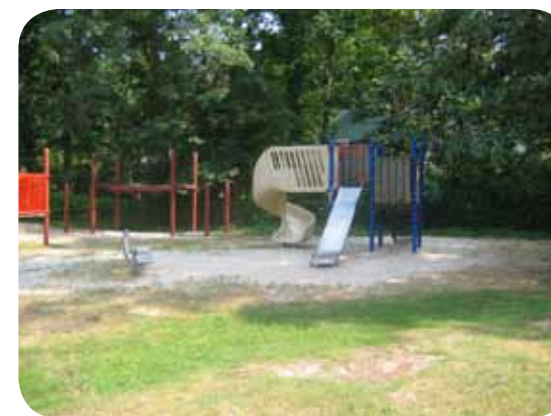
3 The safety surfacing needs to be removed and replaced with engineered wood fiber or poured-in-place rubber surfacing. Edging should be installed to ensure adequate safety surfacing remains within the fall zone.

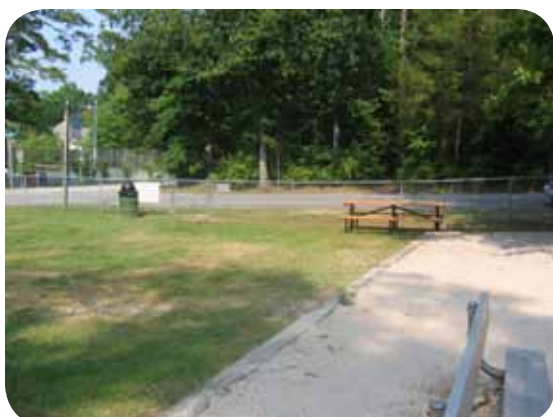
4 Older site furnishings should be replaced. New benches, waste receptacles and ADA accessible picnic tables need to be installed along an ADA accessible route.

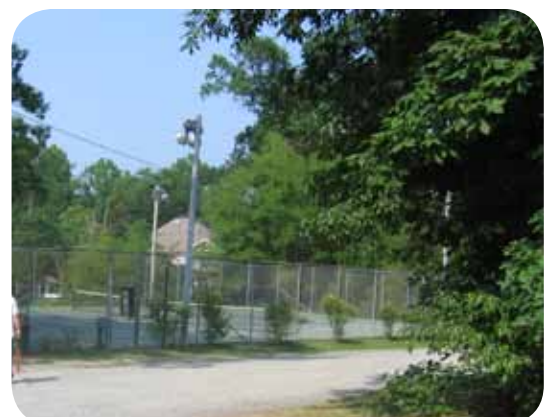
5 The tennis court needs new vinyl coated chain-link fencing. The vegetation along the perimeter of the tennis court needs to be removed. An ADA accessible route should be installed from the sidewalk to the tennis court.

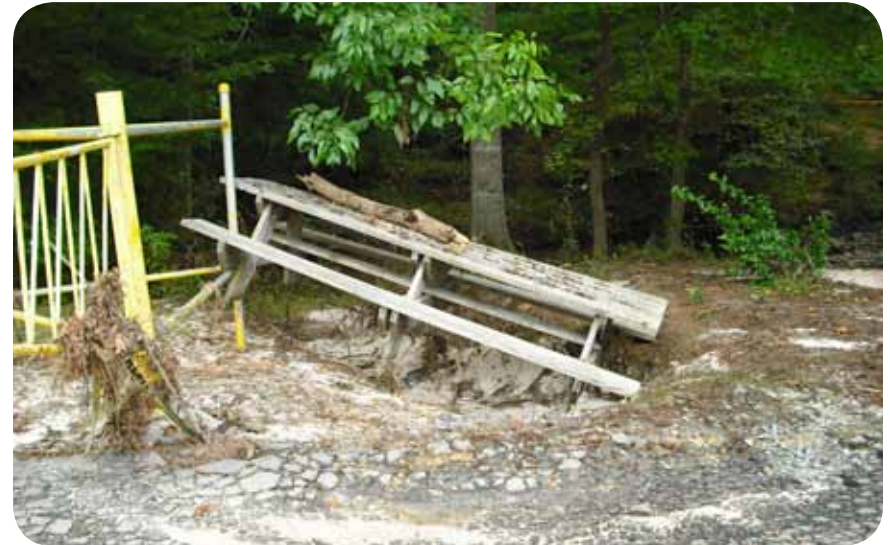
Image of flood damage after Hurricane Hannah during the summer of 2008.
Photo courtesy of the Town of Chapel Hill.

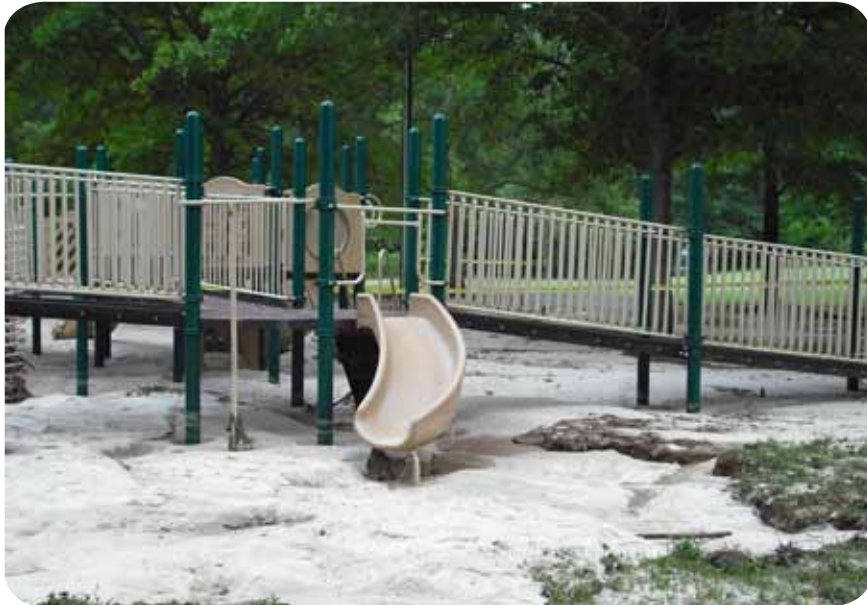
Image of flood damage after Hurricane Hannah during the summer of 2008.
Photo courtesy of the Town of Chapel Hill.

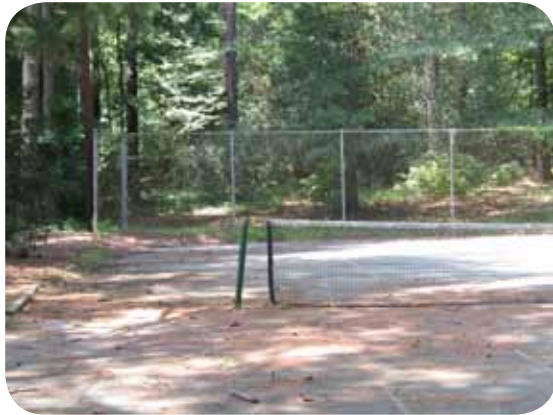
1 To keep the tennis court in its current location, the entire court and fence should be demolished and replaced with a new court system and vinyl coated chain-link fence, set at a higher finished grade. The surrounding vegetation needs to be trimmed and all vines need to be removed from the area.

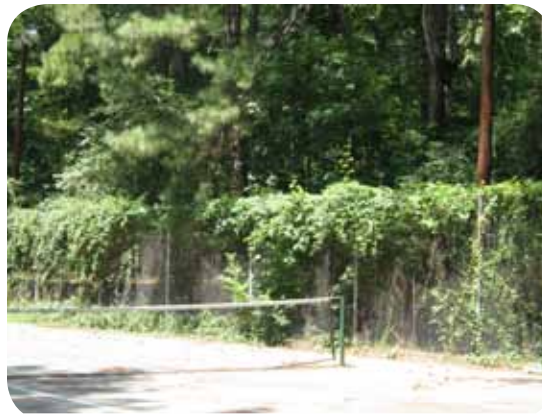
2 All vegetation should be removed from fence fabric, poles, and posts surrounding the ballfield and tennis courts.

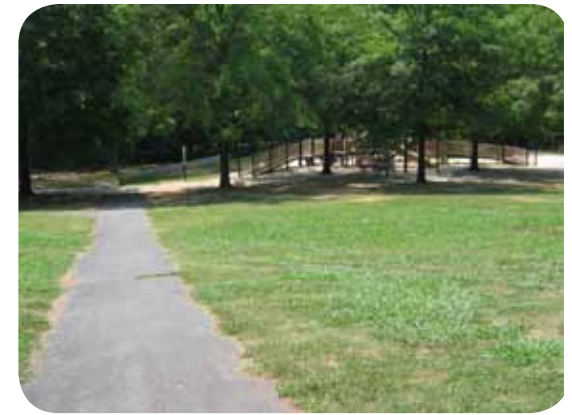
3 ADA accessible routes need to be installed to all of the park facilities including the basketball court, picnic shelters, playground, baseball field, and tennis court. The route shown is between the picnic shelter with restroom and the playground. The slope exceeds 5% and vegetation is growing over and onto the walk.

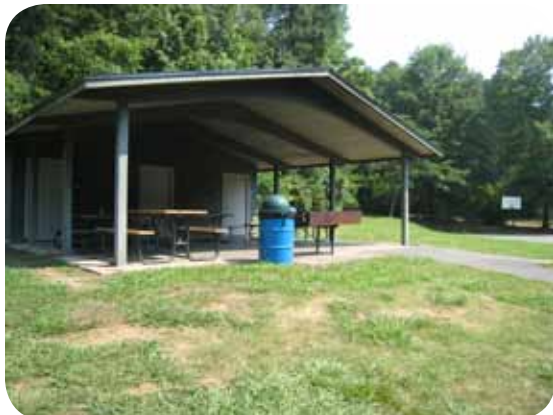
4 The shelter building with the restroom does not have adequate interior drainage, because the wall drains have been closed off during recent renovations. Water is trapped in the building and damage is present on the block walls. Reopen drains and add one in each of the men's and women's bathrooms.

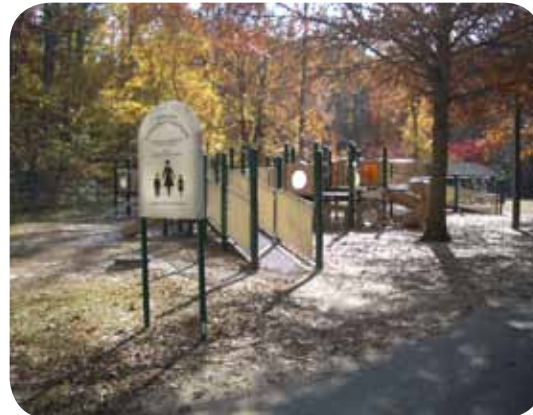
5 The playground is outdated and does not have an adequate depth of mulch or fall zones. It is recommended that a new playground be installed outside of the floodplain.

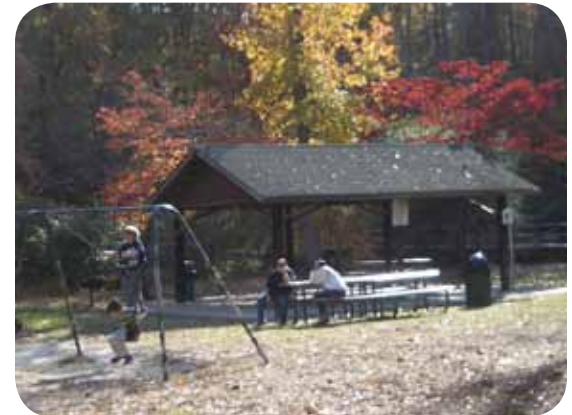
6 The picnic shelter is unstable and not adequately anchored. The structure should be removed from the floodplain.

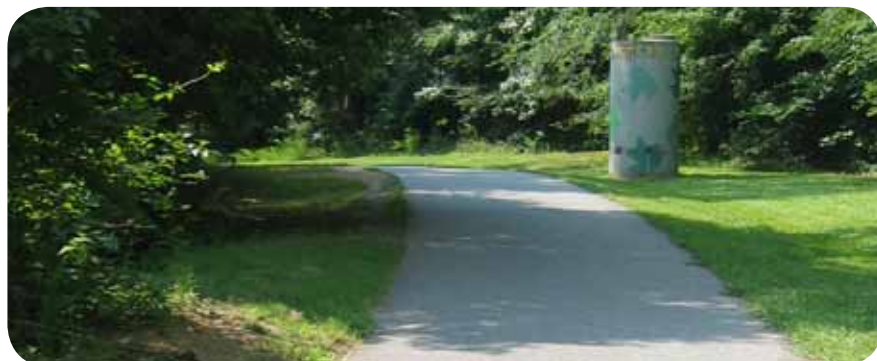
The Bolin Creek Greenway trail is showing signs of wear. The asphalt is cracking in many places. There are portions of the asphalt trail that have been widened by the addition of asphalt strips on either side of the trail's surface. Those seams and other cracks along the trail are allowing weeds and vines to grow through the asphalt. Vegetation is growing over

the edges of the trail on both the asphalt and concrete sections.

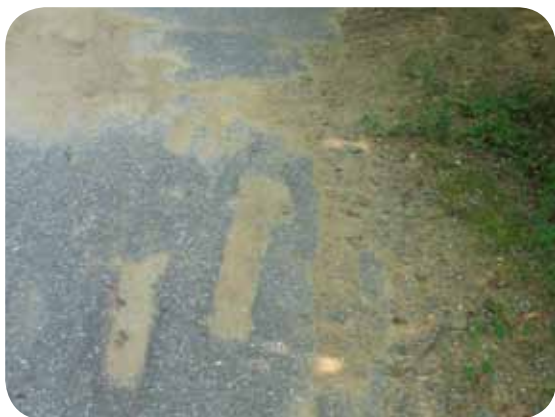
1 The length of the corridor has vegetation encroaching the edges of the trail's surface and causing the trail to crumble and crack. Sediment is also an issue due to clogged drainage pipes. The surface condition of the asphalt paving is fair, except for damaged areas such as the equipment damage shown above.

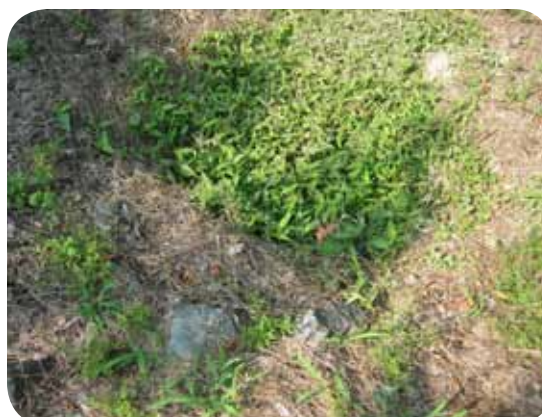
2 Clogged drainage pipes and culverts are increasing flood-related issues along this trail, including the deposits of sediment and leaf litter along the trail's surface.

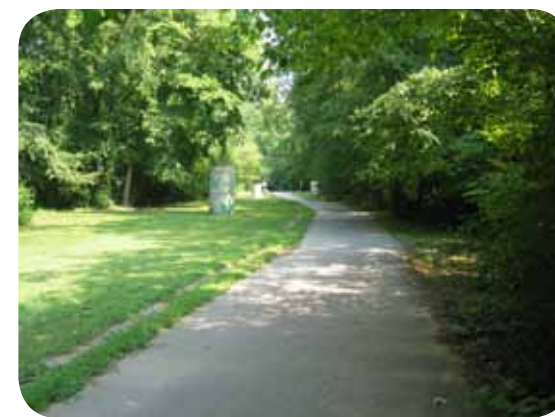
3 The trail runs along a sewer easement adjacent to the Bolin Creek. A worn path adjacent to the trail is heavily used by runners and joggers.

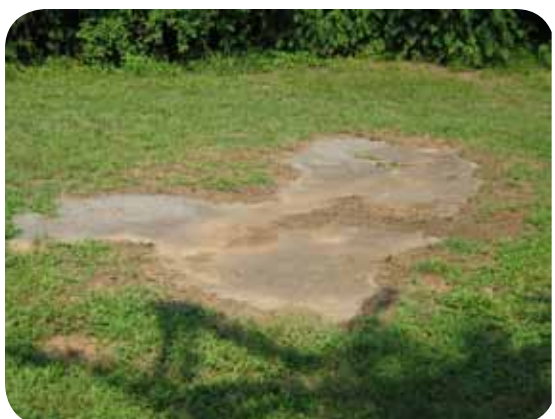
4 Areas such as this pavement should be removed from the greenway corridor, particularly since it is in the floodway of Bolin Creek. Pavement such as this is not usable, increases the impervious surface within the floodway, and is not aesthetically pleasing.

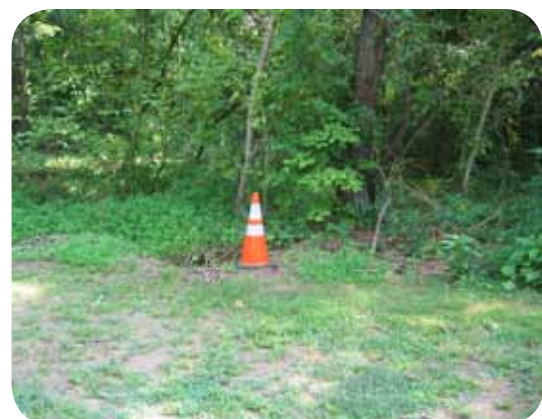
5 Large ruts, holes from uprooted trees, and animal dens should be filled in along the trail corridor to prevent a potentially hazardous situation for trail users and maintenance vehicles.

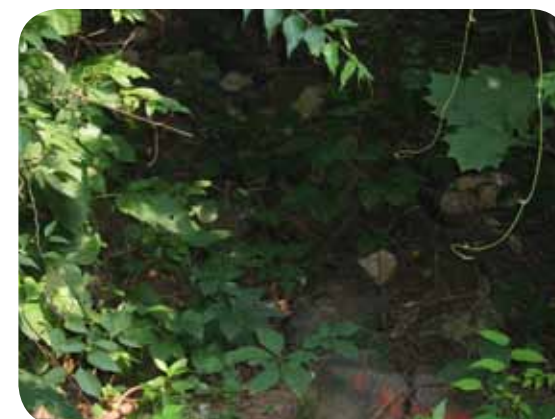
6 Major drainage problems along trail corridors should be addressed by staff or by an outside contractor when storm water issues become a hazard. Major drainageways such as this one should be maintained.

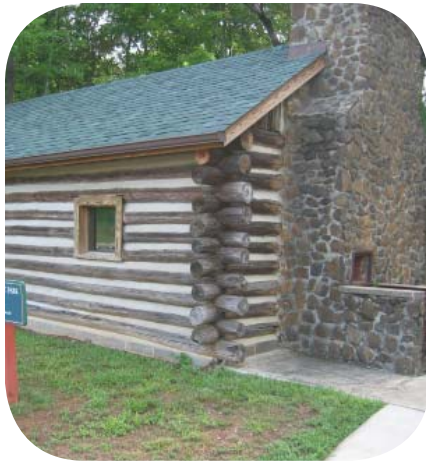
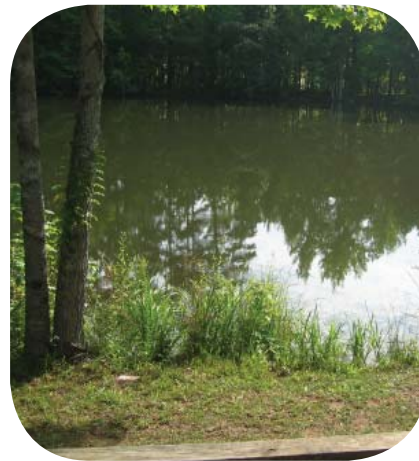
9.2 Meadowmont Park

Meadowmont Park is a 68-acre park located in southeastern Chapel Hill. Constructed in 2004, the park contains an historic log building used for storage and an adjacent picnic shelter. The parking lot is a shared lot with the Rashkis Elementary School. Natural trails surround a pond located on the property. The Meadowmont Trail links the Meadowmont Neighborhood to this park.

The timber wall that runs between the picnic shelter and the pond is failing and needs to be replaced. In addition, the dam should be inspected by an engineer and all debris should be removed from the dam immediately.

1. Perform the following immediate modifications to this park to address life safety issues:
 - Repair the retaining wall adjacent to the picnic shelter.
2. Evaluate the structural integrity of the dam.

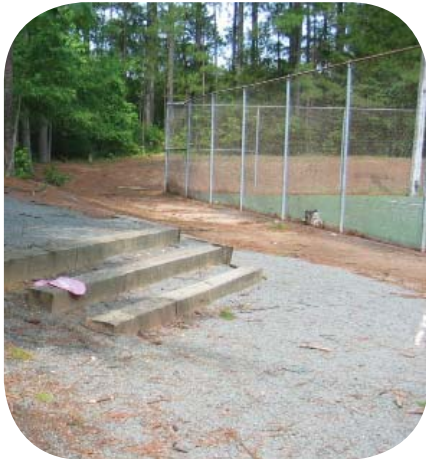
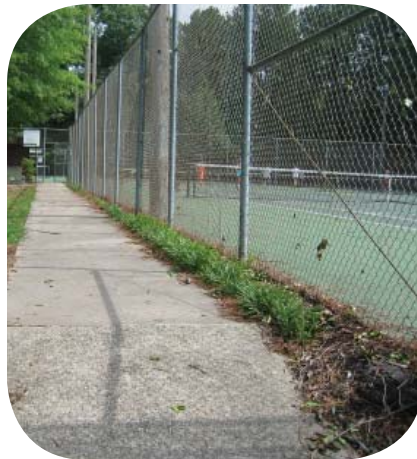
The telephone box was observed to be broken, exposing wires. The telephone box needs to be replaced and locked.

At the picnic area, abandoned grill posts and concrete pads should be removed. The concrete pads are not the correct size to support the existing picnic tables and they pose a trip hazard. The concrete pads should be removed or additional concrete should be poured to create an ADA accessible seating area.

The drain inlet between the parking lot and the restroom building is a major hazard, because the concrete supports are cracking. Also, the opening between the cap and the ground is very wide and could be a hazard to younger park users.

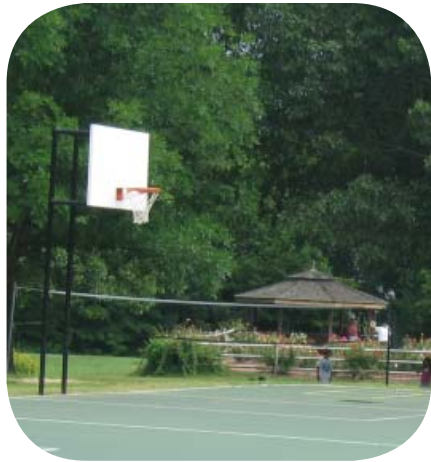
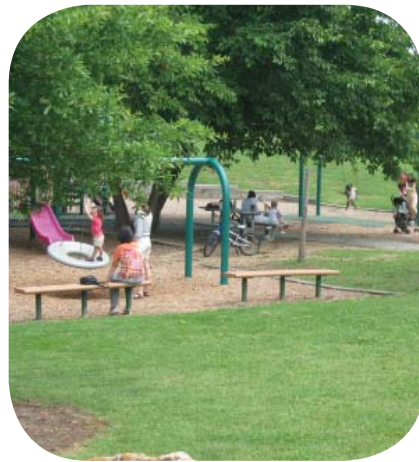
9.4 Community Center Park

Community Center Park is a 6-acre facility located in southeastern Chapel Hill. This park was built in the 1970's. The Community Center was completed in 1980. Other additions were added in the 1990's. The park contains a playground, a bocce ball court, basketball court, a rose garden, and sculptural pieces. The parking lot is asphalt and the majority of the trails are asphalt and concrete. This park is a trailhead for the Bolin Creek Greenway and the Battle Branch Trail. Parking is inadequate for the number of users.

At the playground, the poured in place rubber surfacing and engineered wood fiber are not at correct depths. Replenish or reinstall to match the depth required by the play equipment, manufacturer, and CPSC guidelines.

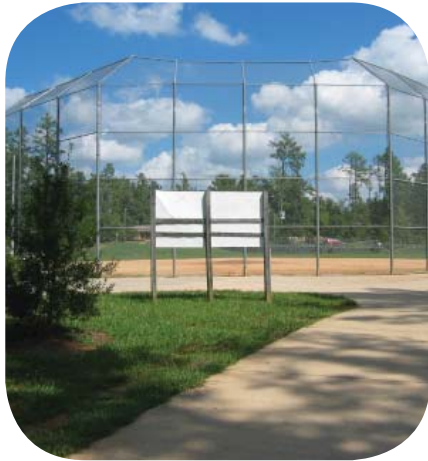
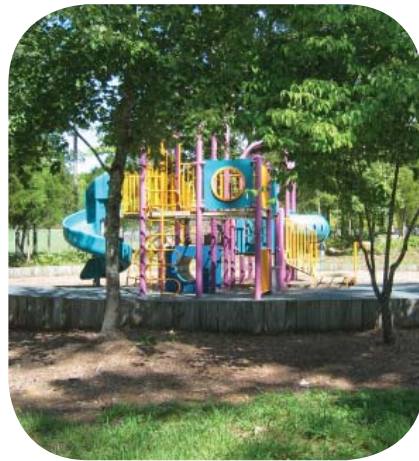
9.6 Homestead Park

Homestead Park is a 41-acre park located in northern Chapel Hill. Built in 1999, the park contains two ballfields, two athletic fields, a basketball court, playground, picnic shelter with restroom,

picnic area, two parking lots, and a dog park. There is a large recreation center under construction on the property. The parking lots are asphalt with designated ADA accessible spaces. The trails are a combination of asphalt and gravel.
