Appendix F

Example Case Studies from Other Communities of Implementations of Some of the Possible Treatments for Airport Road

Bridgeport Way Corridor Improvement

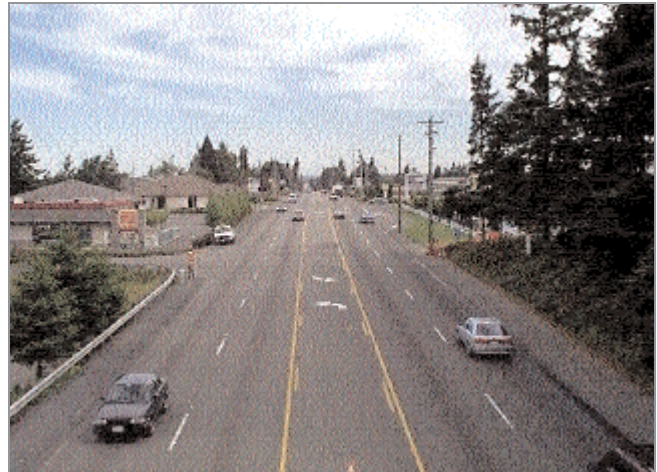
Bridgeport Way before the redesign.

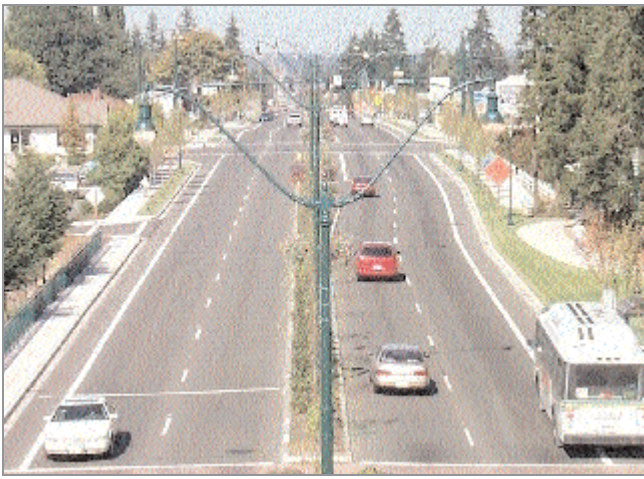
Bridgeport Way after the redesign.

- Replacement of the existing two-way-left-turn-lane with a raised, landscaped median, which would prevent left turns out of driveways.
- Construction of wide sidewalks on both sides of the roadway.
- Construction of bicycle lanes on both sides of the roadway.
- Placement of planter strips on both sides of the road, between the sidewalk and bicycle lane.
- Street lighting.
- Permission of U-turns at the signalized intersections.
- Placement of utility lines underground.

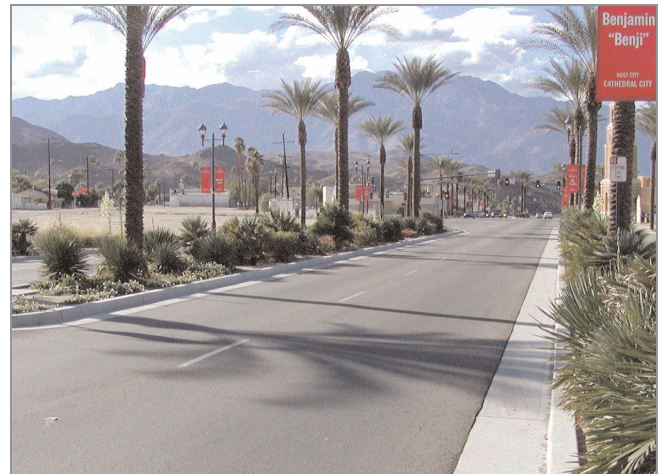
Looking west toward the San Jacinto Mountains after the installation of landscaped medians and enhanced parkways.

The new design for the roadway included a landscaped center median, two travel lanes in each direction 3.7 and 4.0 m (12 and 13 ft) wide, a side landscaped median separating a new parking aisle with angled parking, and the elimination of numerous angular driveways and streets, which had previously compromised the smooth traffic operation of the street. New bus shelters were provided and new traffic signals with pedestrian crossings were installed to better connect the businesses on the south side of the roadway with the north side, which would eventually include a new shopping complex, movie theater, and community park. The speed limit on East Palm Canyon Drive was reduced from 72 km/h (45 mi/h) to 56 km/h (35 mi/h) in order to emphasize the traffic calmed nature of the new redesigned roadway and promote the pedestrian-friendliness of the new downtown area.

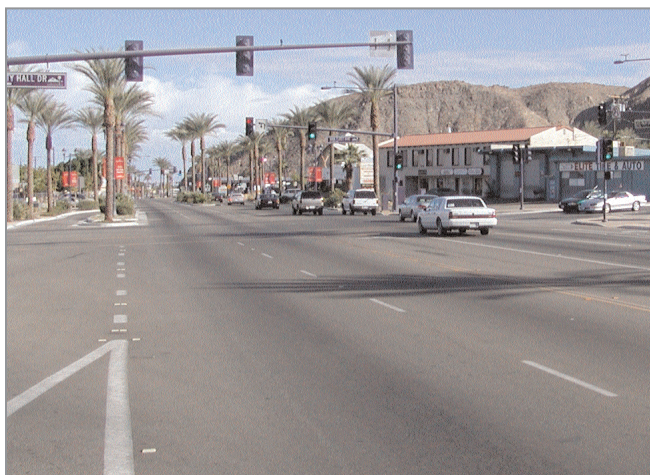
Looking east showing the use of protected/separated right turn and bus lanes.

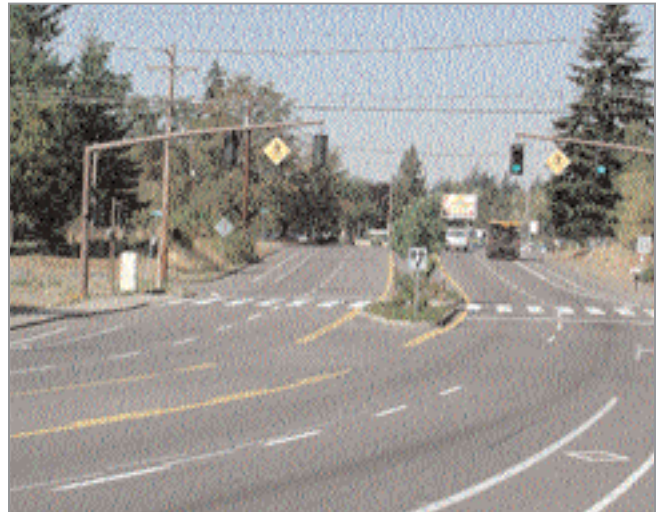
A typical major intersection treatment.

The intersections were broken into three categories—major intersections, minor intersections, and private driveway crossings—based upon type of use, roadway width, traffic gaps available for pedestrian crossings, automobile volume, and automobile speed.

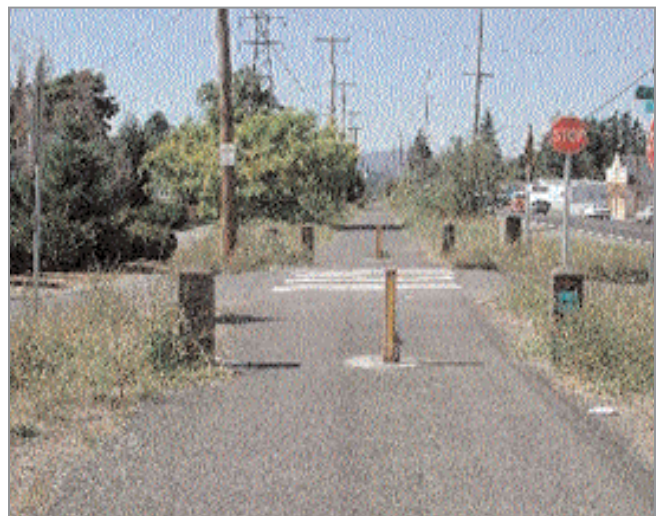
A typical minor intersection treatment.

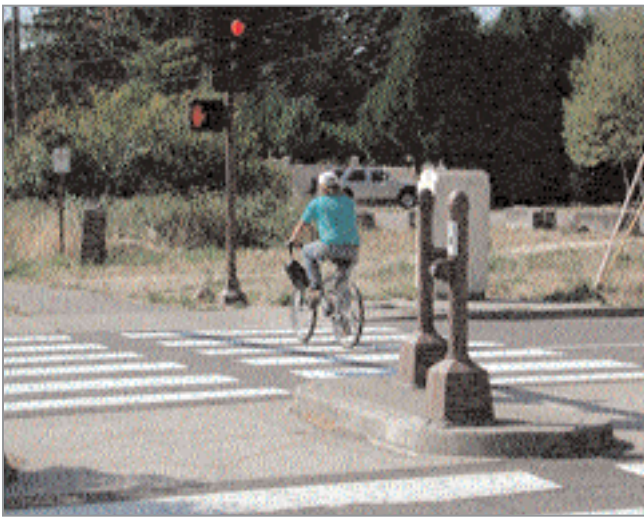
A pedestrian-activated signal button in a refuge island.

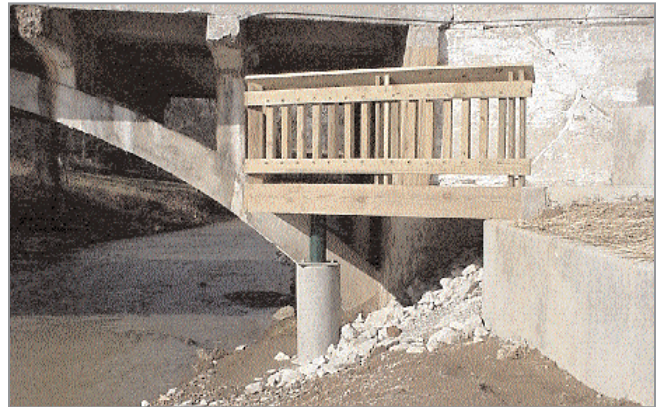
The pedestrian trail bridge utilizes the space beneath the Eighth Street roadway bridge at Four Pole Creek.

sonable for disabled individuals. Brast Thomas, design engineer for this project, supplied a creative solution to both the flooding problem and access challenge by designing the trail structure to rest on the bridge’s arched concrete supports. This allowed the pathway underpass to be at an elevation only inches below the 100-year flood height.

To resolve the safety issue presented by trail users crossing Eighth Street at-grade, James McClelland, Director/Secretary of the Greater Huntington Park and Recreation District and a regular jogger on the pathway, suggested building a bridge to take the pedestrian traffic under Eighth Street, using the space beneath the Eighth Street roadway bridge at Four Pole Creek.

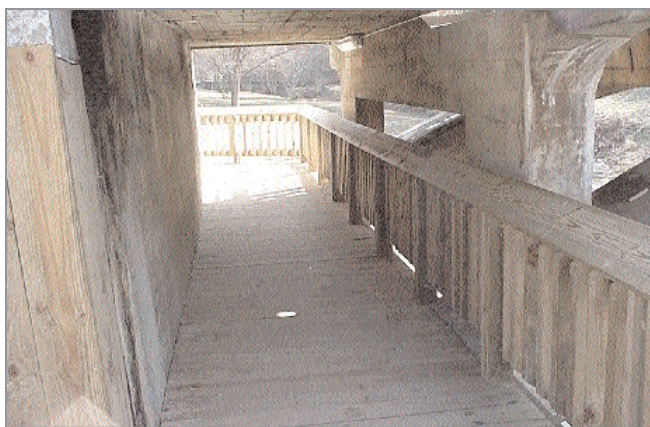
The extensive use of wood made the structure strong, practical, inexpensive, and aesthetically pleasing.

From an engineering standpoint, no unusual methods or materials were employed, but the economy of design was evidenced in linking the two structures.

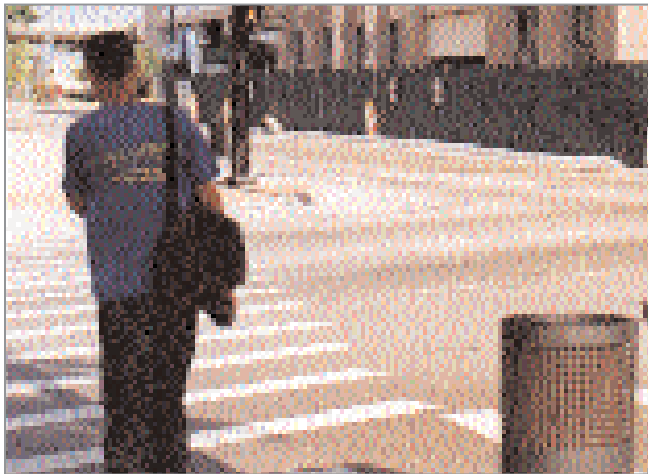
A leading pedestrian interval at the intersection of South Street and Orange Avenue gives pedestrians a 4 second head start in crossing.

The intersection of South Street and Orange Avenue in Downtown Orlando was the site for what is called a leading pedestrian interval. At a cost of only hundreds of dollars and taking only 2 hrs to install, the leading pedestrian interval was simply a change in signal phasing that allowed for a pedestrian phase to begin 4 s before the green phase for motor vehicle traffic. This allowed pedestrians a head start to cross in the crosswalk of the intersection. It provided significant visibility to those crossing, gave extra time for pedestrians to cross, and alerted motorists to the existence of pedestrians in the crosswalk. An illuminated sign was installed on the overhead signal post reminding motorists to “yield to peds” in the crosswalk while the signal was green. When the signal was red, the sign changed to read “no turn on red” to prevent pedestrian collisions from this action.

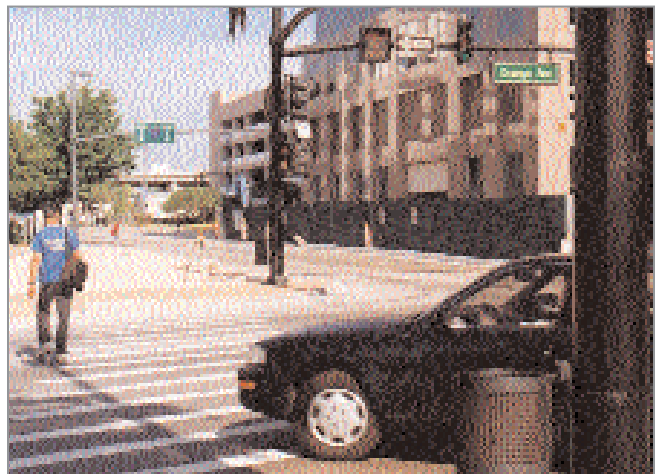
With the 4 second lead time given by the leading pedestrian interval, pedestrians are able to cross part of the intersection before vehicles begin turning.

The extra time for the pedestrian phase was gained from the introduction of a third signal phase at that particular intersection. The intersection was operating on two phases, and a third 6-second phase was added in order to accommodate the additional pedestrian walk time while all other approaches were red. The walk signal is maintained as the green phase begins for motorists.

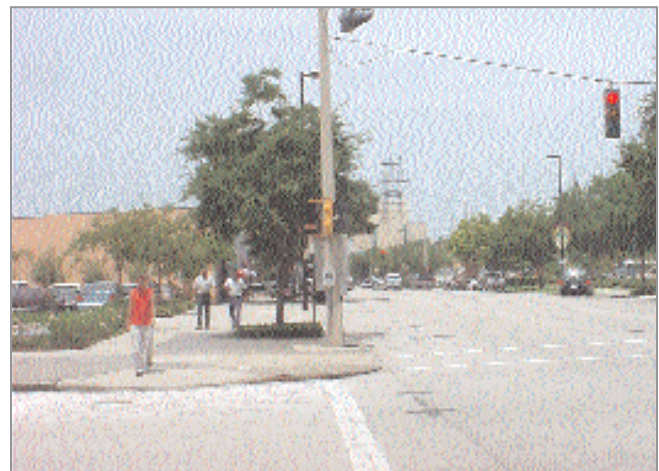
Pedestrians are given a WALK signal three seconds before parallel traffic is given a green light.
