6**MEMORANDUM**

SUBJECT: Response to a Petition from Federal Realty Investment Trust Requesting Town Assistance with Drainage Improvements to Mitigate the Potential for Flooding at the Eastgate Shopping Center

DATE: February 26, 2001

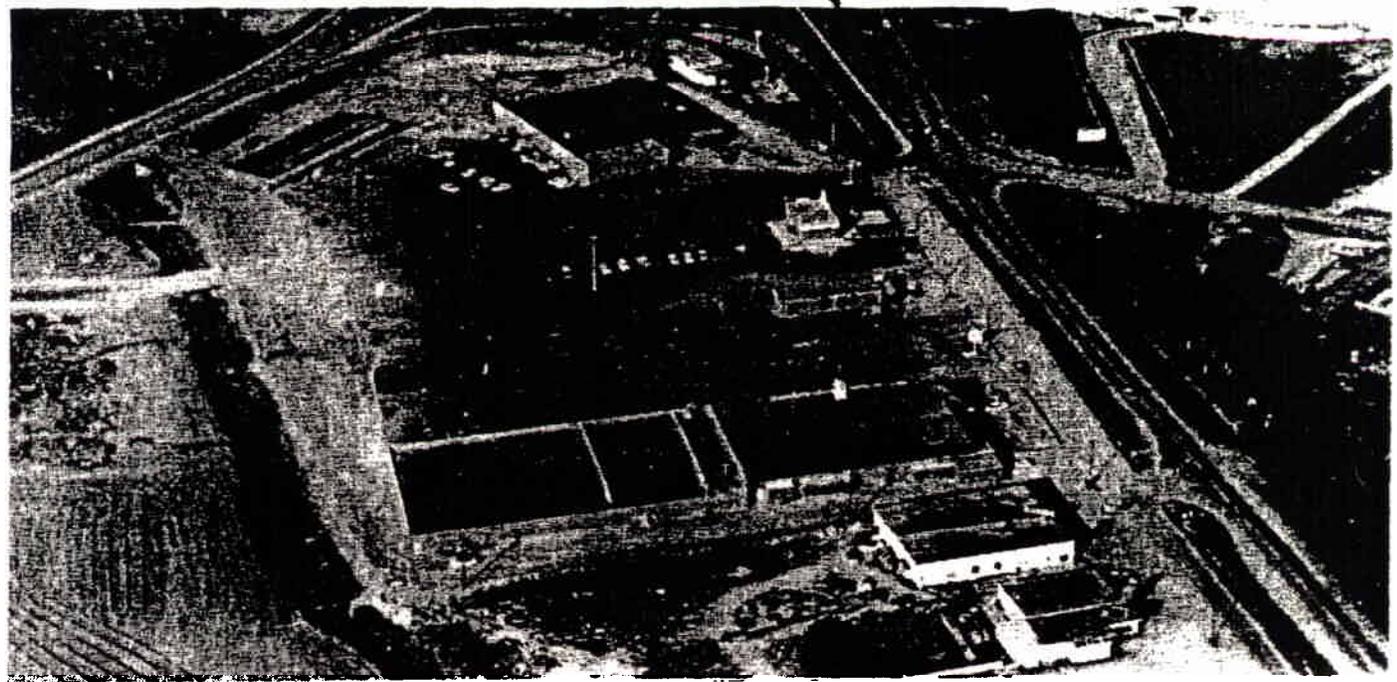
Photo 1

Aerial photograph, dated 1961, shows Booker Creek as an open channel prior to full development of shopping center. Photograph also reveals the drainage flowing from the left and discharging into Booker Creek.
(Franklin Street drainage as described in report)

The Eastgate Shopping Center was constructed in the 1960's adjacent to the banks of Booker Creek (see attached Photo 1). Subsequently, the creek was covered by expanding development of the shopping center and placed underneath the parking lot in a closed conveyance system. The Eastgate Shopping Center was constructed prior to implementation of the Town's Resource Conservation District Ordinance in 1983 and before development in Chapel Hill was regulated by the Federal Emergency Management Agency (FEMA) regulations for floodplains and floodways (established in 1973) in association with the National Flood Insurance Program (NFIP). Current regulations would prohibit much of the existing Eastgate Shopping Center development now.
