October 29, 2007

Re: Traffic Issues on Sedgefield Drive – No sidewalks, No traffic calming, No slowing down

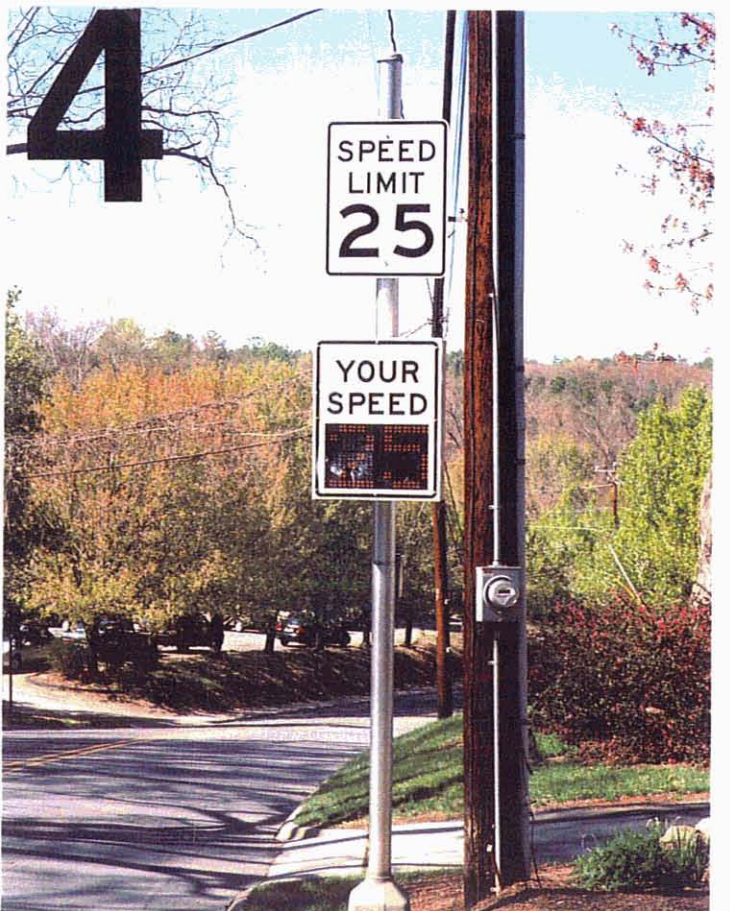
- 5.) Take an excellent idea and replicate it. There are two 20 MPH speed limit signs on Sedgefield Drive co-located with the Chapel Hill Transit bus stops. Please upgrade the 20 MPH speed limit signs to utilize the permanent, local speed measuring devices found on Hillsborough Street between Mill Race Drive and North Street in Chapel Hill. As you know, that area also has noticeable elevation changes. See photo #4.
