APPENDIX A

APPENDIX B

Photo Log

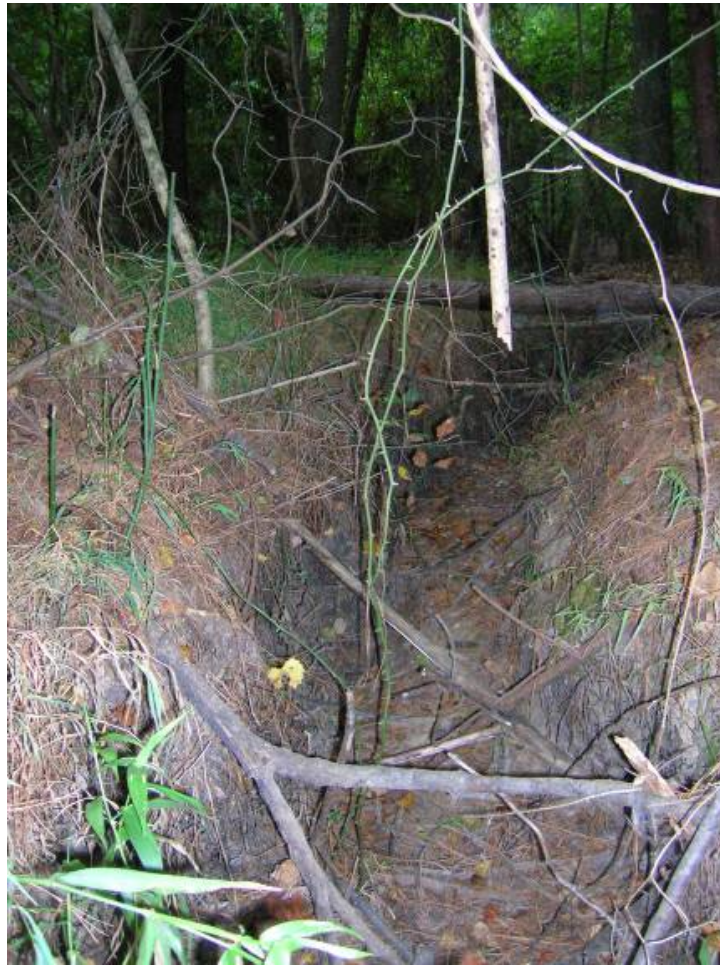
Downstream of the headcut. Facing upstream.

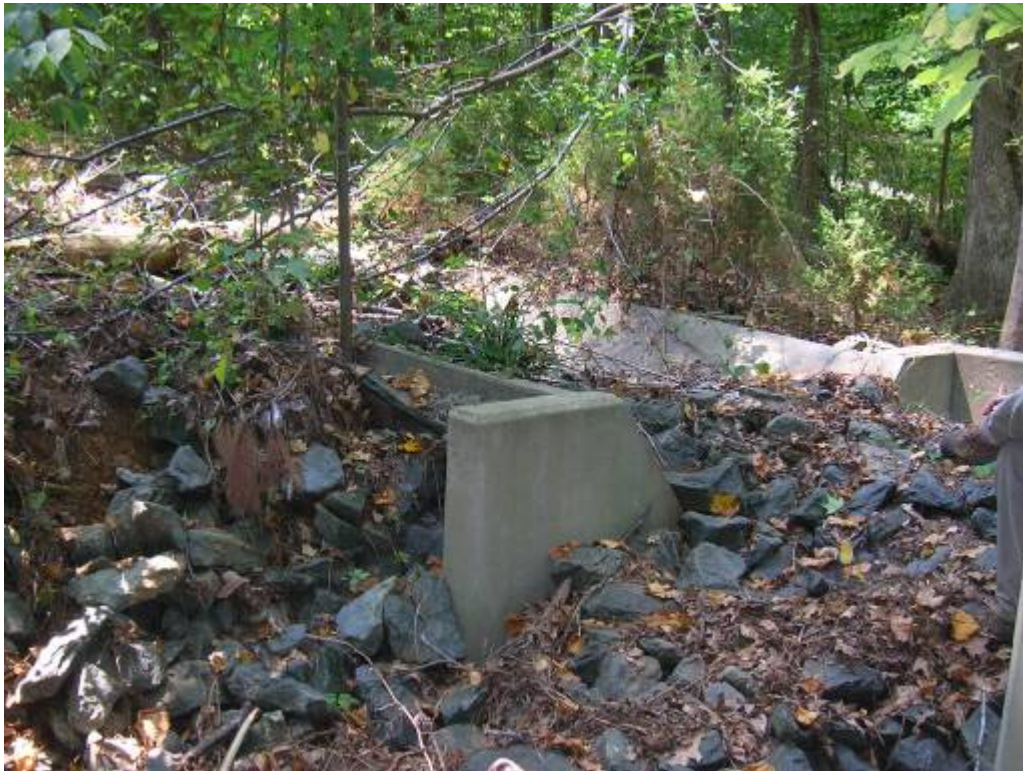
The concrete flow dissipation structure at Site 4.

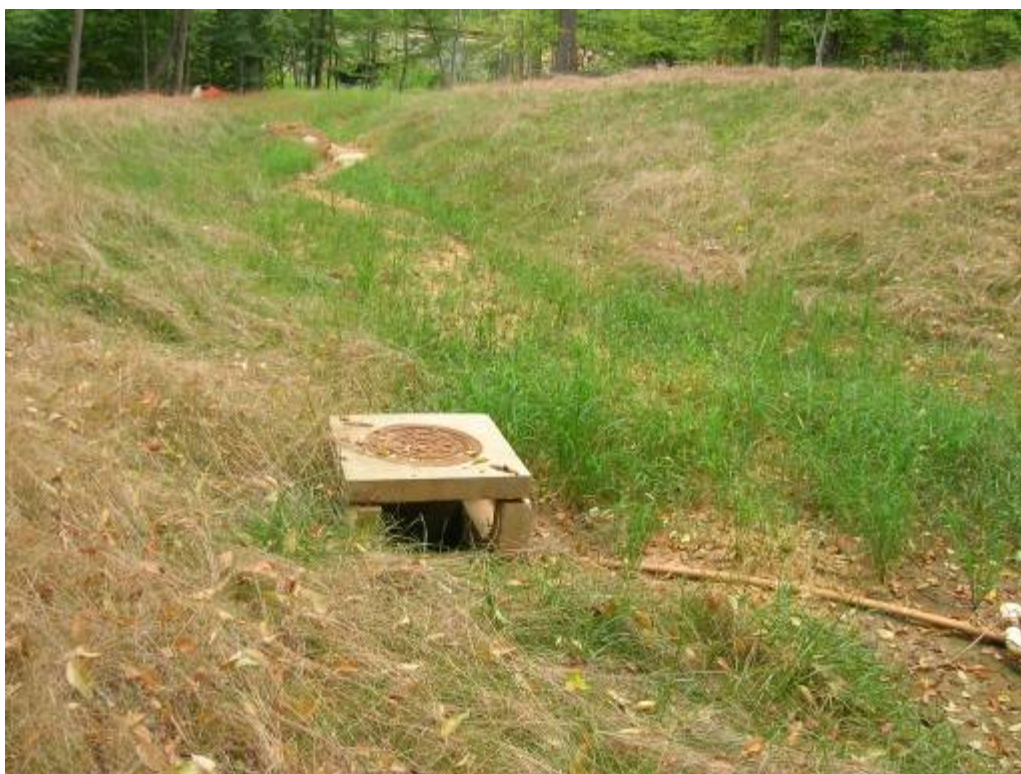
Another sediment basin at Site 6. Note the eroding grassy swale leading into the basin. Facing east.

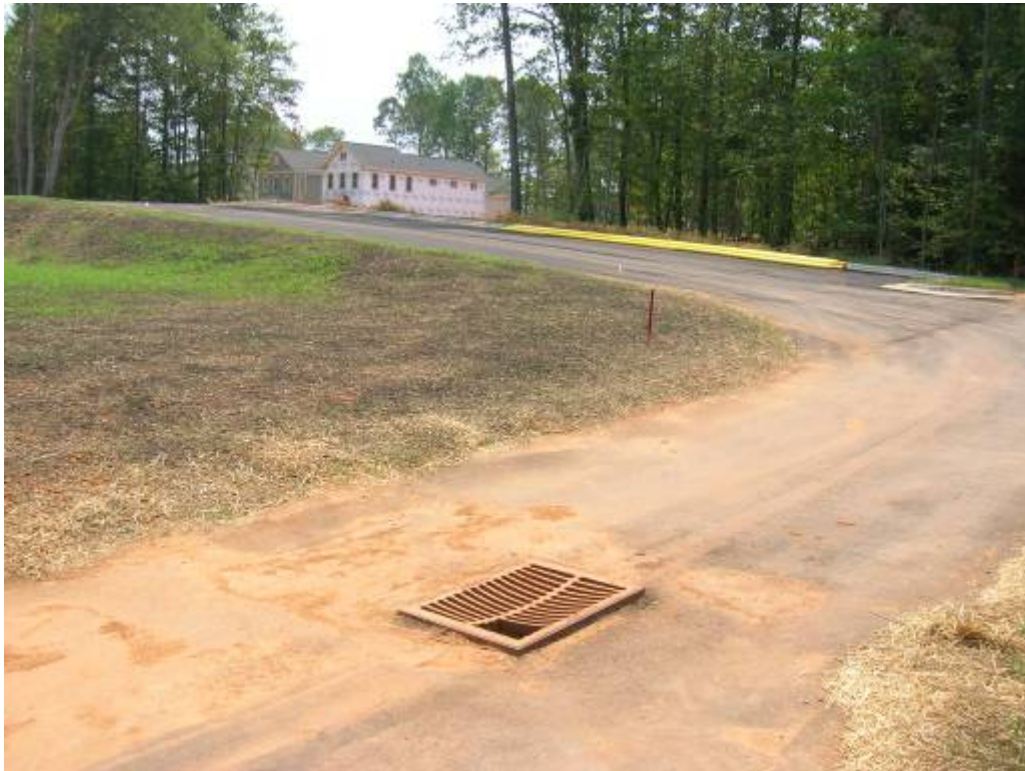
Facing south from the same location as above.

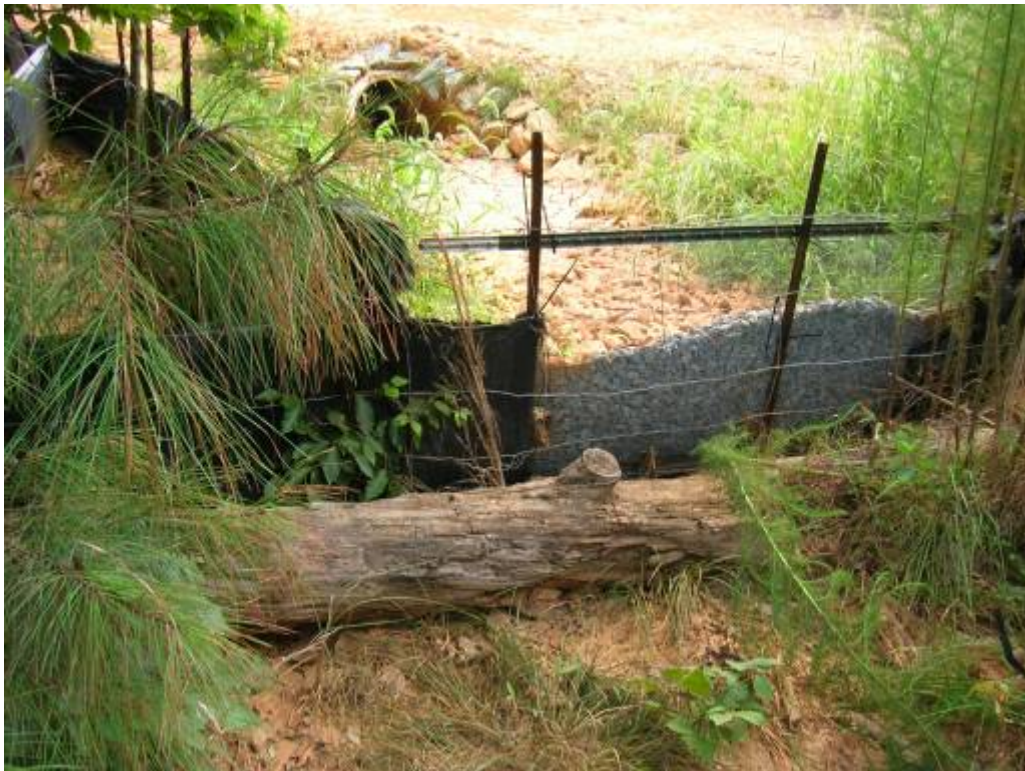
The current pipe and outlet at Site 7. Facing east.

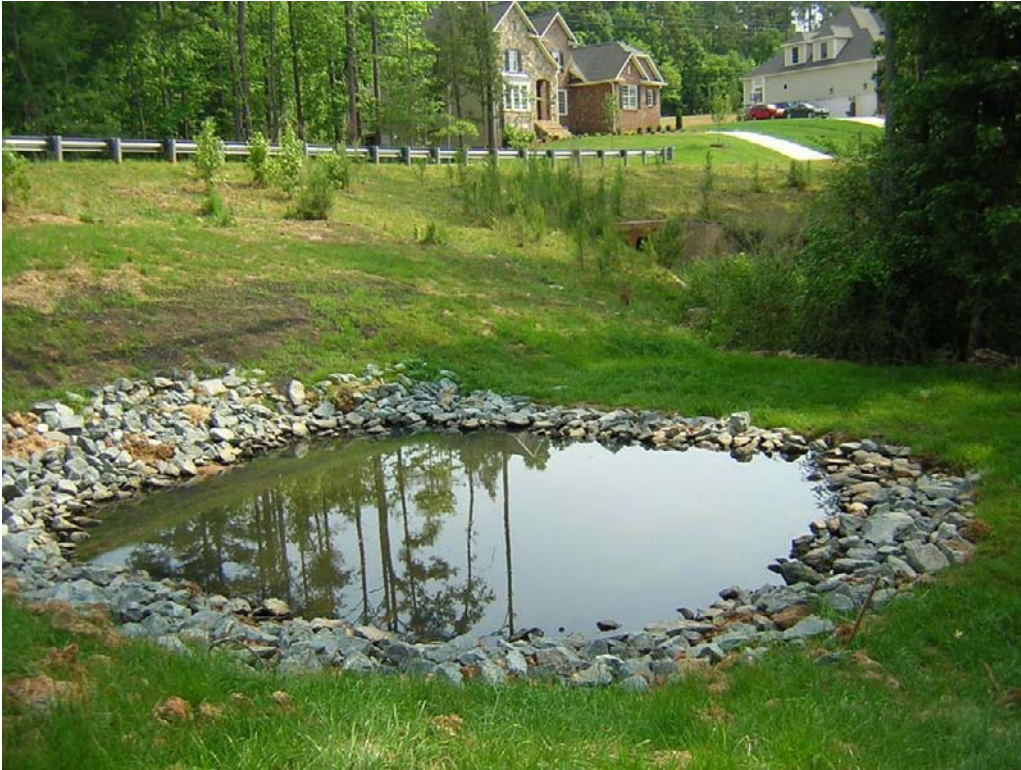
Site 8

An existing stormwater basin at Site 8. Facing northeast.

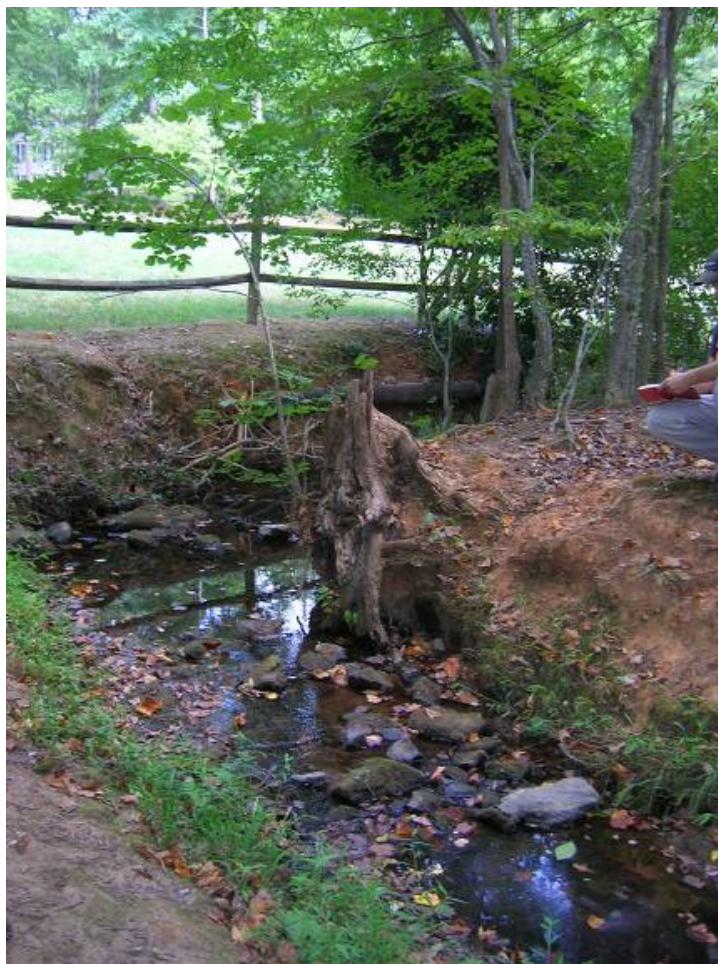
Site 9

Eroding stream banks upstream of the Cobblestone Drive crossing. Facing downstream.

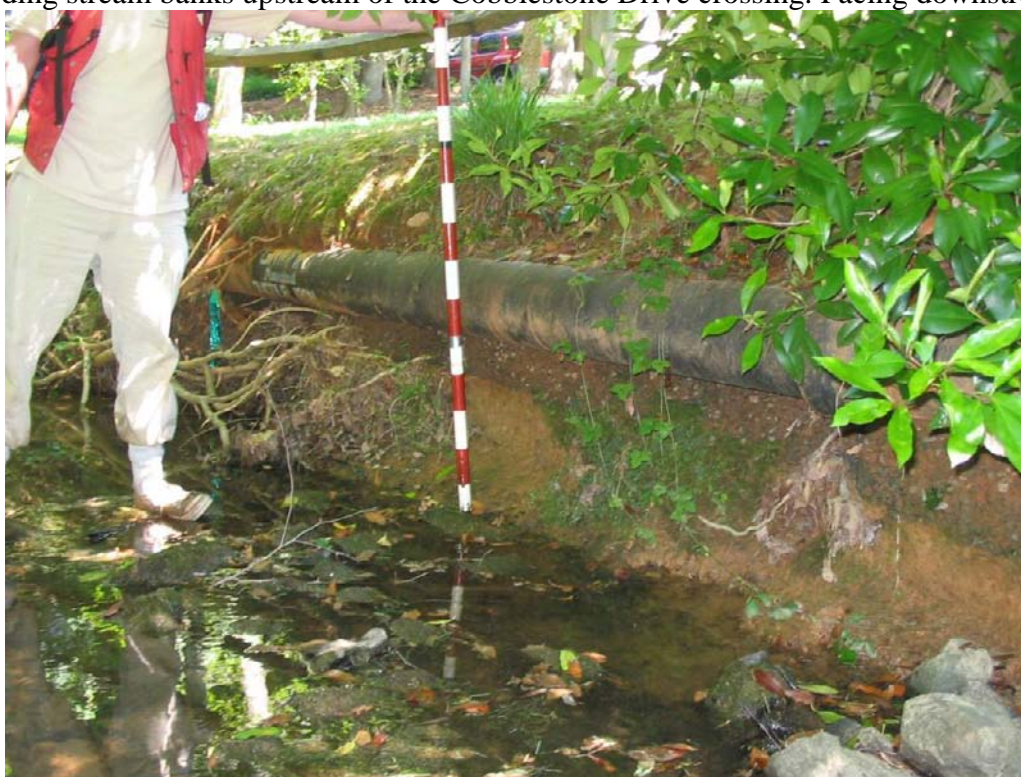
A utility line runs parallel with the streambank, just upstream of Cobblestone Drive crossing.

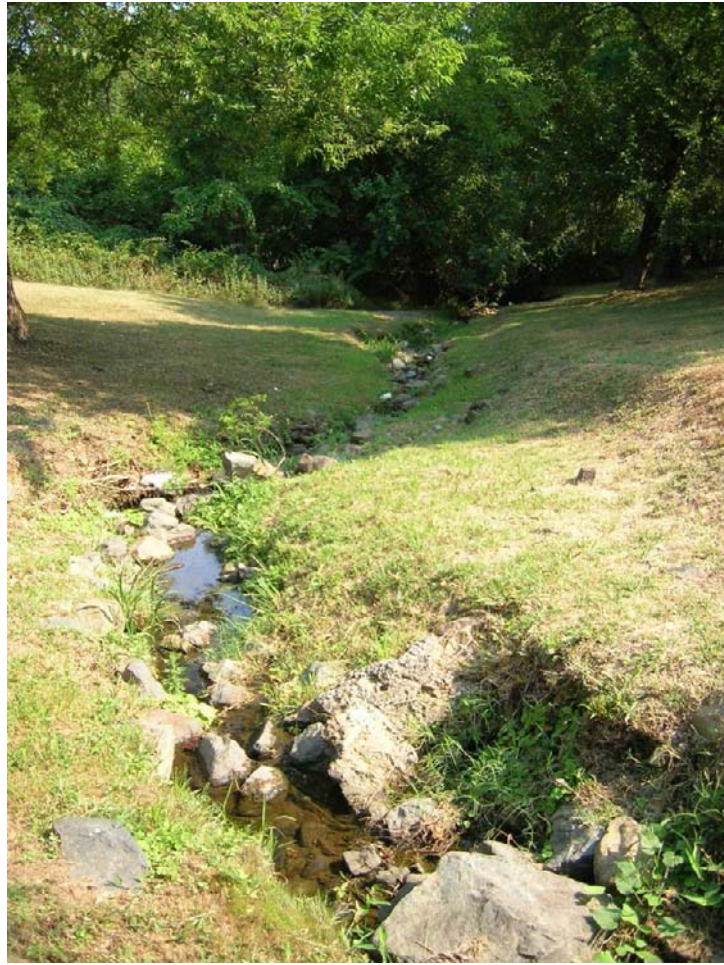
Facing downstream.

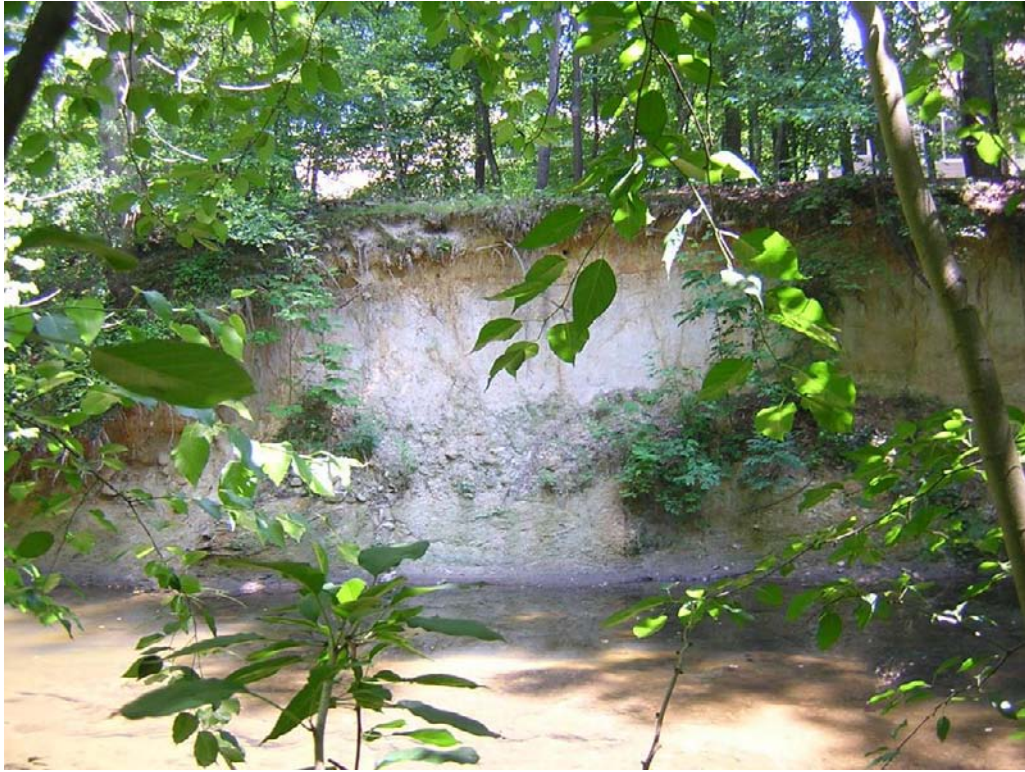
Site 22

An eroding hillside along Bolin Creek is the primary feature at Site 22. The bank is approximately 18 feet high.

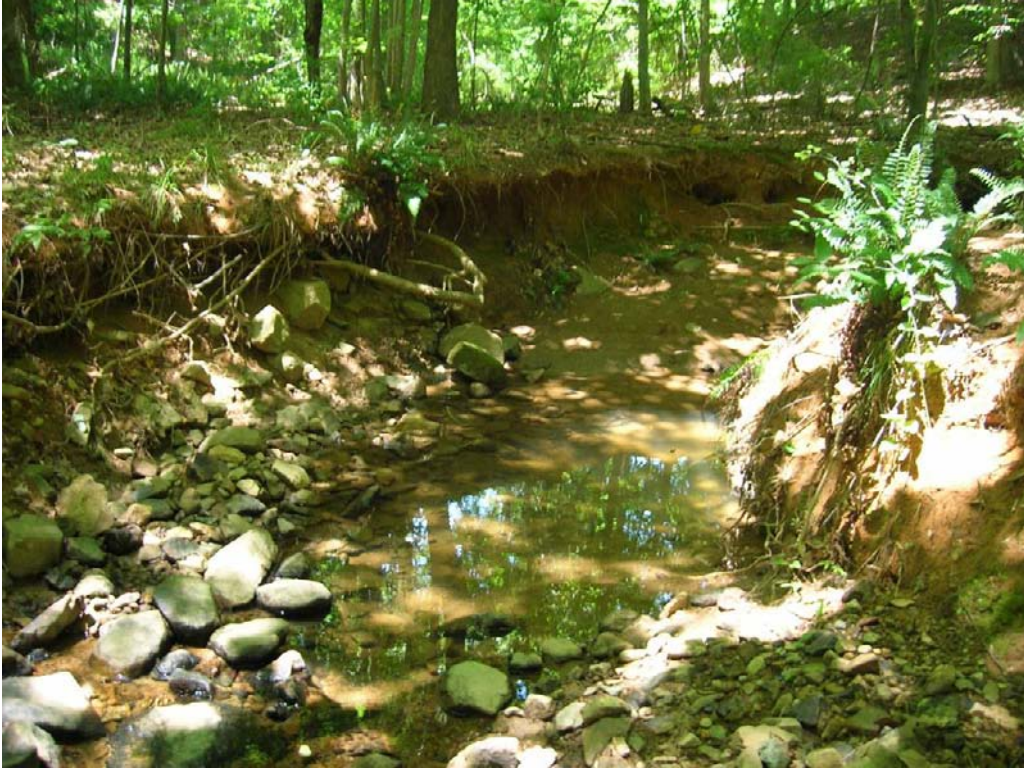
Cole Springs Branch is incised with undercut banks near Site 25. Facing downstream.

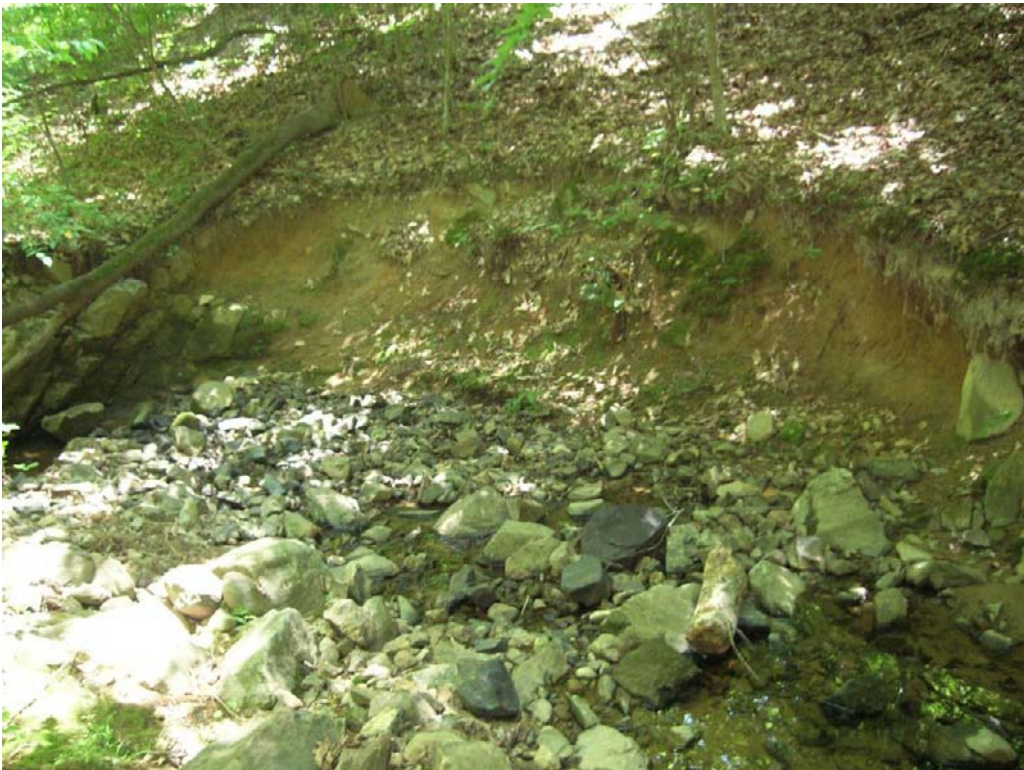
An eroding bank on Cole Springs Branch near Site 25. Facing downstream.

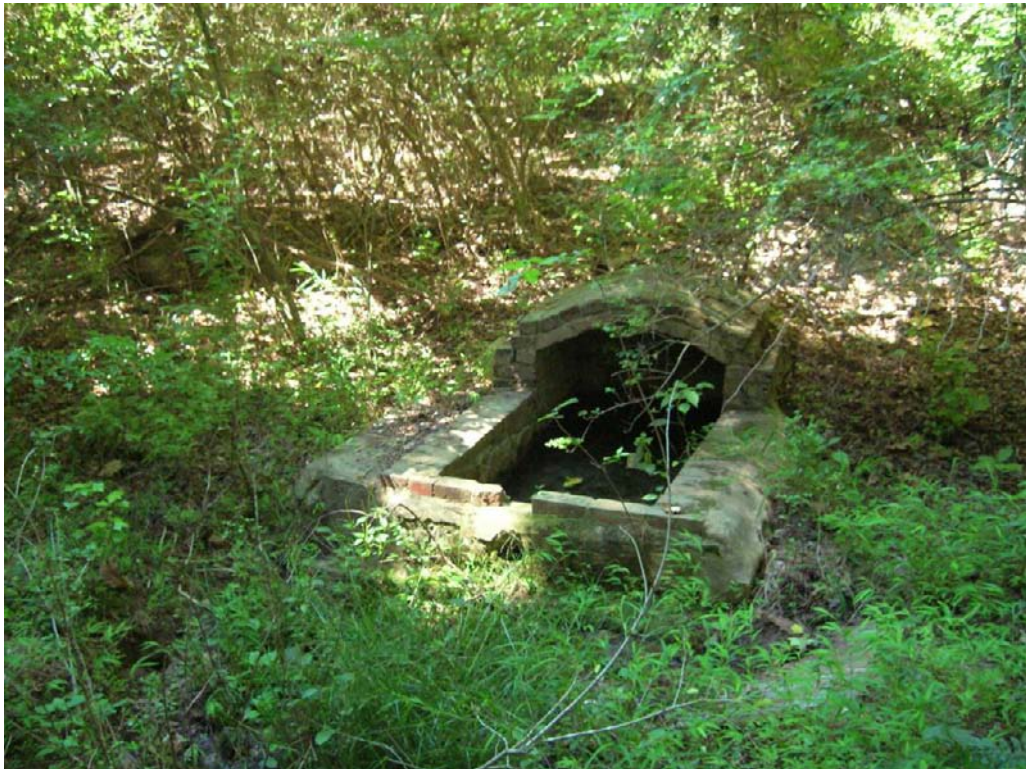
An old spring-head improvement near Site 26.

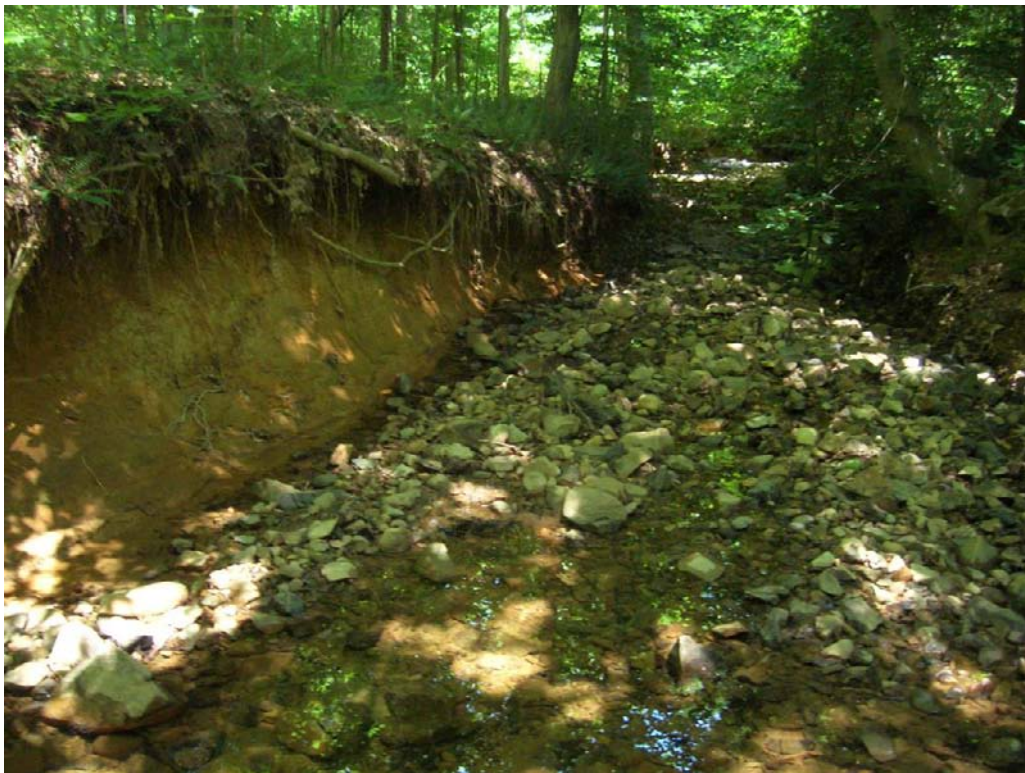
The stream channel near Site 27.

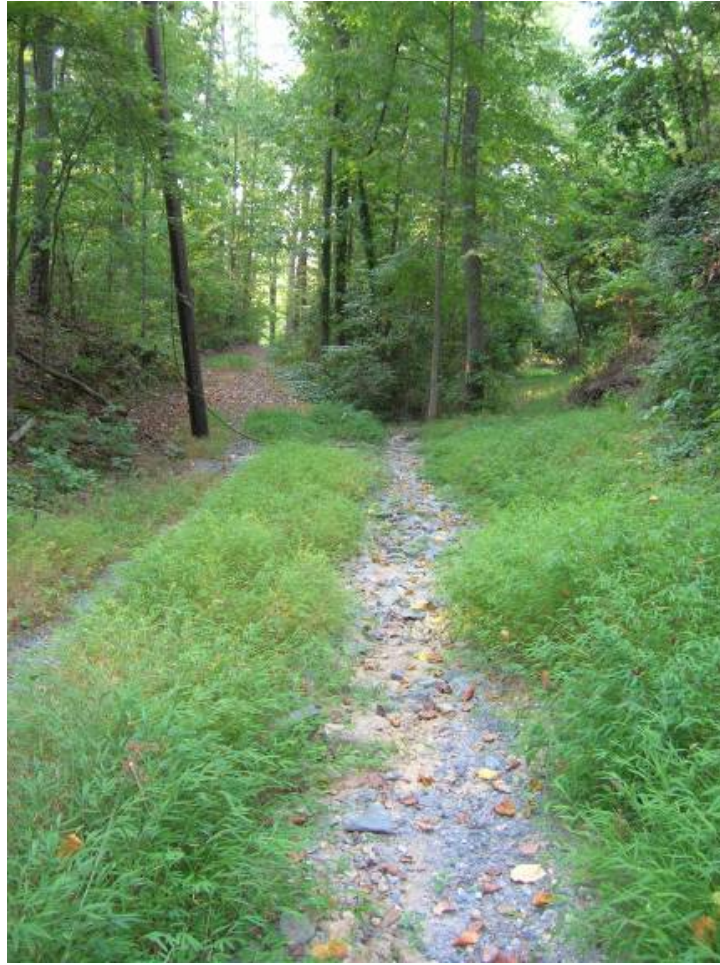
After flowing downhill, the stream flows across a utility easement road. Facing upstream and west.

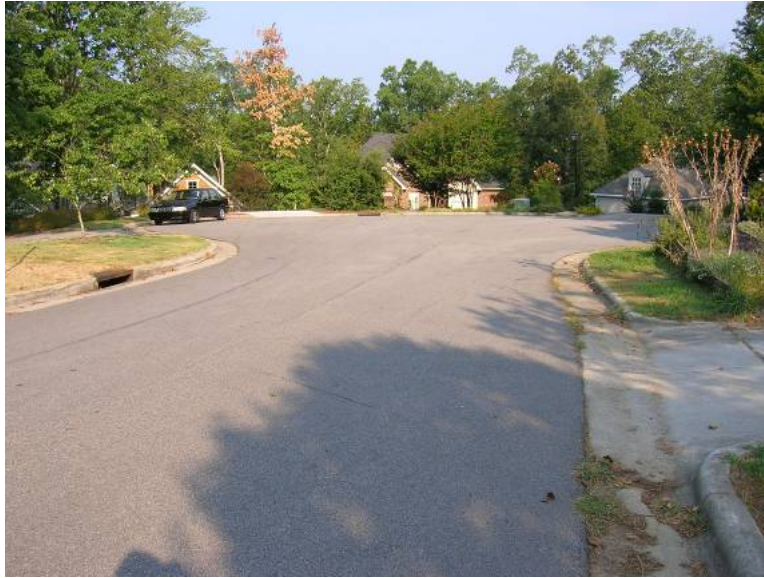
Site 30

A view of Hotelling Ct, which comprises part of the drainage area of the basin at Site 30. The existing BMP is downhill and to the left of the photo. Facing northwest.

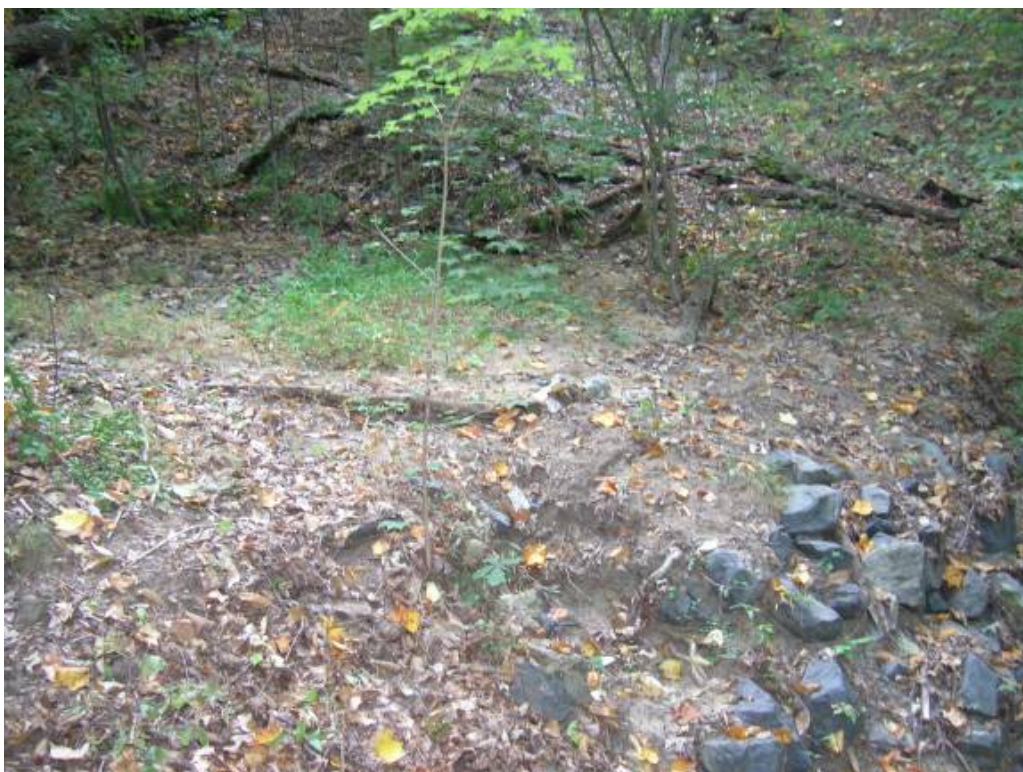
The existing BMP has filled in since its construction. Facing southeast.

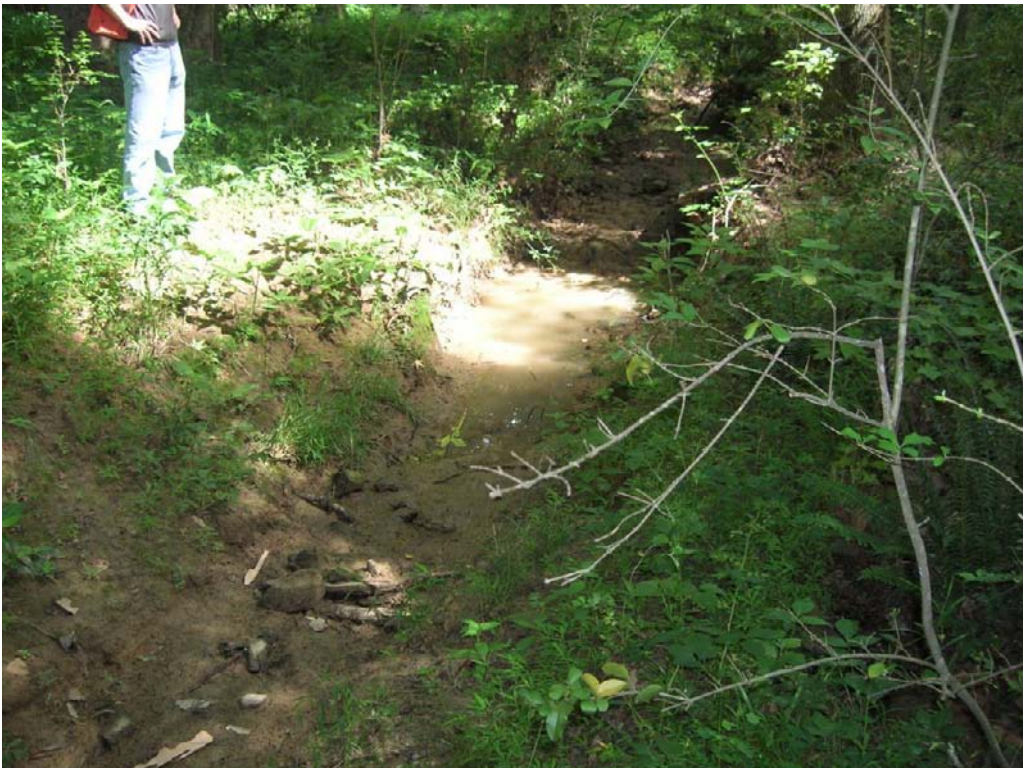
A view of a stormwater scour area flowing from the paved roads of a residential area into the floodplain ditch.

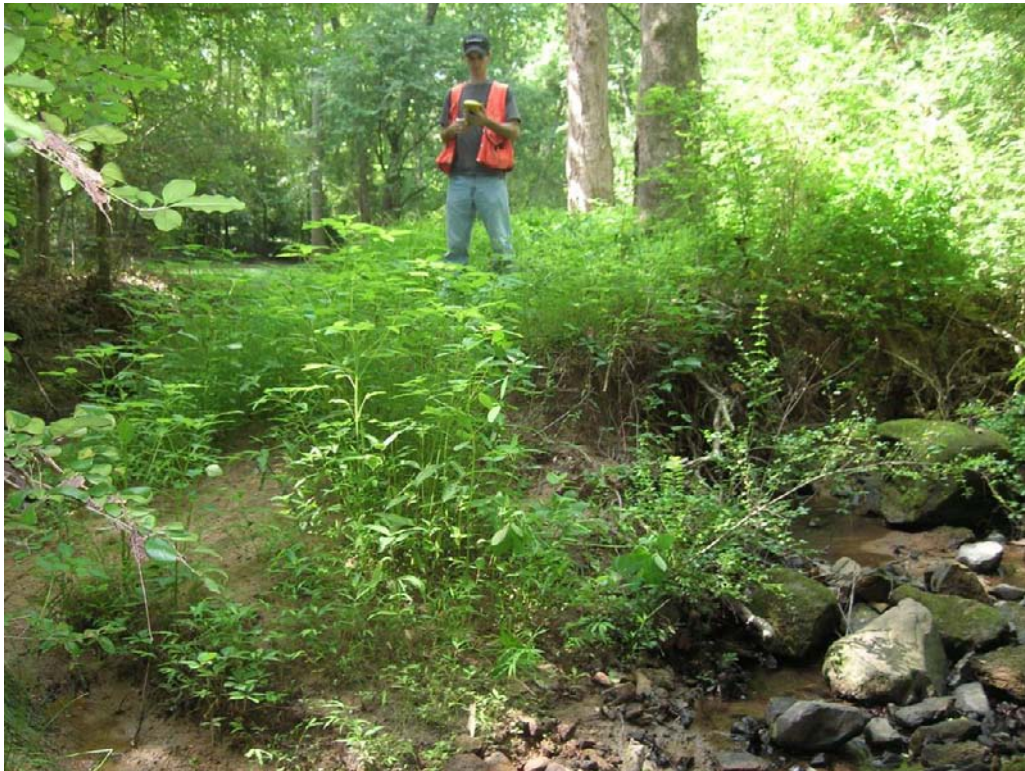
The confluence of the floodplain ditch with Battle Branch. Facing upstream.

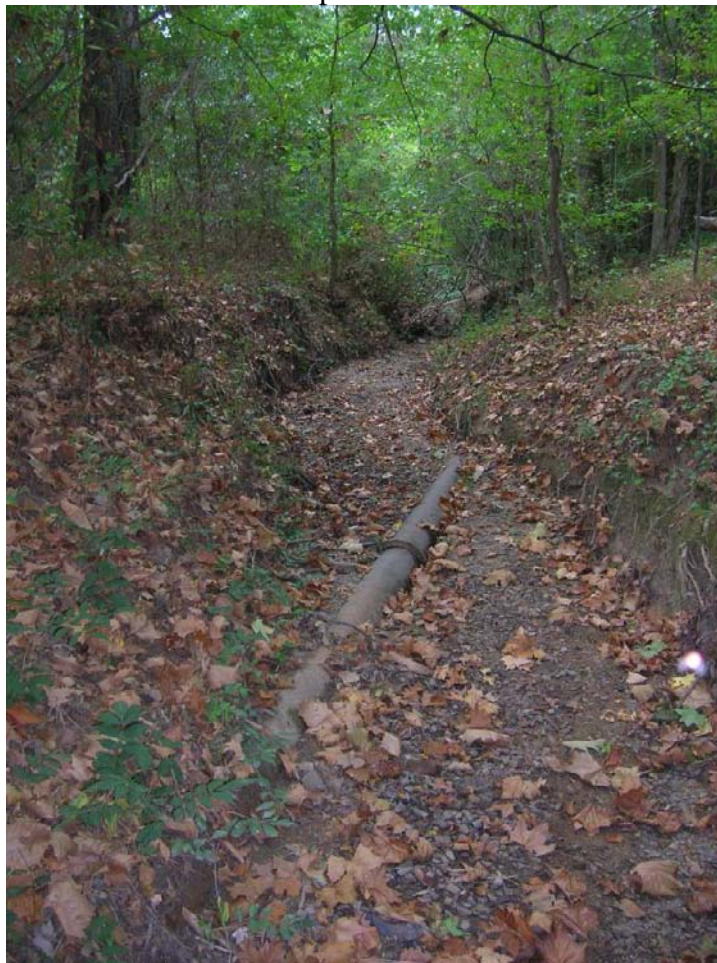
A utility line crosses the bed of the stream. Facing downstream.

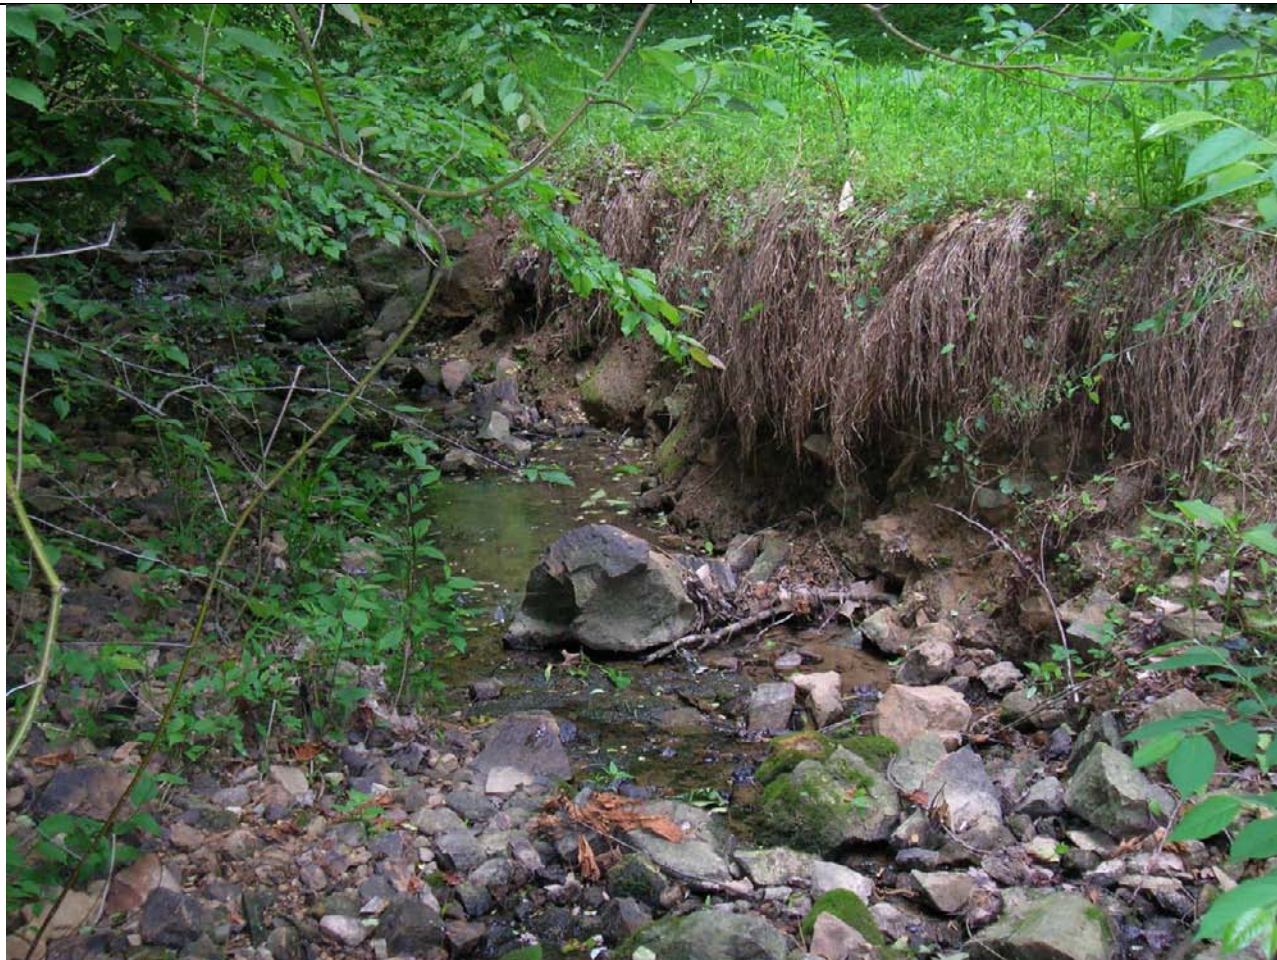
STREAM NAME: UT BOLIN		DATE: 5/8/07	MAP SHEET #: 20
PHOTO NUMBERS: 23		LANDMARK:	SKETCH ON BACK
GPS ID START: BD 11		GPS ID END:	
DESCRIPTION:		DESCRIPTION:	
RAIN IN LAST 24 HOURS <input type="checkbox"/> Heavy rain <input type="checkbox"/> Steady rain <input type="checkbox"/> None <input type="checkbox"/> Intermittent <input checked="" type="checkbox"/> Trace		PRESENT CONDITIONS <input type="checkbox"/> Heavy rain <input type="checkbox"/> Steady rain <input type="checkbox"/> Intermittent <input type="checkbox"/> Clear <input type="checkbox"/> Trace <input checked="" type="checkbox"/> Overcast <input type="checkbox"/> Partly cloudy	
SURROUNDING LAND USE: <input type="checkbox"/> Industrial <input type="checkbox"/> Commercial <input type="checkbox"/> Urban/Residential <input checked="" type="checkbox"/> Suburban/Res <input checked="" type="checkbox"/> Forested <input type="checkbox"/> Institutional <input type="checkbox"/> Golf course <input type="checkbox"/> Park <input type="checkbox"/> Crop <input type="checkbox"/> Pasture <input type="checkbox"/> Other:

BASE FLOW WIDTH AS % CHANNEL WIDTH <input checked="" type="checkbox"/> 0-25% <input type="checkbox"/> 25-50 % <input type="checkbox"/> 50%-75% <input type="checkbox"/> 75-100%		WATER CLARITY <input checked="" type="checkbox"/> Clear <input type="checkbox"/> Turbid (<i>suspended matter</i>) <input type="checkbox"/> Stained (<i>clear, naturally colored</i>) <input type="checkbox"/> Opaque (<i>milky</i>) <input type="checkbox"/> Other (chemicals, dyes)	
DOMINANT SUBSTRATE <input type="checkbox"/> Silt/clay (fine or slick) <input type="checkbox"/> Sand (gritty) <input type="checkbox"/> Gravel (0.1-2.5") <input checked="" type="checkbox"/> Cobble (2.5 –10") <input type="checkbox"/> Boulder (>10") <input type="checkbox"/> Bed rock	CHANNEL DIMENSIONS AT RIFFLE Height: Low bank ____3.2____(ft) Width: Bottom ____13____(ft) Top ____17____(ft) Water Surface ____1.4____(ft) Depth: Max BKF ____0.6____(ft) B:H Ratio: Low bank/Max BKF=____		OBSERVED IMPACTS <input type="checkbox"/> Outfall <input type="checkbox"/> Confluence <input type="checkbox"/> Impacted buffer <input type="checkbox"/> Stream crossing <input type="checkbox"/> Channel mod <input checked="" type="checkbox"/> Utility impacts <input type="checkbox"/> Beaver <input type="checkbox"/> Other

CHANNEL DYNAMICS <input type="checkbox"/> Downcutting <input type="checkbox"/> Bed scour <input type="checkbox"/> Slope failure <input type="checkbox"/> Widening <input checked="" type="checkbox"/> Bank failure <input type="checkbox"/> Channelized <input type="checkbox"/> Headcutting <input checked="" type="checkbox"/> Bank scour <input type="checkbox"/> Unknown <input type="checkbox"/> Aggrading <input type="checkbox"/> Sed. deposition		NOTES	
QUALITATIVE IMPAIRMENT RATING: <input type="checkbox"/> Low <input checked="" type="checkbox"/> Moderate <input type="checkbox"/> Severe		CHANNEL EVOLUTIUON STAGE: <input type="checkbox"/> I <input type="checkbox"/> II <input type="checkbox"/> III <input type="checkbox"/> IV <input type="checkbox"/> V <input type="checkbox"/> VI (<i>Simon et. al., 2003</i>)

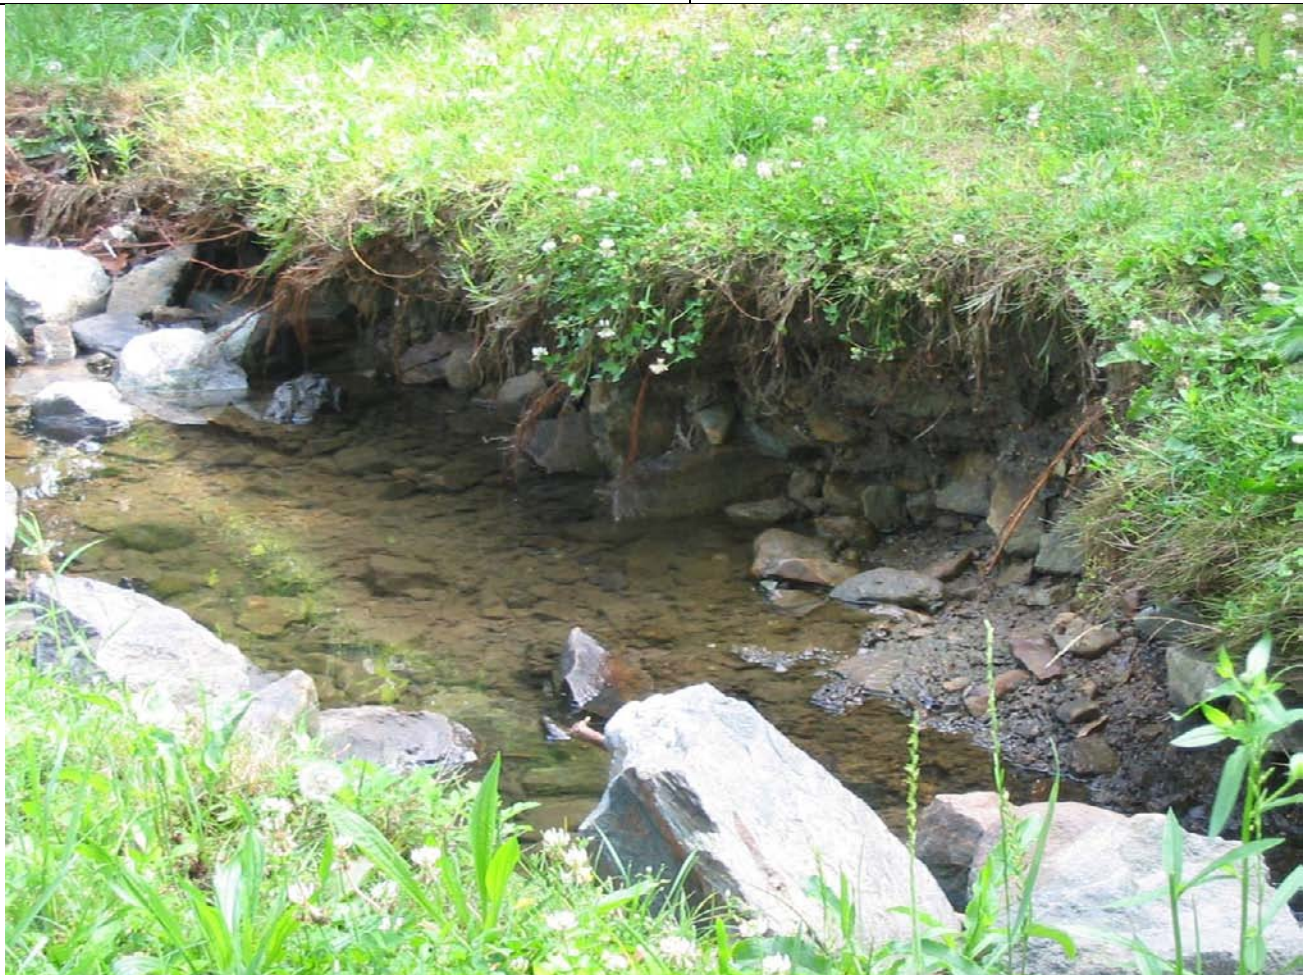
STREAM NAME: UT		DATE: 6/7/07	MAP SHEET #: 23
PHOTO NUMBERS: 1117- PIPED CH 1118-11120 DEGRADED		LANDMARK: BROAD ST.	SKETCH ON BACK
GPS ID START: TA 29		GPS ID END: TA 30	
DESCRIPTION: PIPED ST NO GPS		DESCRIPTION: DEGRADED STR NO GPS	
RAIN IN LAST 24 HOURS <input type="checkbox"/> Heavy rain <input type="checkbox"/> Steady rain <input checked="" type="checkbox"/> None <input type="checkbox"/> Intermittent <input type="checkbox"/> Trace		PRESENT CONDITIONS <input type="checkbox"/> Heavy rain <input type="checkbox"/> Steady rain <input type="checkbox"/> Intermittent <input checked="" type="checkbox"/> Clear <input type="checkbox"/> Trace <input type="checkbox"/> Overcast <input type="checkbox"/> Partly cloudy	
SURROUNDING LAND USE: <input type="checkbox"/> Industrial <input type="checkbox"/> Commercial <input checked="" type="checkbox"/> Urban/Residential <input type="checkbox"/> Suburban/Res <input type="checkbox"/> Forested <input type="checkbox"/> Institutional <input type="checkbox"/> Golf course <input checked="" type="checkbox"/> Park <input type="checkbox"/> Crop <input type="checkbox"/> Pasture <input type="checkbox"/> Other:

BASE FLOW WIDTH AS % CHANNEL WIDTH <input type="checkbox"/> 0-25% <input type="checkbox"/> 25-50 % <input checked="" type="checkbox"/> 50%-75% <input type="checkbox"/> 75-100%		WATER CLARITY <input checked="" type="checkbox"/> Clear <input type="checkbox"/> Turbid (<i>suspended matter</i>) <input type="checkbox"/> Stained (<i>clear, naturally colored</i>) <input type="checkbox"/> Opaque (<i>milky</i>) <input type="checkbox"/> Other (chemicals, dyes)	
DOMINANT SUBSTRATE <input type="checkbox"/> Silt/clay (fine or slick) <input checked="" type="checkbox"/> Sand (gritty) <input checked="" type="checkbox"/> Gravel (0.1-2.5") <input checked="" type="checkbox"/> Cobble (2.5 -10") <input type="checkbox"/> Boulder (>10") <input type="checkbox"/> Bed rock	CHANNEL DIMENSIONS AT RIFFLE Height: Low bank 1.3 (ft) Width: Bottom 4.0 (ft) Top 5.0 (ft) Water Surface 3.0 (ft) Depth: Max BKF 1.3 (ft) B:H Ratio: Low bank/Max BKF=_____		OBSERVED IMPACTS <input checked="" type="checkbox"/> Outfall <input type="checkbox"/> Confluence <input type="checkbox"/> Impacted buffer <input type="checkbox"/> Stream crossing <input type="checkbox"/> Channel mod <input type="checkbox"/> Utility impacts <input type="checkbox"/> Beaver <input type="checkbox"/> Other

CHANNEL DYNAMICS <input checked="" type="checkbox"/> Downcutting <input type="checkbox"/> Bed scour <input type="checkbox"/> Slope failure <input checked="" type="checkbox"/> Widening <input type="checkbox"/> Bank failure <input type="checkbox"/> Channelized <input type="checkbox"/> Headcutting <input checked="" type="checkbox"/> Bank scour <input type="checkbox"/> Unknown <input type="checkbox"/> Aggrading <input type="checkbox"/> Sed. deposition		NOTES- UPSTREAM OF BROAD ST STREAM IS PIPED AND COULD BE DAYLIGHTED TA 29 - DOWN STR OF BROAD ST STREAM IS DEGRADED AND COULD USE RESTORATION	
QUALITATIVE IMPAIRMENT RATING: <input type="checkbox"/> Low <input checked="" type="checkbox"/> Moderate <input type="checkbox"/> Severe		CHANNEL EVOLUTIUON STAGE: <input type="checkbox"/> I <input type="checkbox"/> II <input type="checkbox"/> III <input checked="" type="checkbox"/> IV <input type="checkbox"/> V <input type="checkbox"/> VI (<i>Simon et. al., 2003</i>)

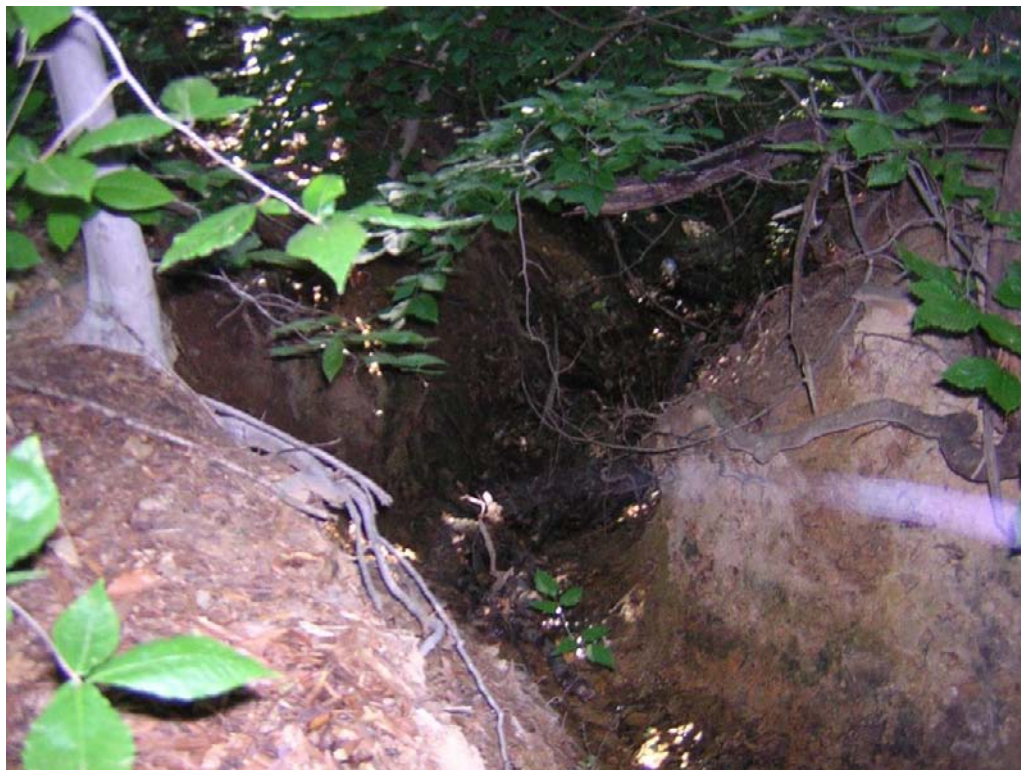
STREAM NAME: UT MILL RACE		DATE: 5/21/07	MAP SHEET #: 25-24
PHOTO NUMBERS: 2976-2979		LANDMARK: HILLSBOROUGH ST	SKETCH ON BACK
GPS ID START: IJ 43		GPS ID END: IJ 43	
DESCRIPTION:		DESCRIPTION:	
RAIN IN LAST 24 HOURS <input type="checkbox"/> Heavy rain <input type="checkbox"/> Steady rain <input type="checkbox"/> None <input checked="" type="checkbox"/> Intermittent <input type="checkbox"/> Trace		PRESENT CONDITIONS <input type="checkbox"/> Heavy rain <input type="checkbox"/> Steady rain <input type="checkbox"/> Intermittent <input checked="" type="checkbox"/> Clear <input type="checkbox"/> Trace <input type="checkbox"/> Overcast <input type="checkbox"/> Partly cloudy	
SURROUNDING LAND USE: <input type="checkbox"/> Industrial <input type="checkbox"/> Commercial <input checked="" type="checkbox"/> Urban/Residential <input checked="" type="checkbox"/> Suburban/Res <input checked="" type="checkbox"/> Forested <input type="checkbox"/> Institutional <input type="checkbox"/> Golf course <input type="checkbox"/> Park <input type="checkbox"/> Crop <input type="checkbox"/> Pasture <input type="checkbox"/> Other:

BASE FLOW WIDTH AS % CHANNEL WIDTH <input type="checkbox"/> 0-25% <input checked="" type="checkbox"/> 25-50 % <input type="checkbox"/> 50%-75% <input type="checkbox"/> 75-100%		WATER CLARITY <input type="checkbox"/> Clear <input checked="" type="checkbox"/> Turbid (<i>suspended matter</i>) <input type="checkbox"/> Stained (<i>clear, naturally colored</i>) <input type="checkbox"/> Opaque (<i>milky</i>) <input type="checkbox"/> Other (chemicals, dyes)	
DOMINANT SUBSTRATE <input checked="" type="checkbox"/> Silt/clay (fine or slick) <input type="checkbox"/> Sand (gritty) <input type="checkbox"/> Gravel (0.1-2.5") <input type="checkbox"/> Cobble (2.5 -10") <input type="checkbox"/> Boulder (>10") <input type="checkbox"/> Bed rock	CHANNEL DIMENSIONS AT RIFFLE Height: Low bank ____3-10____(ft) Width: Bottom ____3-6____(ft) Top ____3-6____(ft) Water Surface ____0.5____(ft) Depth: Max BKF ____0.2____(ft) B:H Ratio: Low bank/Max BKF=____		OBSERVED IMPACTS <input checked="" type="checkbox"/> Outfall <input type="checkbox"/> Confluence <input type="checkbox"/> Impacted buffer <input type="checkbox"/> Stream crossing <input type="checkbox"/> Channel mod <input type="checkbox"/> Utility impacts <input type="checkbox"/> Beaver <input type="checkbox"/> Other

CHANNEL DYNAMICS <input type="checkbox"/> Downcutting <input type="checkbox"/> Bed scour <input type="checkbox"/> Slope failure <input type="checkbox"/> Widening <input type="checkbox"/> Bank failure <input type="checkbox"/> Channelized <input type="checkbox"/> Headcutting <input type="checkbox"/> Bank scour <input type="checkbox"/> Unknown <input type="checkbox"/> Aggrading <input type="checkbox"/> Sed. deposition		NOTES: BURIED PIP IS CAUSING MASSIVE EROSION ON HILLSIDE DEEP GULLY FORMED POSSIBLE STEP-POOL OR ENERGY DISSIPATION EVEN CULVERT REPLACEMENT	
QUALITATIVE IMPAIRMENT RATING: <input type="checkbox"/> Low <input type="checkbox"/> Moderate <input checked="" type="checkbox"/> Severe		CHANNEL EVOLUTIUON STAGE: <input type="checkbox"/> I <input type="checkbox"/> II <input checked="" type="checkbox"/> III <input type="checkbox"/> IV <input type="checkbox"/> V <input type="checkbox"/> VI (<i>Simon et. al., 2003</i>)
