APPENDIX A

APPENDIX B

Photo Log

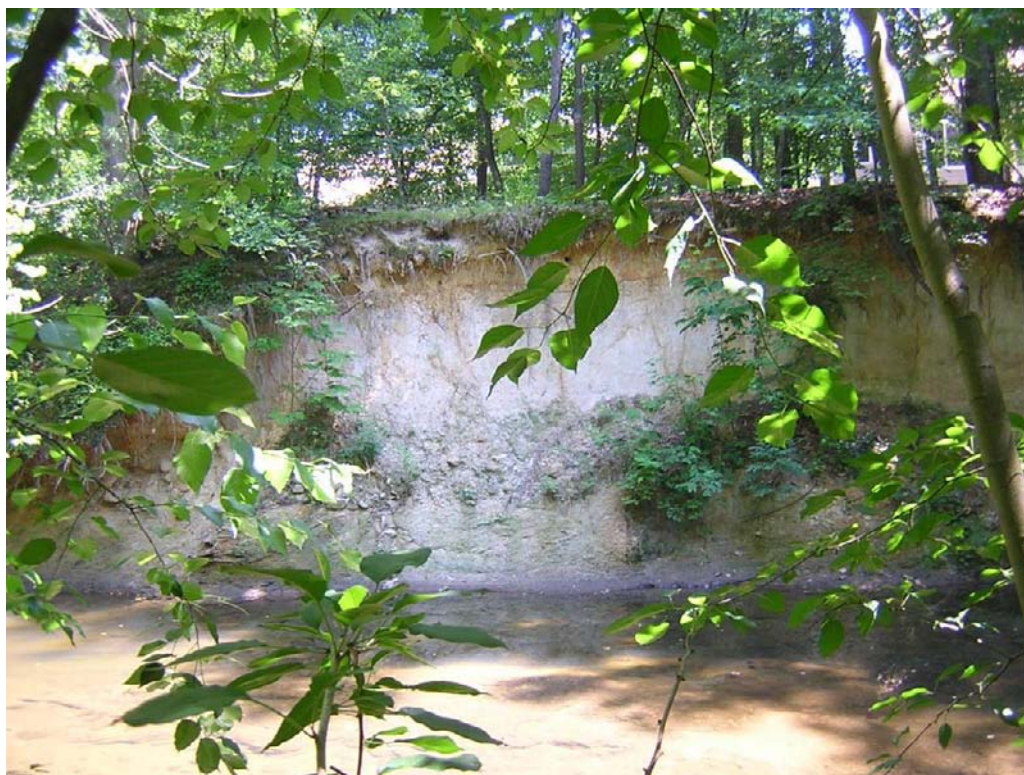
STREAM NAME: BOLIN CREEK		DATE: 2/21/07	MAP SHEET #: 25
PHOTO NUMBERS: 3015-3016		LANDMARK: BOLINWOOD DR	SKETCH ON BACK
GPS ID START: IJ53		GPS ID END: IJ53	
DESCRIPTION:		DESCRIPTION:	
RAIN IN LAST 24 HOURS <input type="checkbox"/> Heavy rain <input type="checkbox"/> Steady rain <input type="checkbox"/> None <input checked="" type="checkbox"/> Intermittent <input type="checkbox"/> Trace		PRESENT CONDITIONS <input type="checkbox"/> Heavy rain <input type="checkbox"/> Steady rain <input type="checkbox"/> Intermittent <input checked="" type="checkbox"/> Clear <input type="checkbox"/> Trace <input type="checkbox"/> Overcast <input type="checkbox"/> Partly cloudy	
SURROUNDING LAND USE: <input type="checkbox"/> Industrial <input type="checkbox"/> Commercial <input checked="" type="checkbox"/> Urban/Residential <input type="checkbox"/> Suburban/Res <input checked="" type="checkbox"/> Forested <input type="checkbox"/> Institutional <input type="checkbox"/> Golf course <input type="checkbox"/> Park <input type="checkbox"/> Crop <input type="checkbox"/> Pasture <input type="checkbox"/> Other:

BASE FLOW WIDTH AS % CHANNEL WIDTH <input type="checkbox"/> 0-25% <input type="checkbox"/> 25-50 % <input type="checkbox"/> 50%-75% <input checked="" type="checkbox"/> 75-100%		WATER CLARITY <input checked="" type="checkbox"/> Clear <input type="checkbox"/> Turbid (<i>suspended matter</i>) <input type="checkbox"/> Stained (<i>clear, naturally colored</i>) <input type="checkbox"/> Opaque (<i>milky</i>) <input type="checkbox"/> Other (chemicals, dyes)	
DOMINANT SUBSTRATE <input checked="" type="checkbox"/> Silt/clay (fine or slick) <input checked="" type="checkbox"/> Sand (gritty) <input checked="" type="checkbox"/> Gravel (0.1-2.5") <input type="checkbox"/> Cobble (2.5 –10") <input type="checkbox"/> Boulder (>10") <input checked="" type="checkbox"/> Bed rock	CHANNEL DIMENSIONS AT RIFFLE Height: Low bank ____5-20__(ft) Width: Bottom ____20__(ft) Top ____20__(ft) Water Surface ____20__(ft) Depth: Max BKF ____2.5__(ft) B:H Ratio: Low bank/Max BKF=_____		OBSERVED IMPACTS <input type="checkbox"/> Outfall <input type="checkbox"/> Confluence <input checked="" type="checkbox"/> Impacted buffer <input type="checkbox"/> Stream crossing <input type="checkbox"/> Channel mod <input type="checkbox"/> Utility impacts <input type="checkbox"/> Beaver <input type="checkbox"/> Other

CHANNEL DYNAMICS <input type="checkbox"/> Downcutting <input type="checkbox"/> Bed scour <input type="checkbox"/> Slope failure <input type="checkbox"/> Widening <input checked="" type="checkbox"/> Bank failure <input type="checkbox"/> Channelized <input type="checkbox"/> Headcutting <input type="checkbox"/> Bank scour <input type="checkbox"/> Unknown <input type="checkbox"/> Aggrading <input type="checkbox"/> Sed. deposition		NOTES MAJOR BANK FAILURE ON BOLIN CREEK POSSIBLE BANK STABILIZATION	
QUALITATIVE IMPAIRMENT RATING: <input type="checkbox"/> Low <input type="checkbox"/> Moderate <input type="checkbox"/> Severe		CHANNEL EVOLUTIUON STAGE: <input type="checkbox"/> I <input type="checkbox"/> II <input type="checkbox"/> III <input type="checkbox"/> IV <input type="checkbox"/> V <input type="checkbox"/> VI (<i>Simon et. al., 2003</i>)

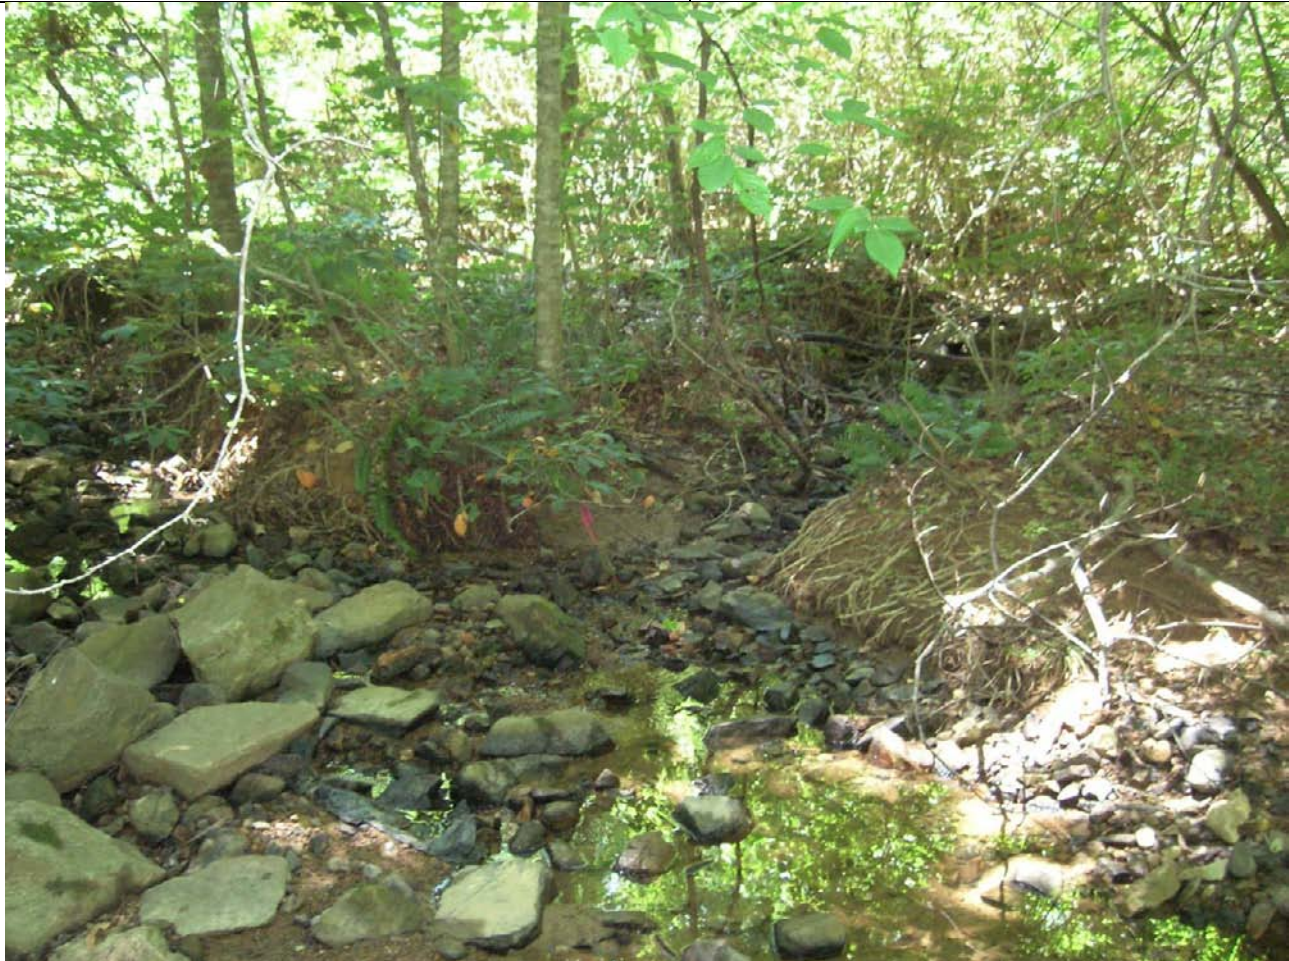
STREAM NAME: UT		DATE: 6/21/07	MAP SHEET #: 26
PHOTO NUMBERS: 1162-1165		LANDMARK: YMCA	SKETCH ON BACK
GPS ID START: BD 58		GPS ID END: BD 59	
DESCRIPTION:		DESCRIPTION:	
RAIN IN LAST 24 HOURS <input type="checkbox"/> Heavy rain <input checked="" type="checkbox"/> Steady rain <input type="checkbox"/> None <input type="checkbox"/> Intermittent <input type="checkbox"/> Trace		PRESENT CONDITIONS <input type="checkbox"/> Heavy rain <input type="checkbox"/> Steady rain <input type="checkbox"/> Intermittent <input checked="" type="checkbox"/> Clear <input type="checkbox"/> Trace <input type="checkbox"/> Overcast <input type="checkbox"/> Partly cloudy	
SURROUNDING LAND USE: <input type="checkbox"/> Industrial <input checked="" type="checkbox"/> Commercial <input checked="" type="checkbox"/> Urban/Residential <input type="checkbox"/> Suburban/Res <input type="checkbox"/> Forested <input type="checkbox"/> Institutional <input type="checkbox"/> Golf course <input type="checkbox"/> Park <input type="checkbox"/> Crop <input type="checkbox"/> Pasture <input type="checkbox"/> Other:

BASE FLOW WIDTH AS % CHANNEL WIDTH <input checked="" type="checkbox"/> 0-25% <input type="checkbox"/> 25-50 % <input type="checkbox"/> 50%-75% <input type="checkbox"/> 75-100%		WATER CLARITY <input checked="" type="checkbox"/> Clear <input type="checkbox"/> Turbid (<i>suspended matter</i>) <input type="checkbox"/> Stained (<i>clear, naturally colored</i>) <input type="checkbox"/> Opaque (<i>milky</i>) <input type="checkbox"/> Other (chemicals, dyes)	
DOMINANT SUBSTRATE <input type="checkbox"/> Silt/clay (fine or slick) <input checked="" type="checkbox"/> Sand (gritty) <input type="checkbox"/> Gravel (0.1-2.5") <input checked="" type="checkbox"/> Cobble (2.5 –10") <input type="checkbox"/> Boulder (>10") <input type="checkbox"/> Bed rock	CHANNEL DIMENSIONS AT RIFFLE Height: Low bank ____2.1____(ft) Width: Bottom ____7.1____(ft) Top ____9____(ft) Water Surface ____2____(ft) Depth: Max BKF ____0.5____(ft) B:H Ratio: Low bank/Max BKF=_____		OBSERVED IMPACTS <input type="checkbox"/> Outfall <input type="checkbox"/> Confluence <input type="checkbox"/> Impacted buffer <input type="checkbox"/> Stream crossing <input type="checkbox"/> Channel mod <input type="checkbox"/> Utility impacts <input type="checkbox"/> Beaver <input type="checkbox"/> Other

CHANNEL DYNAMICS <input checked="" type="checkbox"/> Downcutting <input type="checkbox"/> Bed scour <input type="checkbox"/> Slope failure <input type="checkbox"/> Widening <input type="checkbox"/> Bank failure <input type="checkbox"/> Channelized <input type="checkbox"/> Headcutting <input checked="" type="checkbox"/> Bank scour <input type="checkbox"/> Unknown <input type="checkbox"/> Aggrading <input type="checkbox"/> Sed. deposition		NOTES THIS NEEDS HELP. ACTIVE, GETS WORSE DS. SEE BD 59-60.	
QUALITATIVE IMPAIRMENT RATING: <input type="checkbox"/> Low <input checked="" type="checkbox"/> Moderate <input type="checkbox"/> Severe		CHANNEL EVOLUTIUON STAGE: <input type="checkbox"/> I <input checked="" type="checkbox"/> II <input type="checkbox"/> III <input type="checkbox"/> IV <input type="checkbox"/> V <input type="checkbox"/> VI (<i>Simon et. al., 2003</i>)
