BOLIN CREEK WATERSHED

Geomorphic Analysis and Potential Site Identification for Stormwater Structures and Retrofits

TOWN OF CARRBORO
NORTH CAROLINA

November 2007

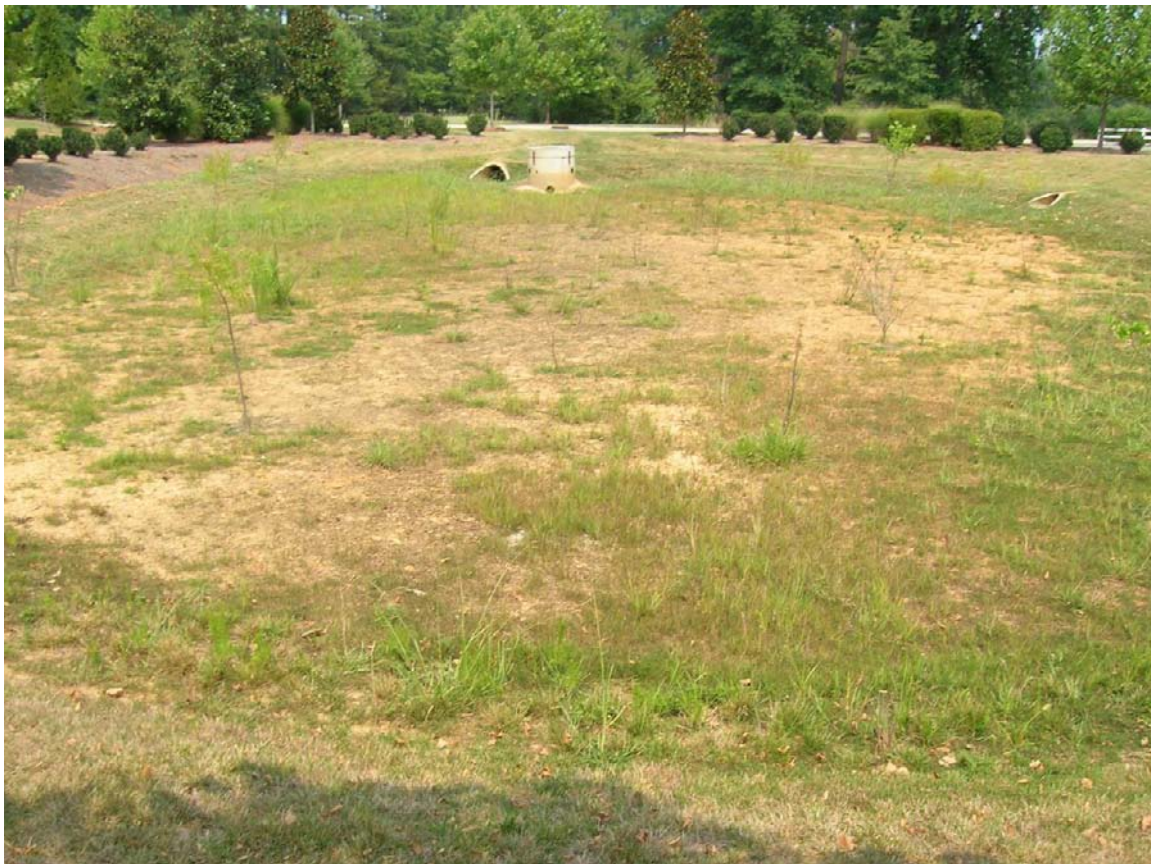
Index Sheet No.: 5
Raw Data Name: BD 100

Retrofit of Existing Stormwater Pond

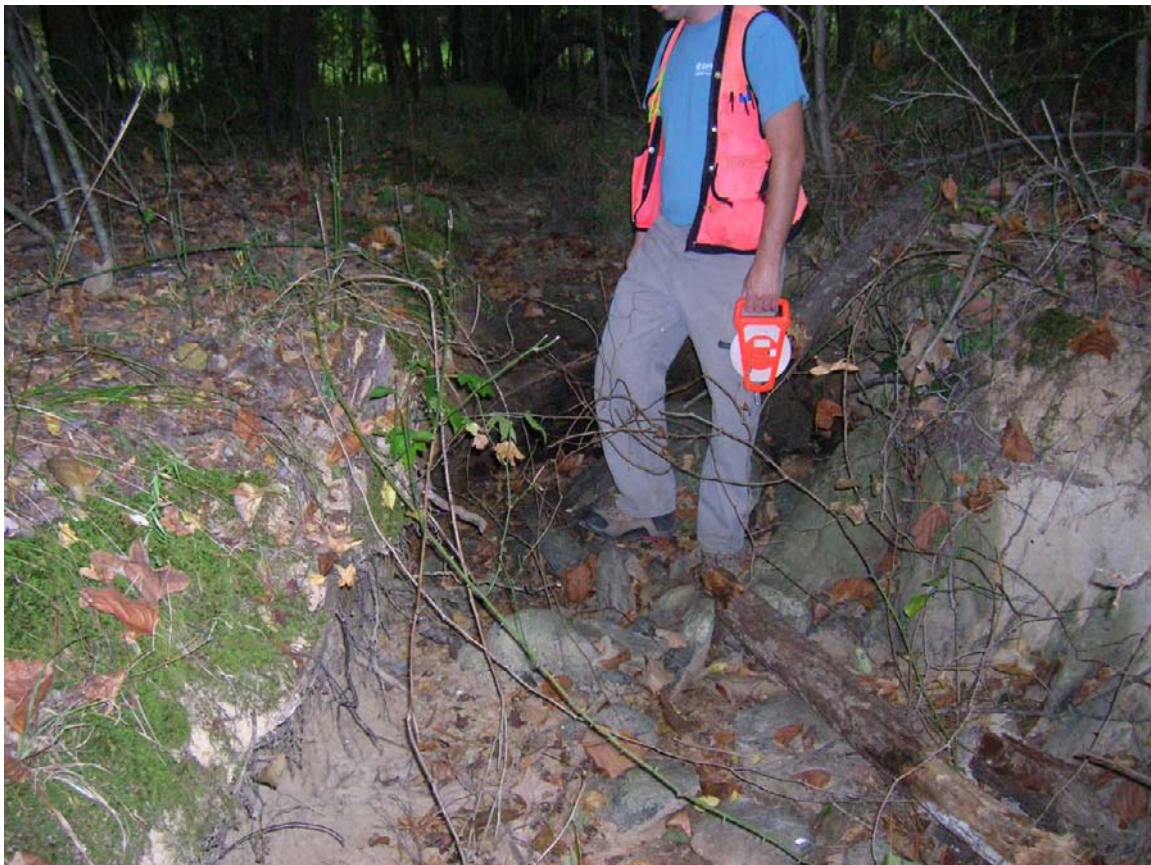
Index Sheet No.: 7
Raw Data Name: BD 27

Stabilization of Headcut on Intermittent Channel

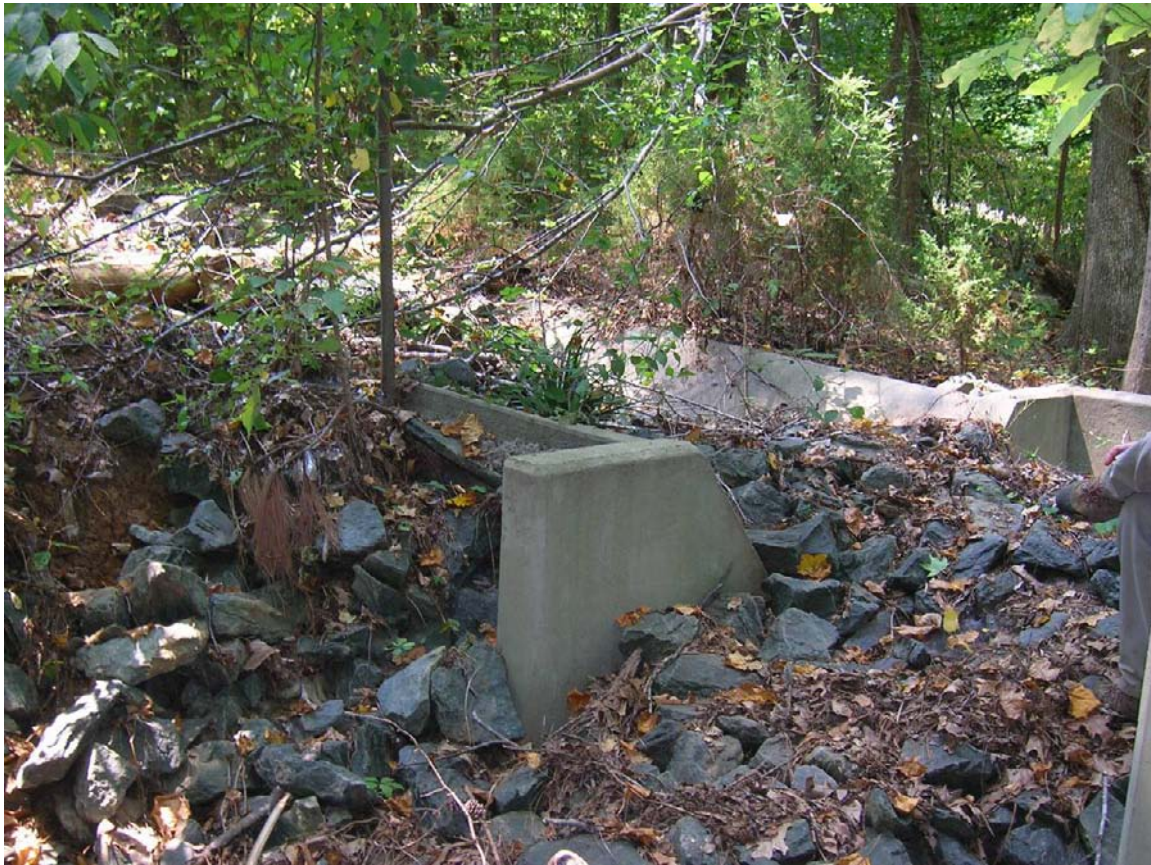
Index Sheet No.: 9
Raw Data Name: TA 3

Retrofit of Stormwater Outfall at Subdivision

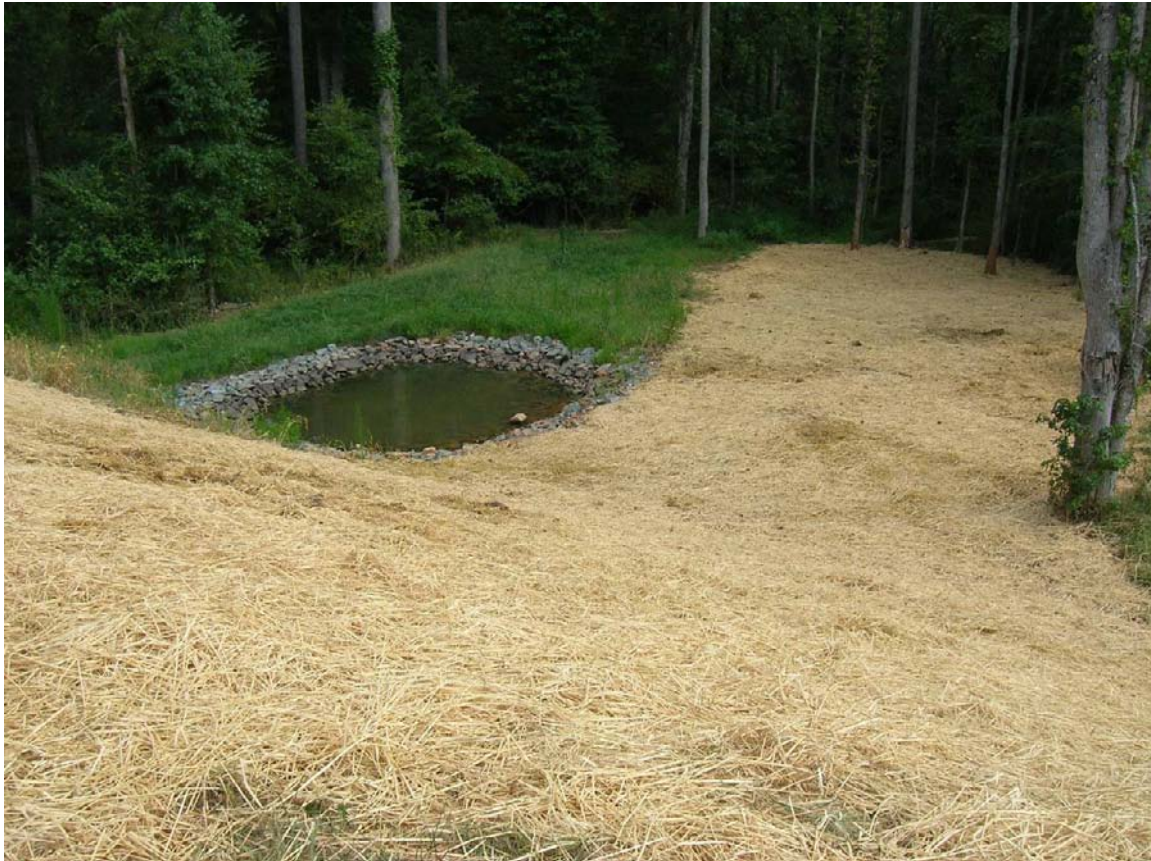
Index Sheet No.: 11
Raw Data Name: IJ 19

Retrofit of Existing Sediment Basin

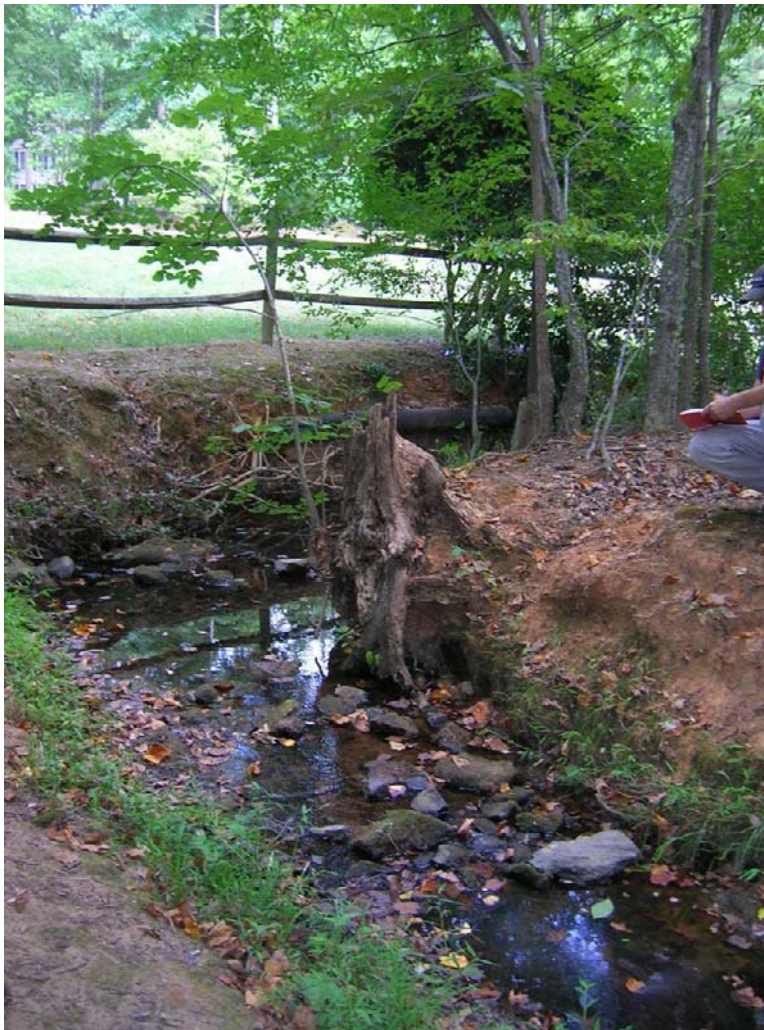
Index Sheet No.: 14
Raw Data Name: TA 5, TA 6 and TA 7

Bank Stabilization and Flow Attenuation

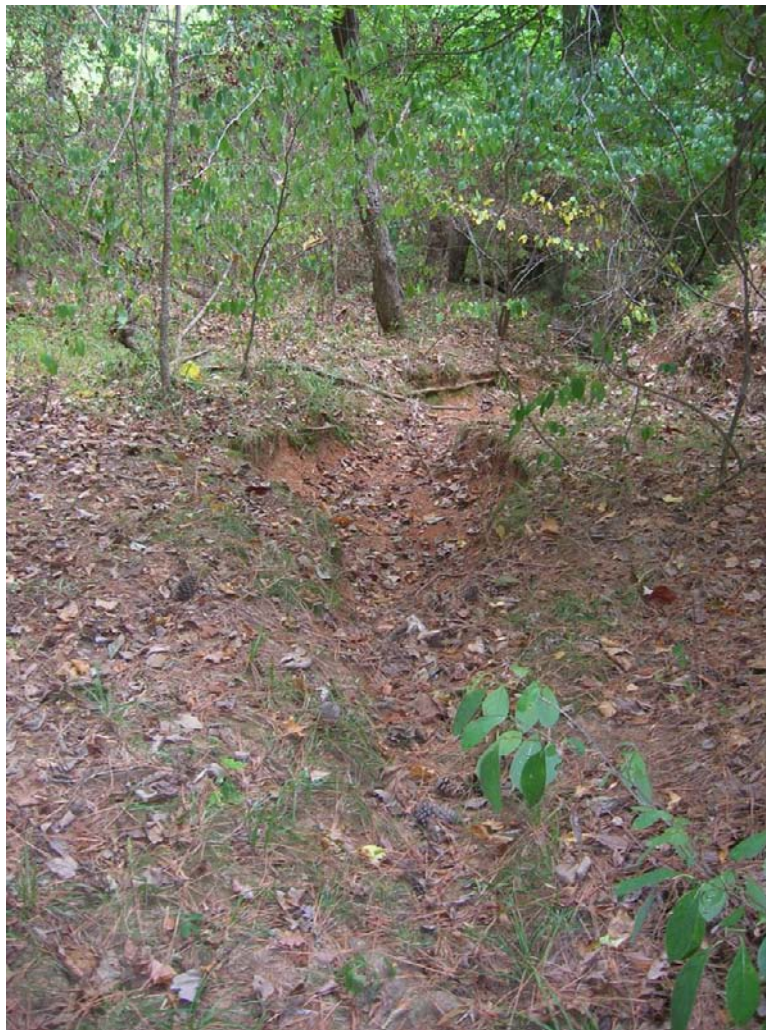
Index Sheet No.: 15
Raw Data Name: TA 12

Construction of Stormwater Wetland on Ephemeral Channel

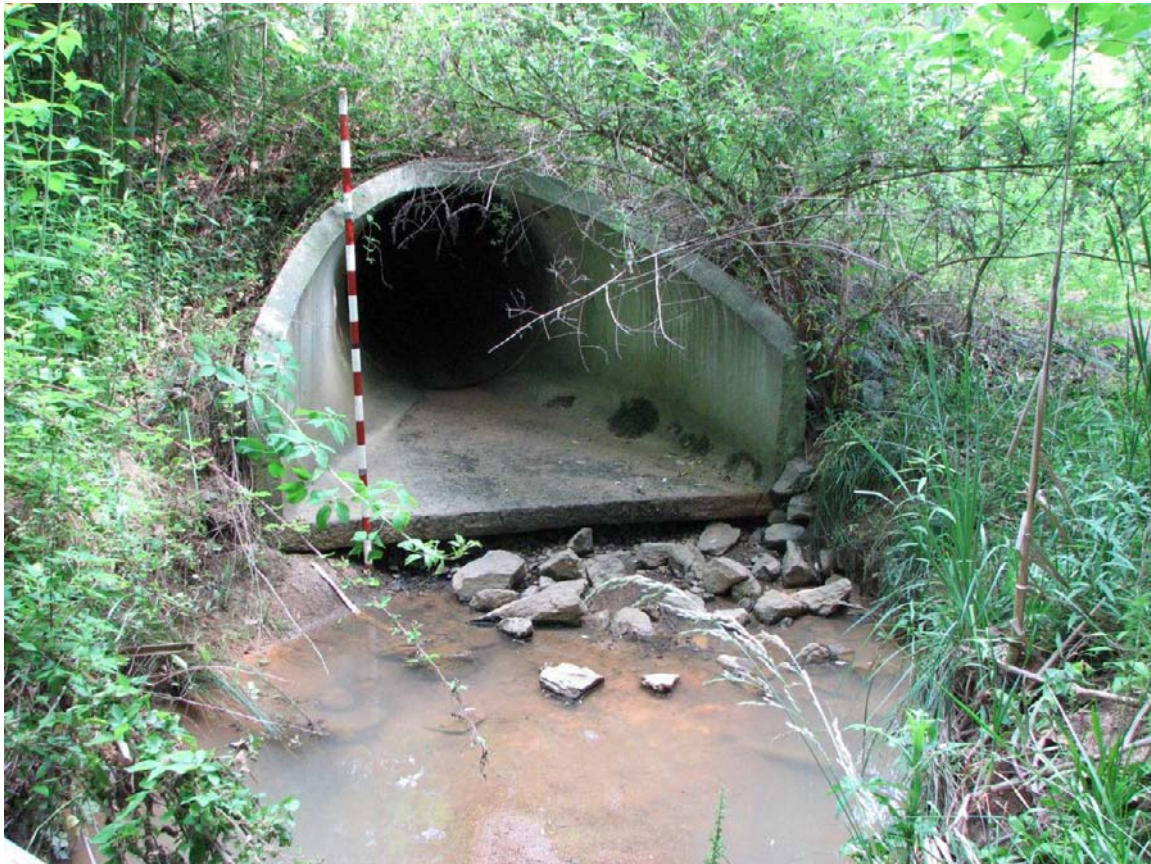
Index Sheet No.: 16
Raw Data Name: IJ 34

SITE 11
BMP retrofits at Smith Middle School

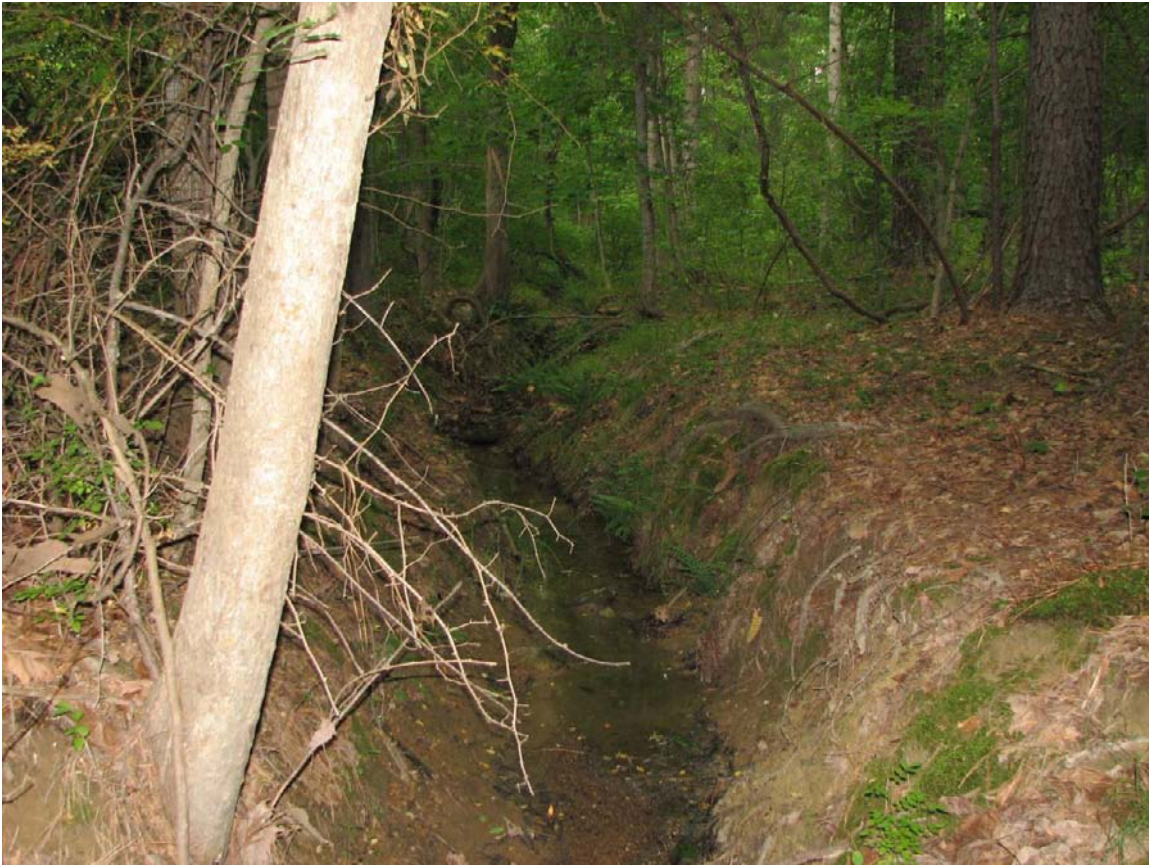
SITE 13

Project 16-03 consists of what was observed to be an ephemeral tributary to Jolly Branch that is currently incised and contains a headcut working upstream towards a paved path. The tributary has been channelized into a ditch, and has a concrete pipe outlet providing stormwater input. The contributing drainage area of this pipe appears to consist of part of the football field at Chapel Hill High School, part of the practice football field, and a portion of the student parking lot. These impervious surfaces are likely contributing pollutants, as well as the nutrients from the fertilization of the football fields, into the ephemeral tributary and into Jolly Branch. The confined ephemeral drainage feature does not have a floodplain or enough surface area to prevent erosion, so bank erosion will continue.

Water quality treatment and quantity treatment at Site 13 could be provided by the construction of a small bio-retention area in-line with the tributary. A bio-retention area is preferred over another structural BMP here because of the lack of available space for construction, and the relatively small drainage area. The tributary on which the bio-retention area should be located was observed to be ephemeral, however further verification will be needed to ensure that an in-line BMP can be placed along it. Runoff volume will be stored in underground storage, reducing peak runoff rates and potentially augmenting baseflow.

An under-drain should be used with the bio-retention area, as the in-situ soils are most likely too impermeable to allow infiltration into the surrounding soils. This under drain or pervious drain layer will allow each successive cell to discharge to the next over extended periods of time.

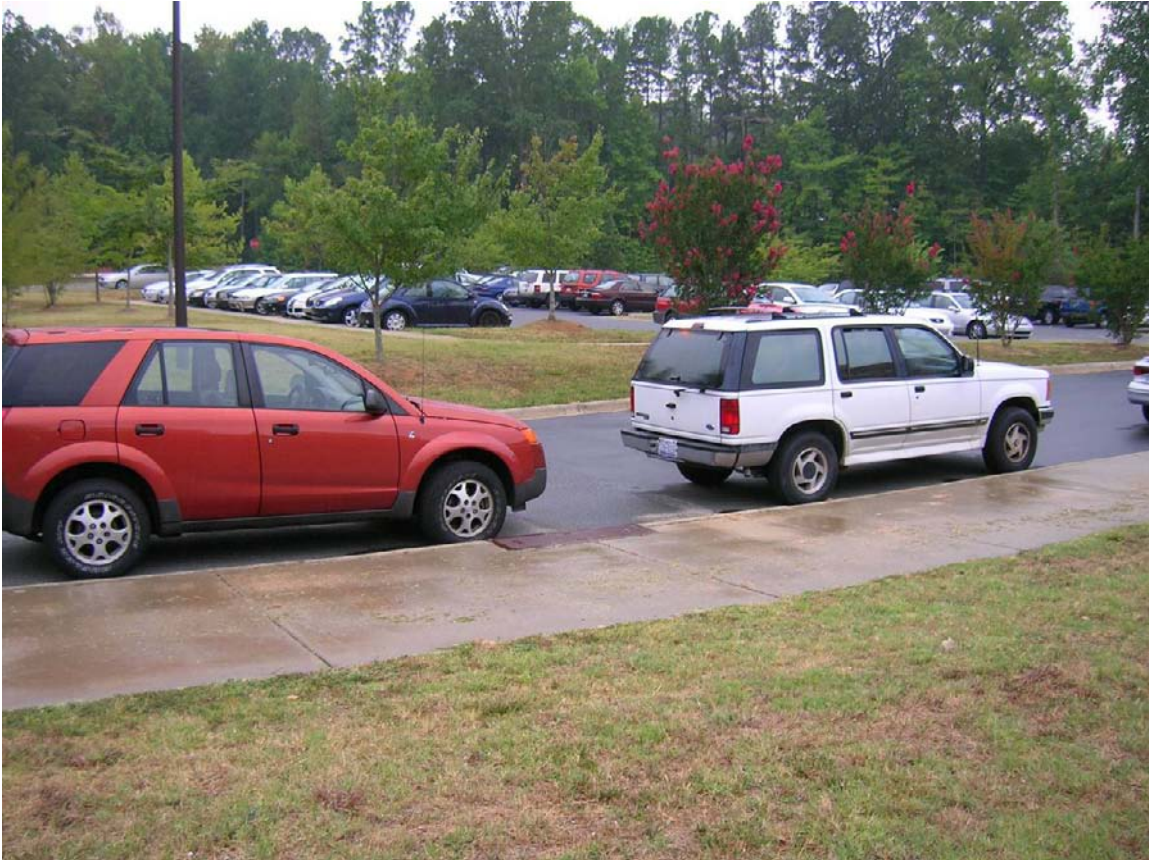
SITE 14

Site 14 is situated at the outlet pipe that discharges the storm flow of one of the parking lots of Smith Middle School. Currently, no water quality treatment is provided for the parking lot runoff before it reaches the receiving stream, Jolly Branch. This direct discharge to the stream has caused channel incision and does not provide water quality or quantity treatment of any form. Channel instability will continue due to this direct discharge of stormwater into the receiving channel, Jolly Branch.

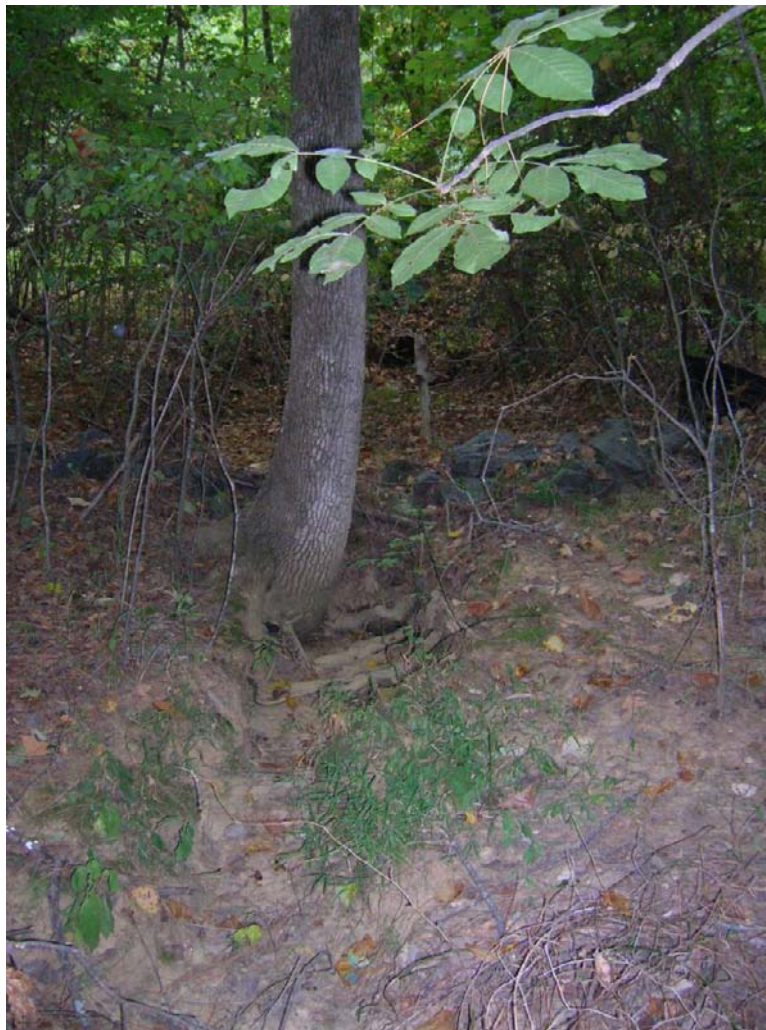
Retrofit of Existing Sediment Basin

Site 15 is heavily wooded, and care would therefore have to be taken to protect the larger trees on the site during construction. During field visits, it was observed that a large, dead maple is still standing just downhill of the sediment basin. This could be removed and provide a significant amount of the surface area for the expansion of the basin into a stormwater wetland.

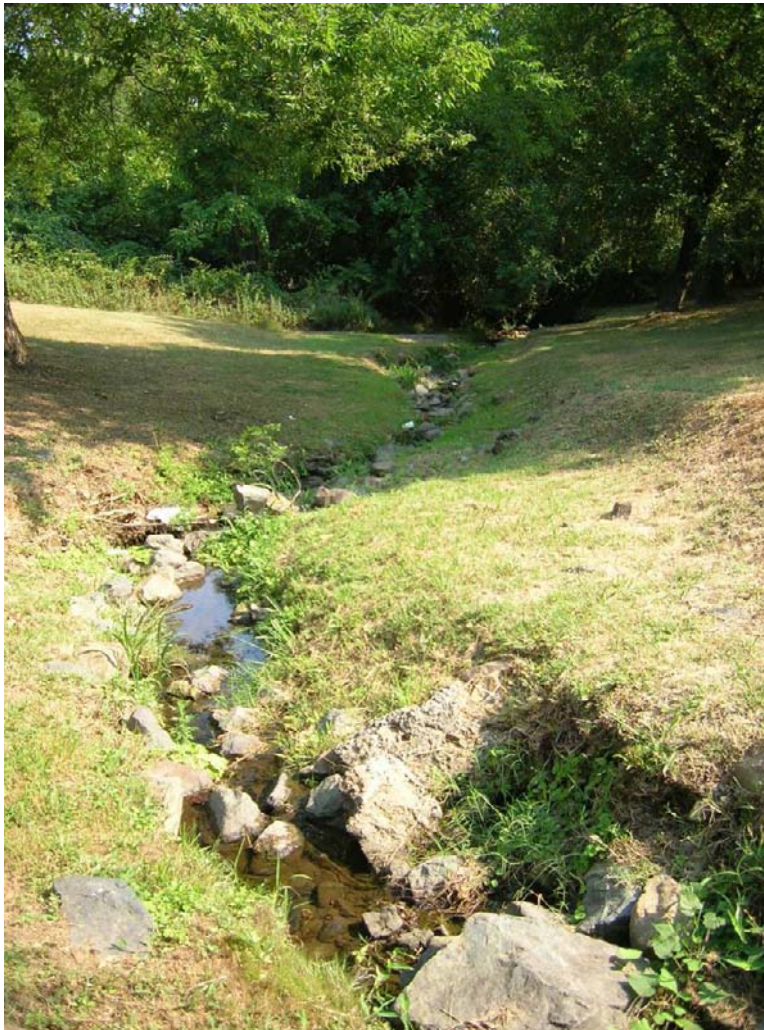
Stream Restoration/Bank Stabilization in Park

Site 19 consists approximate 165 feet of an incised reach of Tanyard Branch, with actively eroding, vertical banks and lack of a riparian buffer. Upstream of the site, the stream is completely piped, and emerges from a culvert after passing under Broad Street, where it then flows through a town-owned park. The eroding streambanks are likely the result of what was observed to be repeated mowing up to the stream (mechanical stresses on the channel) and a lack of riparian buffer to resist the high shear stress coming from the concentrated flow discharge of the upstream pipe network. The eroding stream banks are causing export of sediment and associated nutrients. A preliminary investigation of streambank erosion potential using the BANCS model indicates that approximately 29 tons of sediment is being exported from the site each year. Concomitant nutrient export associated with the sediment has also been calculated and is listed in **Table 19.1**.

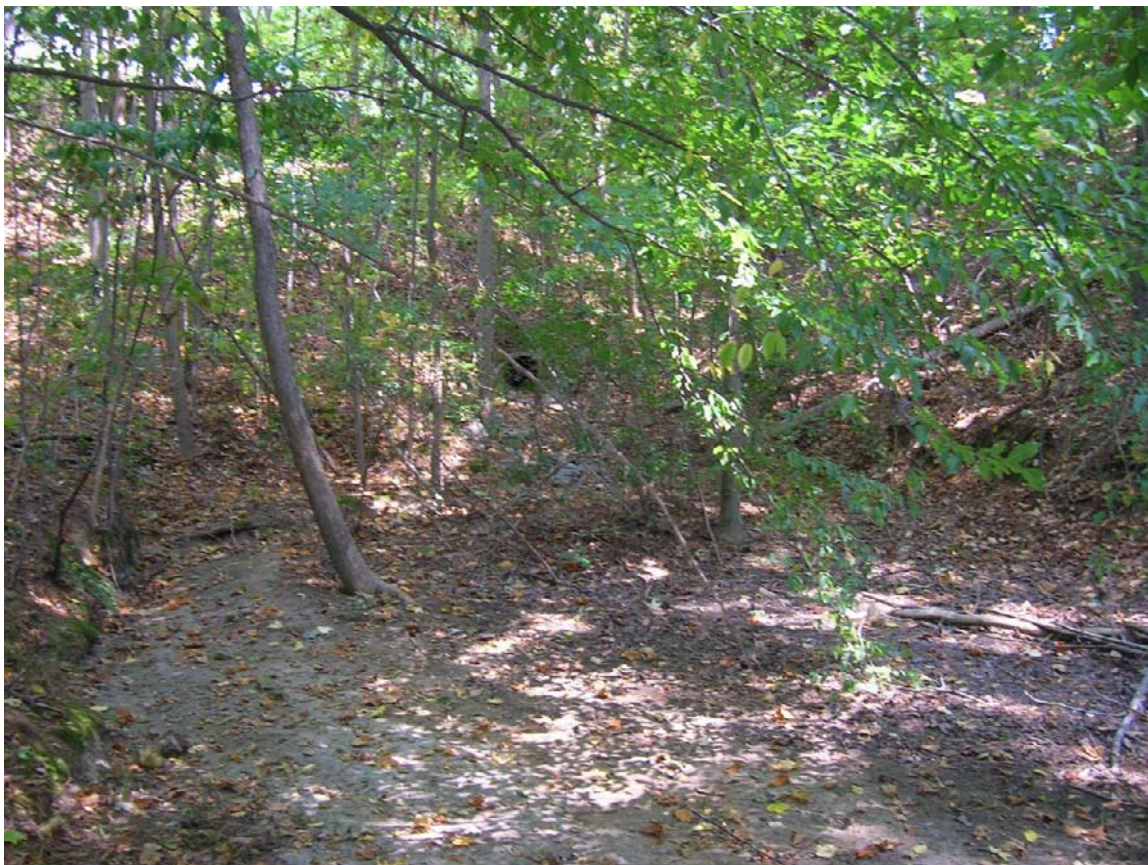
Index Sheet No.: 25
Raw Data Name: BD 57

The existing basin at Site 23 poses a good opportunity for a BMP retrofit in the form of a bioretention area. The existing basin is relatively long, which will provide an adequate flow path ratio of greater than 3:1, which is recommended for bioretention areas (DWQ, 2007). In addition, excavation will be limited to digging out the depth needed for adequate water quality storage volume. The storage volume in the bioretention area will reduce the runoff volume for the downstream reach, change the timing of peak flows and reduce peak flows leaving the site. This site would assist in the successful stabilization of the reach in site 24.

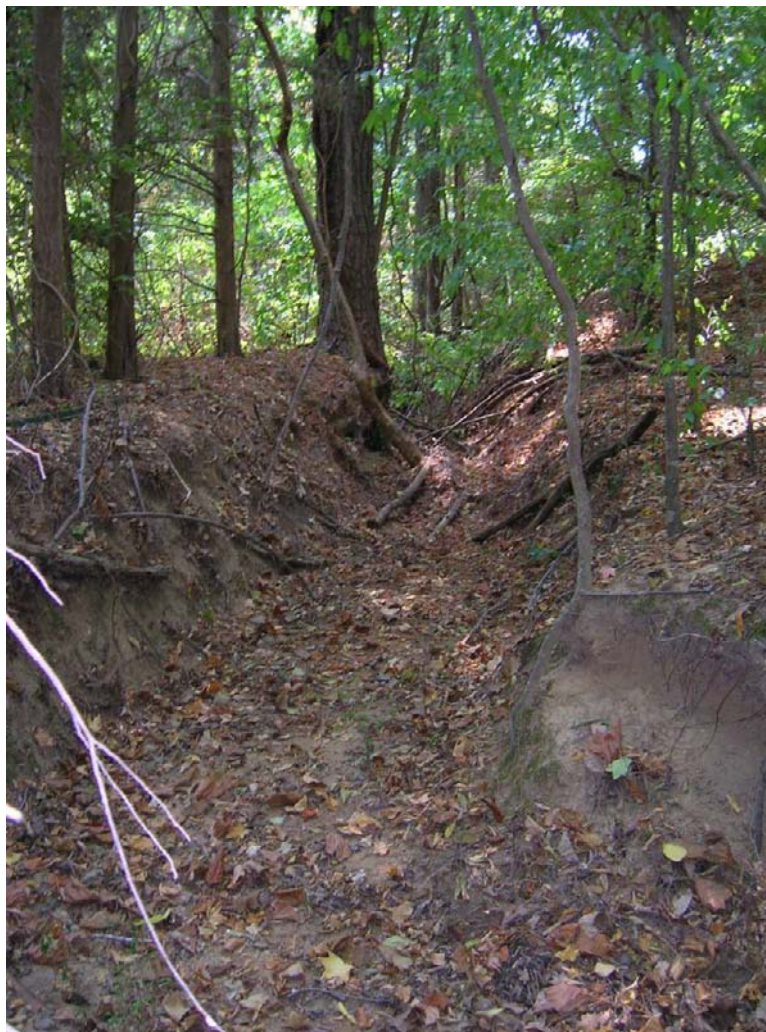
Index Sheet No.: 25
Raw Data Name: BD 55

Site24 consists of 140 feet of an incised, actively eroding stream (low bank height approximately 4 feet). A very prominent headcut (approximately 3' vertical in 1' horizontal) marks the top of this site (upstream). The head cut is active and undercut, demonstrating a high degree of mobility. A BEHI rating of "extreme" was found for the entire length of the channel. Likely causes of this incision are the increase in peak flows of the contributing drainage area due to development, headcut effects caused by the past construction of the greenway downstream, and possible stream modification during the construction of the adjacent apartment complex. The stream flows into Bolin Creek only 70 feet downstream of the site, after passing under the Bolin Creek Greenway.

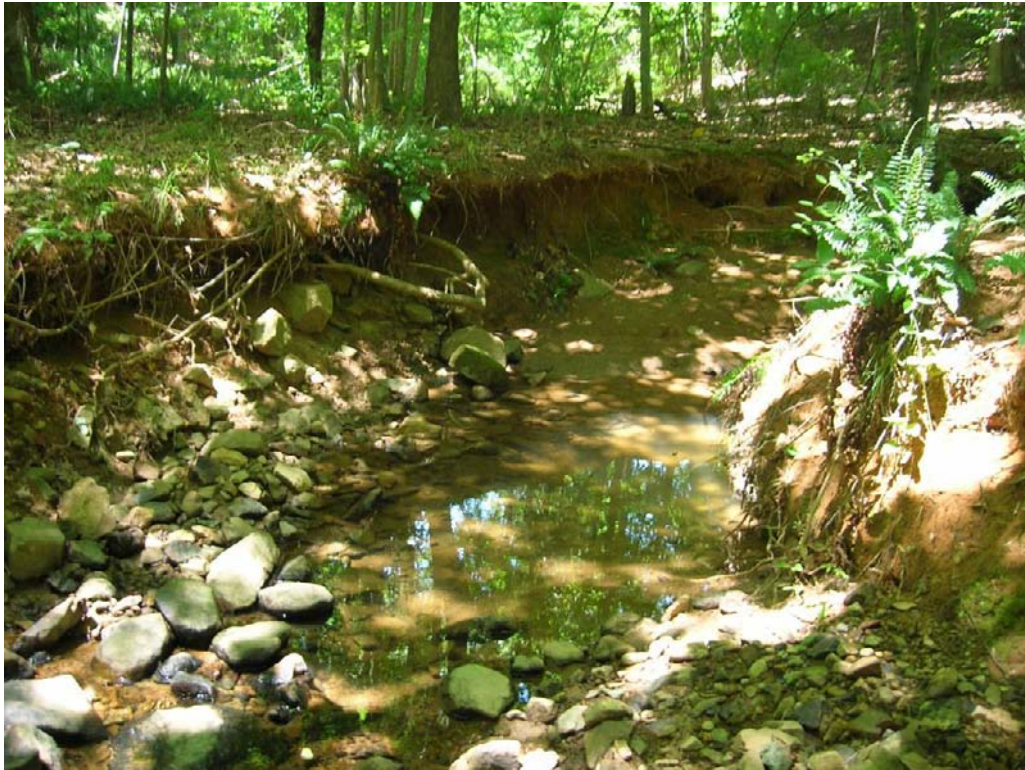
Index Sheet No.: 26
Raw Data Name: BD 58

The perennial stream along which Site 25 is located, Cole Springs Branch, exhibits severe incision and erosion for most of its course from it's headwaters to where it flows into Bolin Creek. The causes of this widespread degradation are apparent when examining the watershed of the stream, which consists of vast areas of impervious surface, including portions of Horace Williams Airport, the UNC facilities management complex, and high density residential developments. The crossing of Martin Luther King Jr. Blvd. also seems to have adversely affected the stream, as the accumulated and concentrated flow of most of the watersheds imperviousness is discharged after passing under that road.

Site 25 is located at the bottom of what was observed to be an ephemeral drainage, consisting of an incised channel. Two BMPs could possibly be constructed here. A bio-retention area could be placed in-line with the ephemeral channel just before it flows into Cole Springs Branch. Just downstream, a small stormwater wetland could be constructed as an off-line BMP where there is a flat, wide area in the valley of Cole Springs Branch. Off-line retention is needed throughout the watershed of Cole Springs Branch, both to attenuate peak flows and provide pollutant treatment. Base flow augmentation of the Cole Springs Branch could also result from this practice.

The bio-retention area is recommended as an in-line structure here, because of its ability to treat small drainage areas, the fact that it needs minimum area to construct it, and because it can function on steep slopes (NCDWQ, 2007). A bio-retention area would not likely be appropriate in the floodplain of Cole Springs Branch as an offline BMP, as it requires a minimum depth of 2 feet between the water table and the bottom of the retention area, which is a situation which is not often present in a floodplain (NCDWQ, 2007). Instead, a stormwater wetland would be more appropriate. Flow diversion into the wetland would be provided by a flow-splitting structure containing a a vane or weir, placed in Cole Springs Branch. This is a common way to “harvest” storm flows without impeding the base flows of the stream in any way. Such a structure would allow a designed volume of flow to enter into the wetland, while allowing any flow above that volume to continue downstream. If properly placed and designed, a grade control or cross vane can serve this same purpose while acting a grade control for the stream.

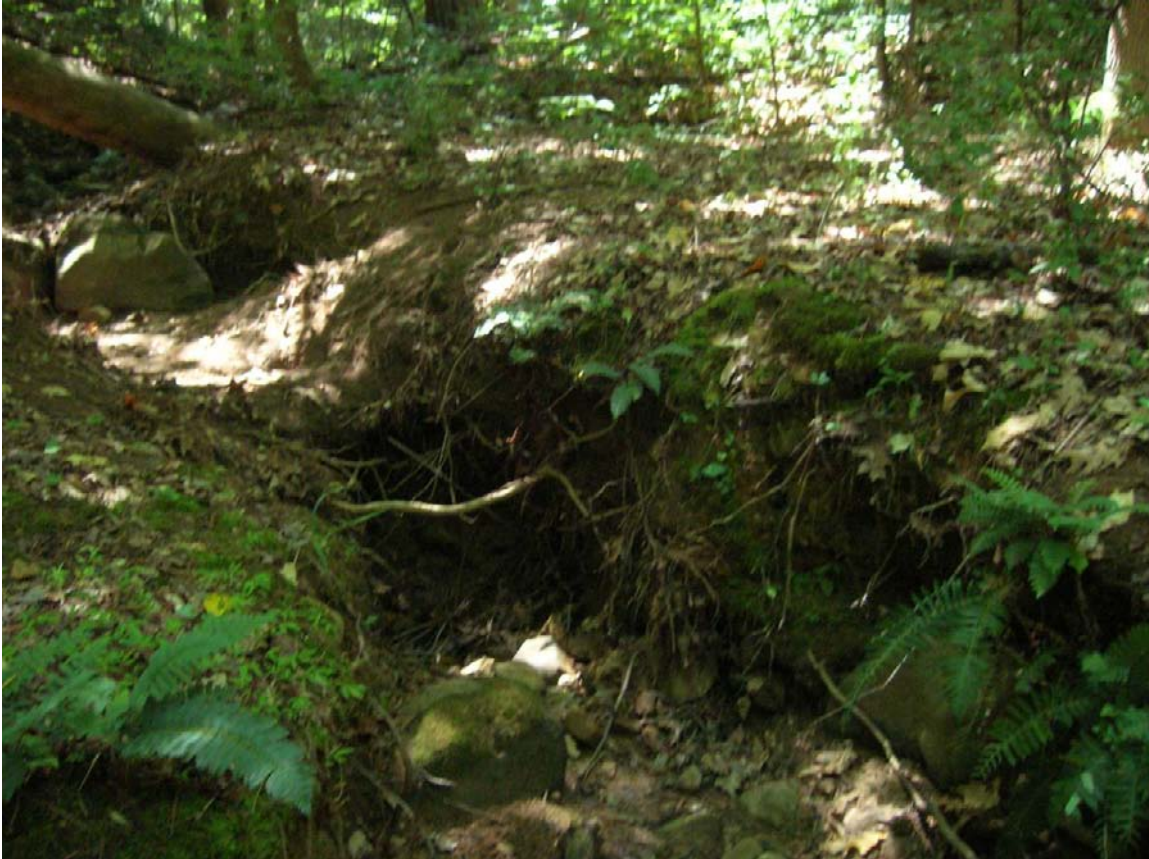
Index Sheet No.: 26
Raw Data Name: BD 71

Site 26 is situated on a small tributary to Cole Springs Branch with active headcuts and bank erosion. The tributary was observed to be ephemeral, based on indicators such as position in the landscape, rooted plants in the channel and other factors. The headcut is actively cutting upstream, and needs immediate attention before it forms more of a gulley. **Table 26.1** shows a summary of calculated pollutant loads being produced by the contributing drainage area.

The ephemeral drain provides an ideal site for bio-retention when the drain meets the floodplain of Cole Springs Branch. The storage volume and reduced velocities will aid the stability of the Cole Springs Branch. Baseflow augmentation should result from this floodplain BMP. The outlet of the proposed bio-retention area should be a level spreader that runs parallel to Cole Springs Branch. This will alleviate the concentrated flow and scour that was observed on the site. Water quality and quantity management from the bio-retention area placed at the confluence of the steep ephemeral channel and Cole Springs Branch represents the type of project that should be implemented throughout this sub-watershed. Though a liner bio-retention, such as bio-grade step, would be applicable here, it is less expensive to manage these flows where they reach the lower slope of the perennial streams floodplain.

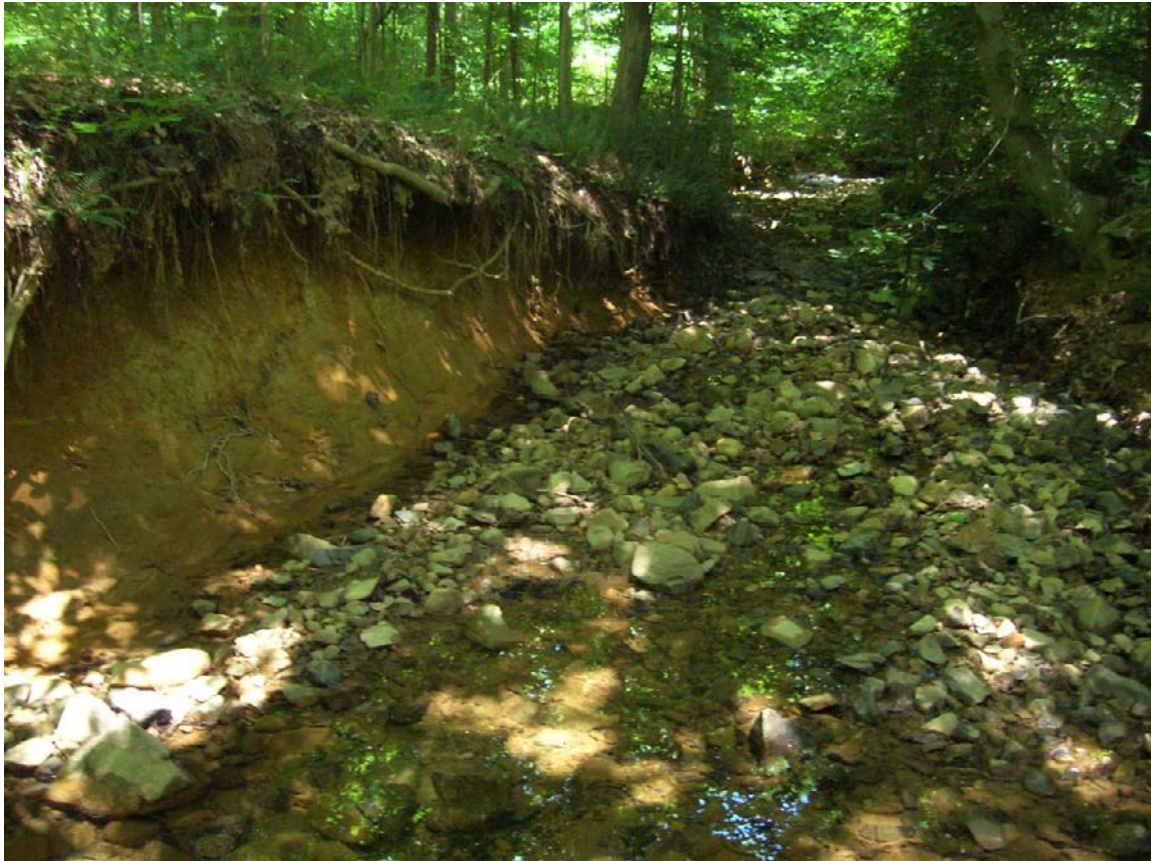
Index Sheet No.: 26
Raw Data Name: BD 65

The perennial stream along which Site 27 is located, Cole Springs Branch, exhibits severe incision and erosion for most of its course from it's headwaters to where it flows into Bolin Creek. The causes of this widespread degradation are apparent when examining the watershed of the stream, which consists of vast areas of impervious surface, including portions of Horace Williams Airport, the UNC facilities management complex, and high density residential developments. The crossing of Martin Luther King Jr. Blvd. also seems to have adversely affected the stream, as the accumulated and concentrated flow of most of the watersheds impervious area is discharged from a culcert after passing under that road.

At least two areas within this valley could be used for off-line stormwater wetlands. Stormwater wetlands are a preferred choice here, as the floodplain may not have the minimum depth required from the water table that is required for bio-retention areas. On the other hand, having a high water table is beneficial to a wetland as it allows for permanent pools (NCDWQ, 2007). These side channel wetlands capture a portion of the runoff volume which reduced the flow rate, velocities and changes the timing of peak flows to the downstream reach. The saturated condition of the wetland may be paralleled to a beaver pond in the expectation to augment baseflow via the saturated soils within the wetland.

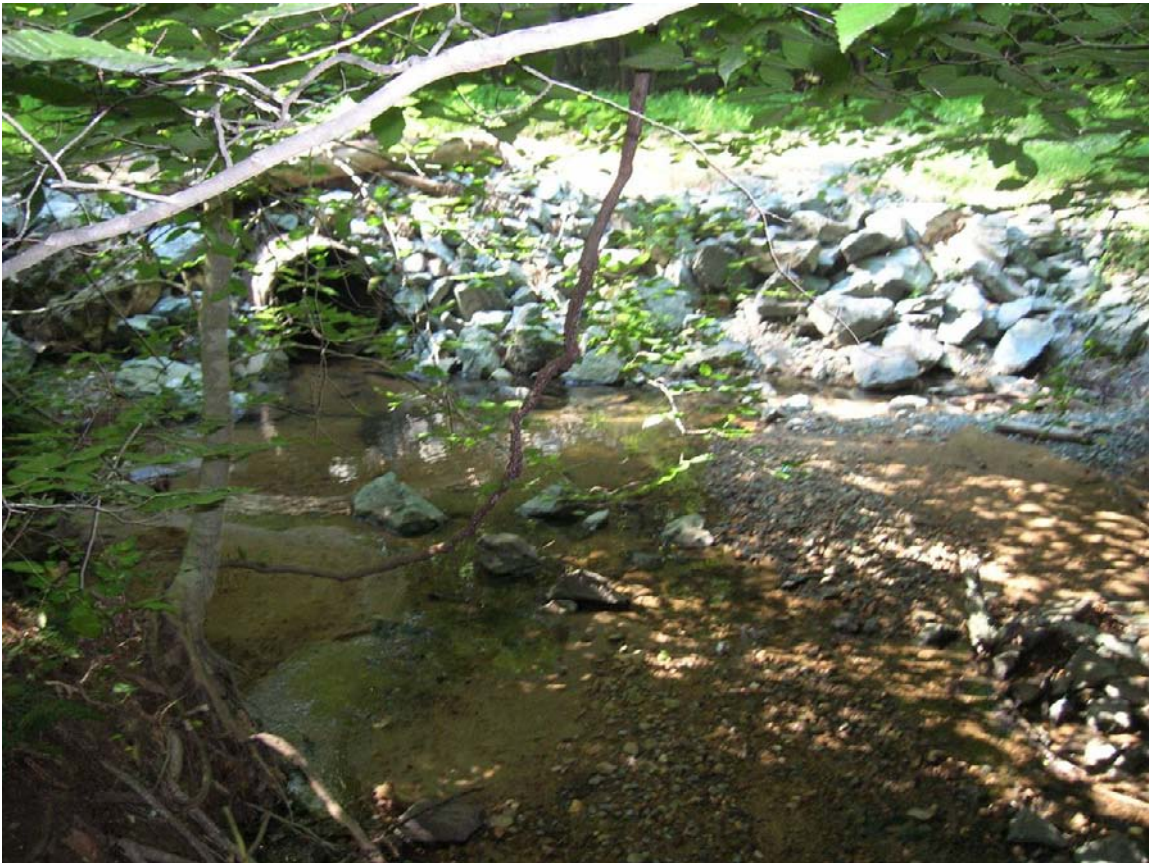
Index Sheet No.: 26
Raw Data Name: BD 75

The perennial stream along which Site 28 is located, Cole Springs Branch, exhibits severe incision and erosion for most of its course from it's headwaters to where it flows into Bolin Creek. The causes of this widespread degradation are apparent when examining the watershed of the stream, which consists of vast areas of impervious surface, including portions of Horace Williams Airport, the UNC facilities management complex, and high density residential developments. The crossing of Martin Luther King Jr. Blvd. also seems to have adversely affected the stream, as the accumulated and concentrated flow of most of the watersheds imperviousness is discharged after passing under that road.

Downstream of the culvert, the already damaged stream banks need stabilization. The combination of these BMP's indicates the typical situation that will be required to restore stream stability in this troubled watershed.

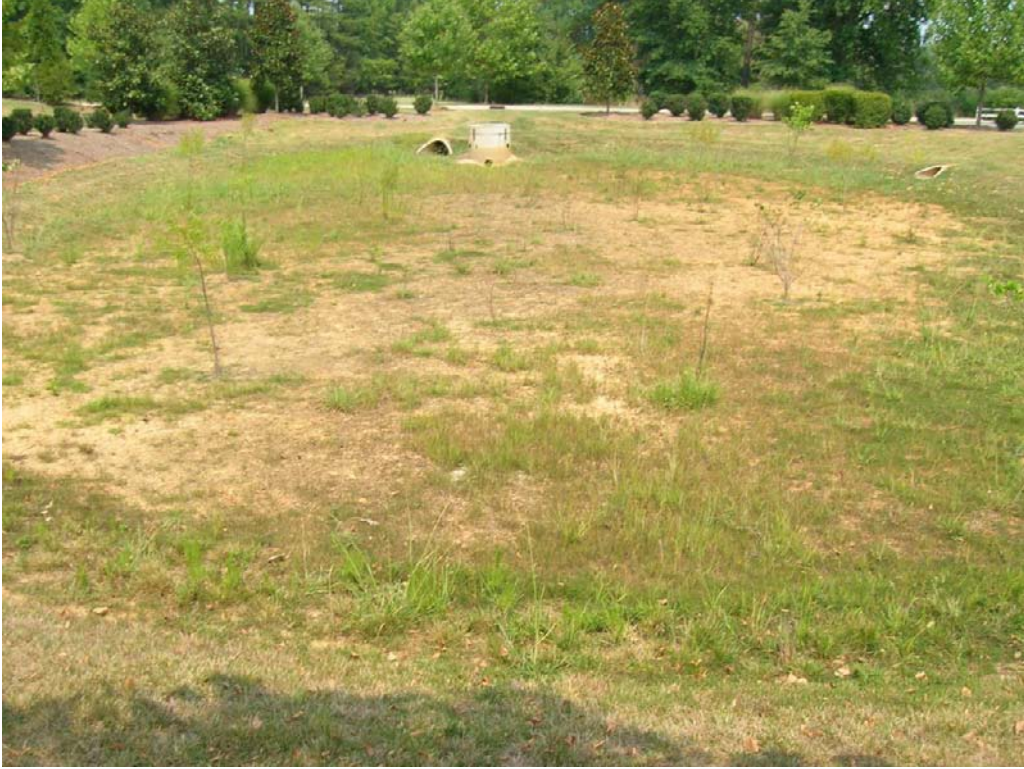
Site 2

The existing stormwater basin. Note the lack of vegetation and the close proximity of the inlet pipe to the outlet structure.

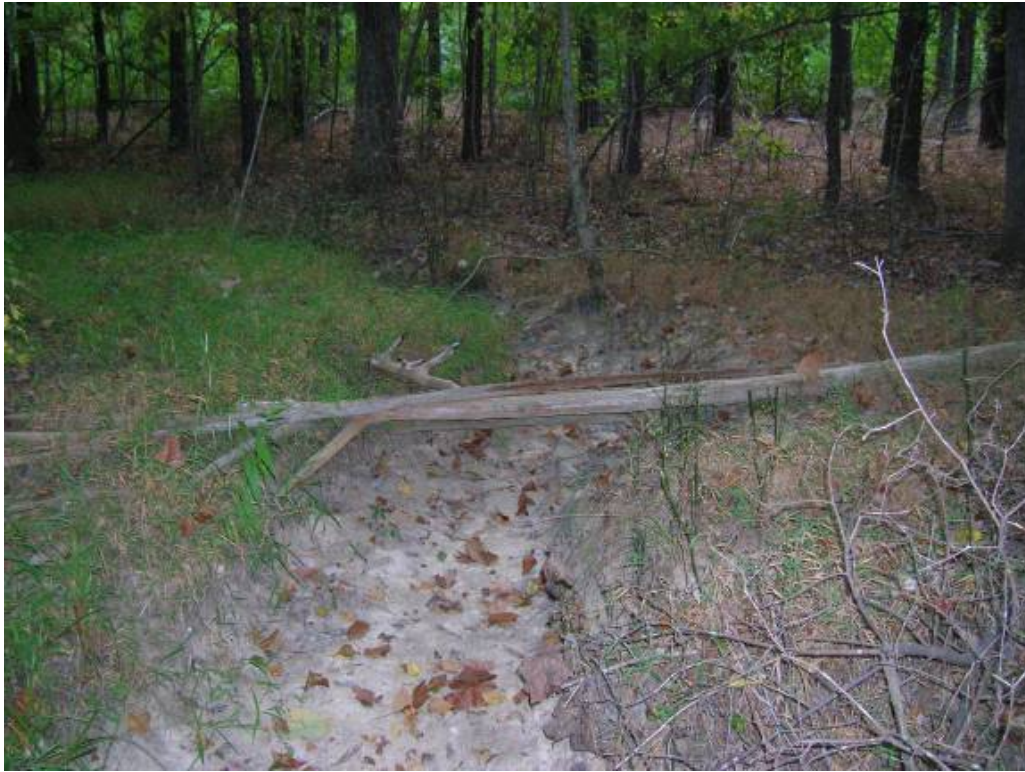
Site 3

Upstream of the headcut at Site 3. Facing downstream.

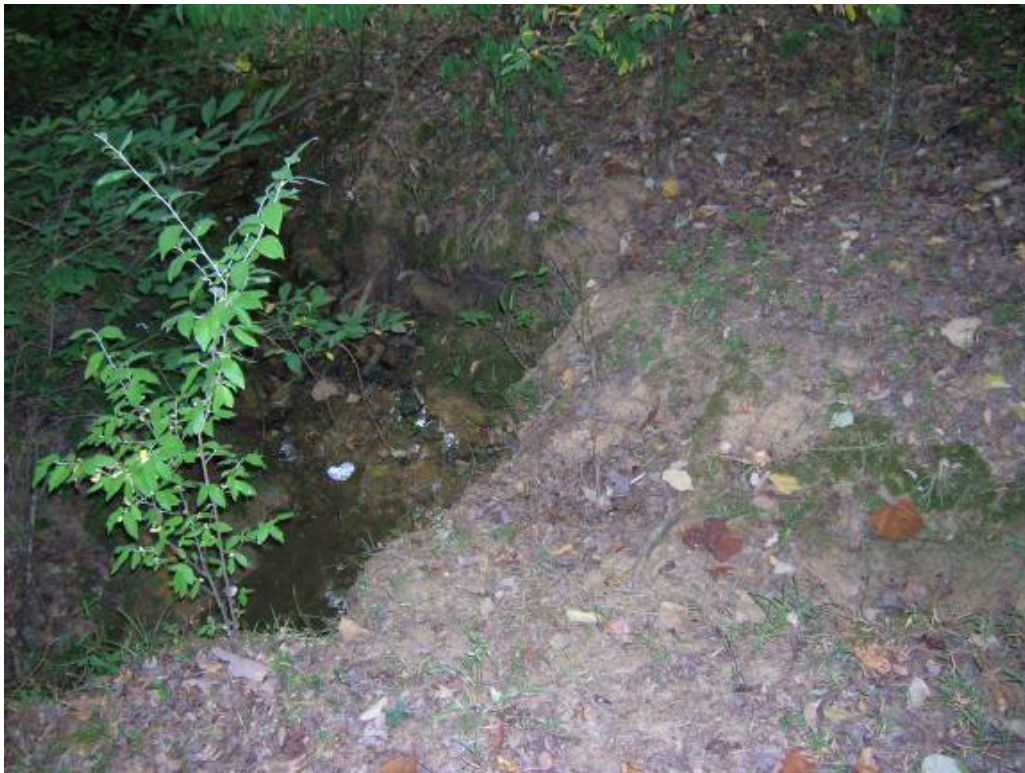
Downstream of the headcut, the channel is much more incised. Facing downstream.

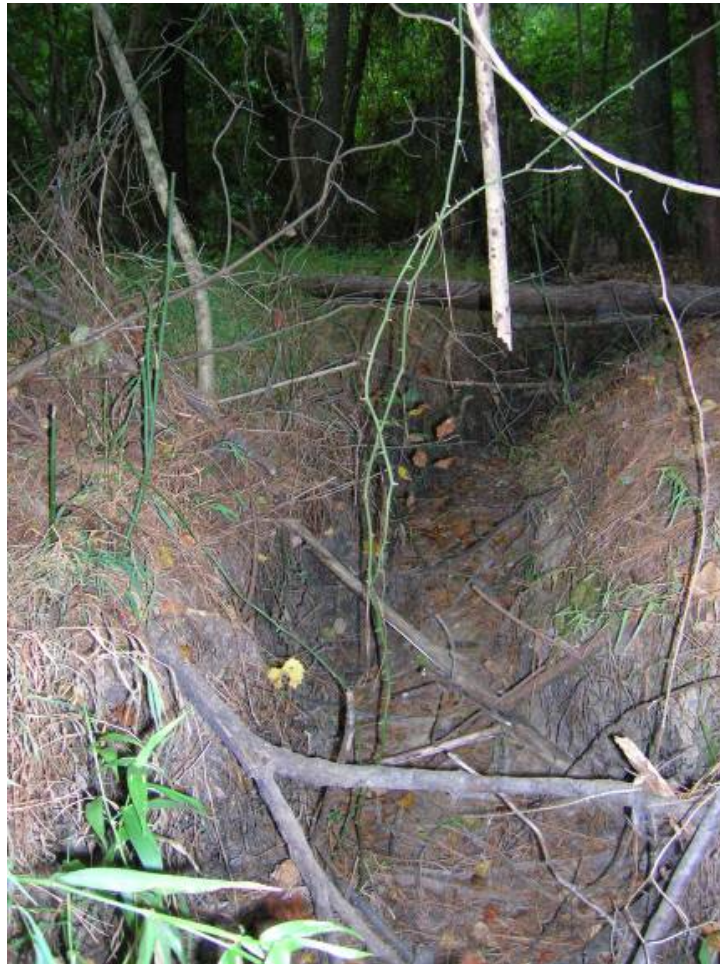
Downstream of the headcut. Facing upstream.

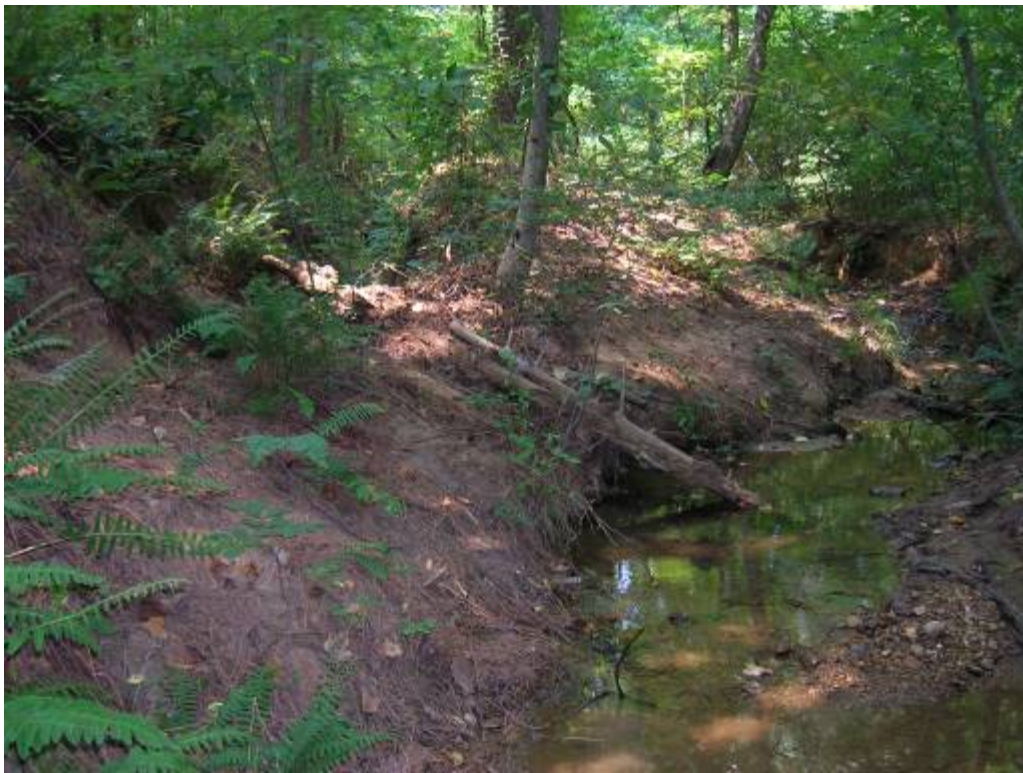
The stream into which the ditch at Site 4 leads. The ditch is on the left side of the photo. Facing upstream.
