BOLIN CREEK WATERSHED

Geomorphic Analysis and Potential Site Identification for Stormwater Structures and Retrofits

TOWN OF CARRBORO
NORTH CAROLINA

November 2007

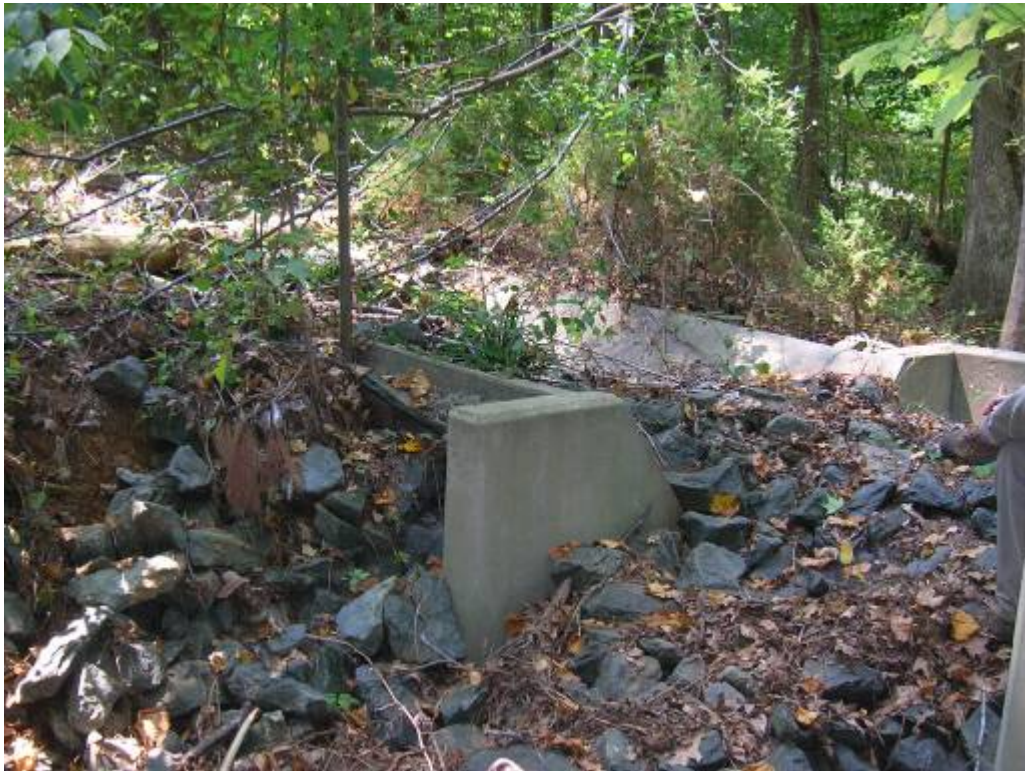
The concrete flow dissipation structure at Site 4.

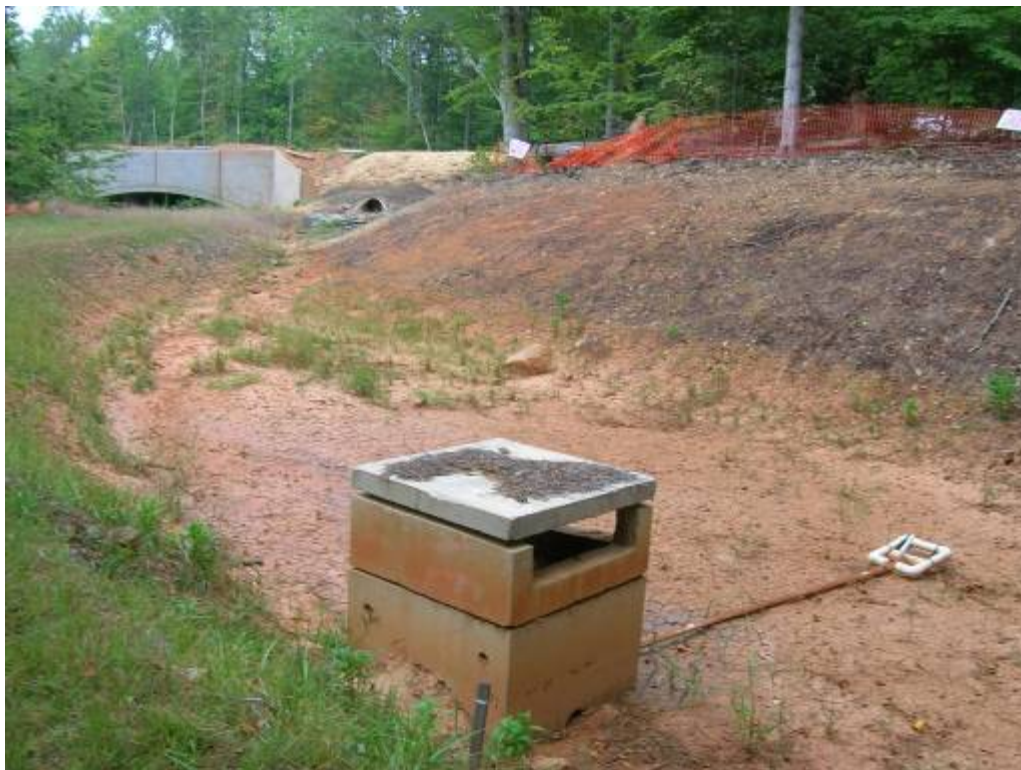
Site 5. The sediment basin outlet structure, facing northwest.

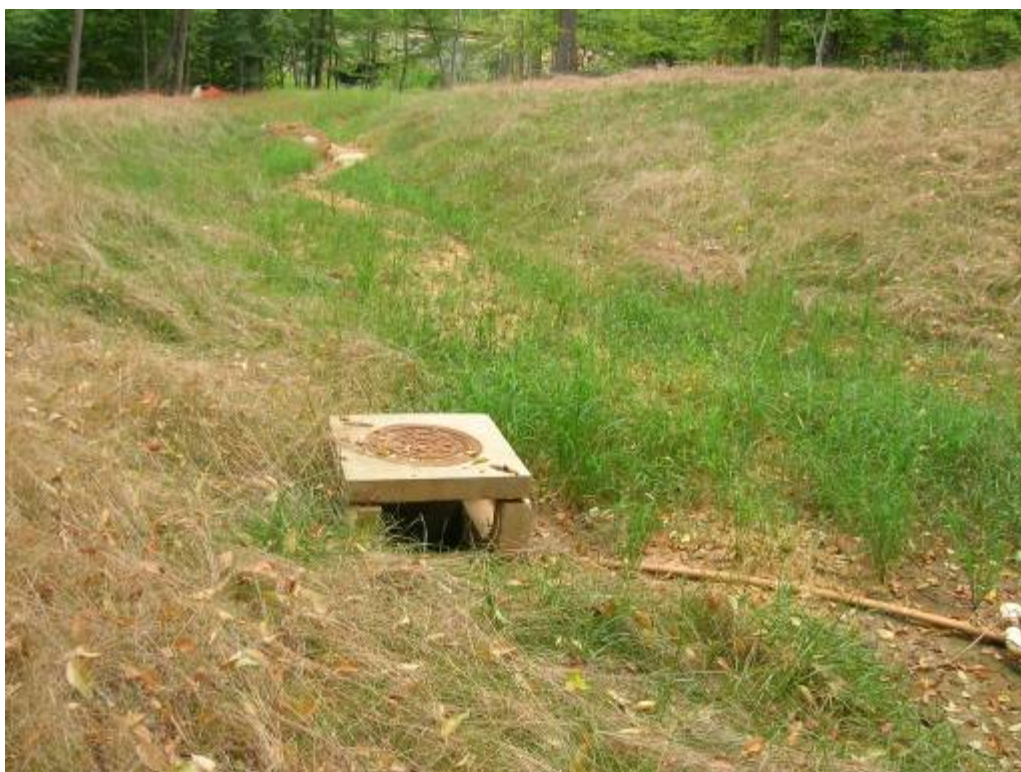
Another sediment basin at Site 6. Note the eroding grassy swale leading into the basin. Facing east.

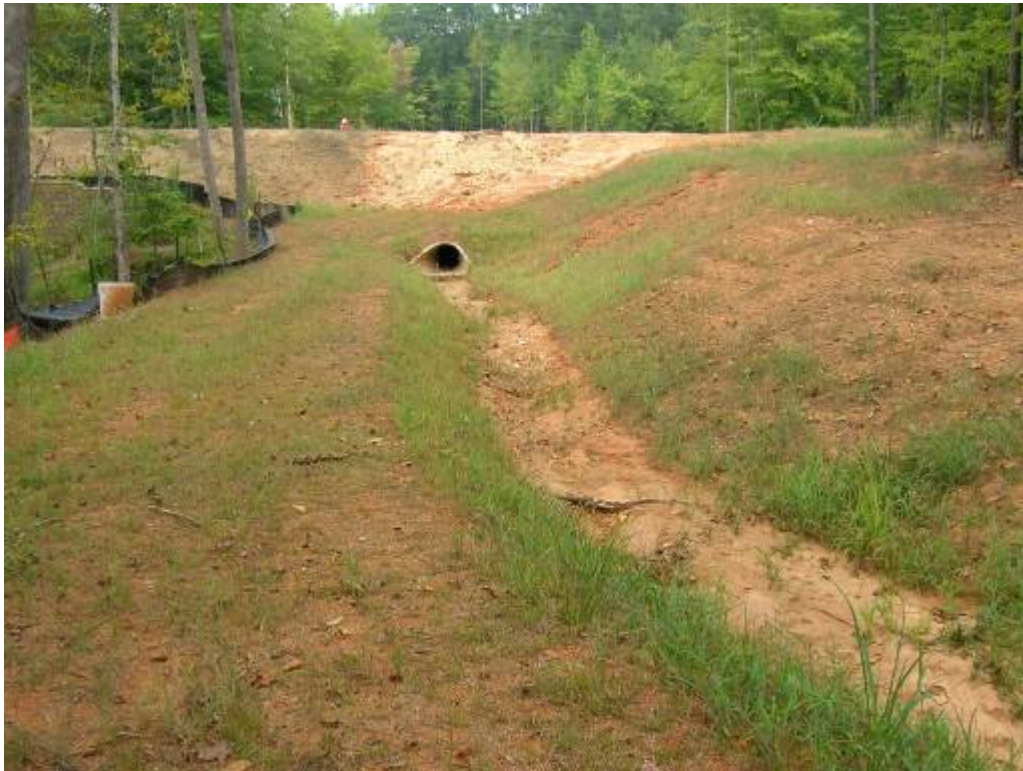
An eroding grassy swale, facing west.

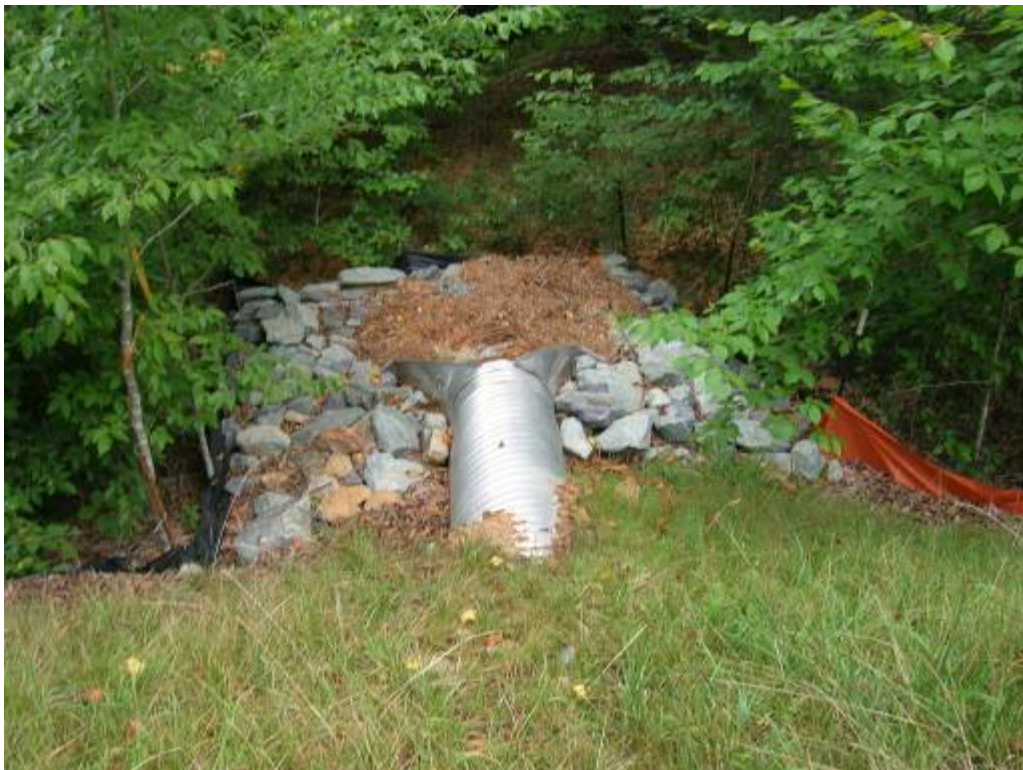
The stormwater outfall of the sediment basin at Site 5. Facing south.

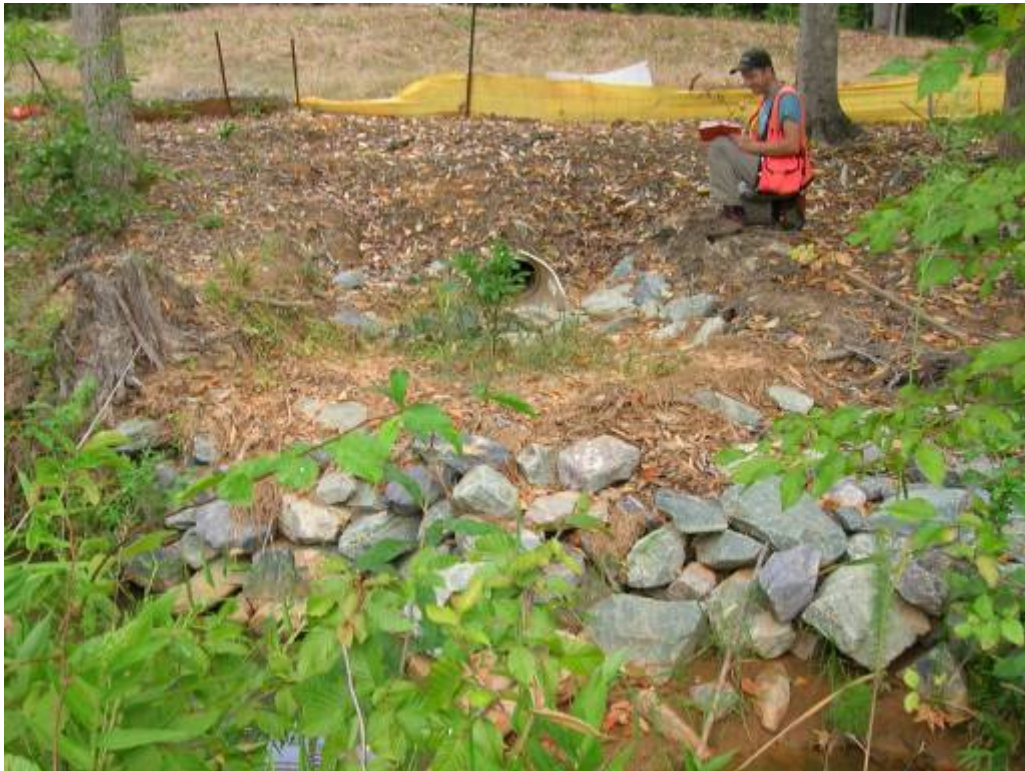
The second sediment basin at Site 6. The pipe outfall is only feet away from the stream, which is located at the bottom of the photo. Facing North.

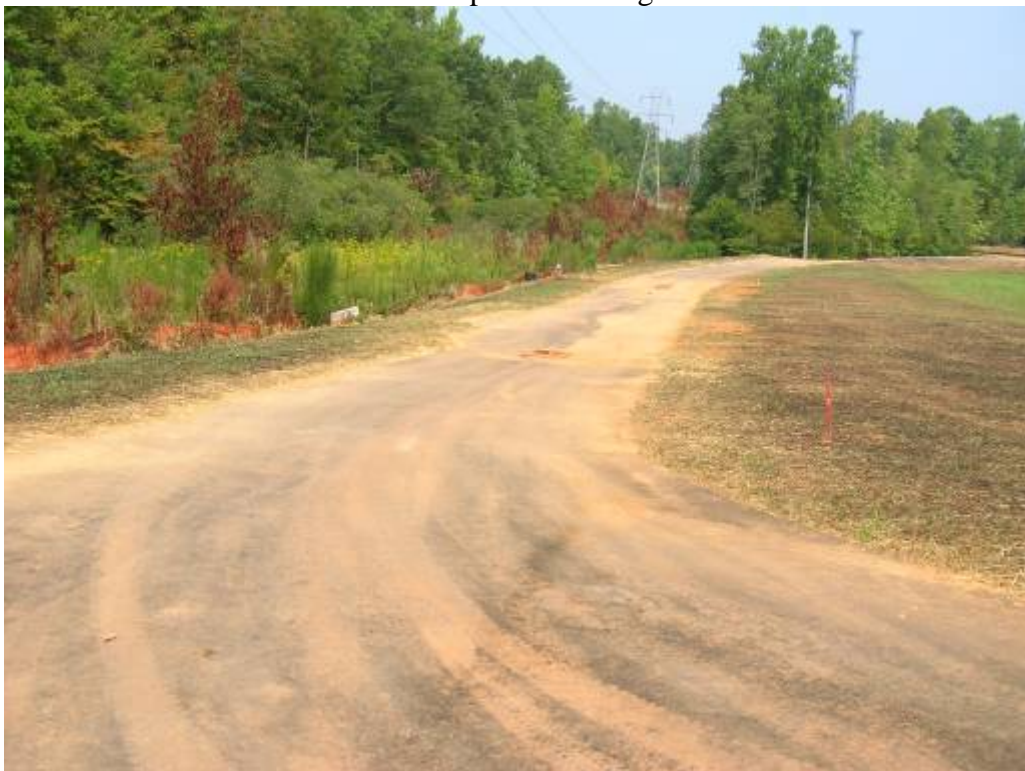
The private alley at Site 7. The potential area for bioretention is on the left side of the photo. Facing north.

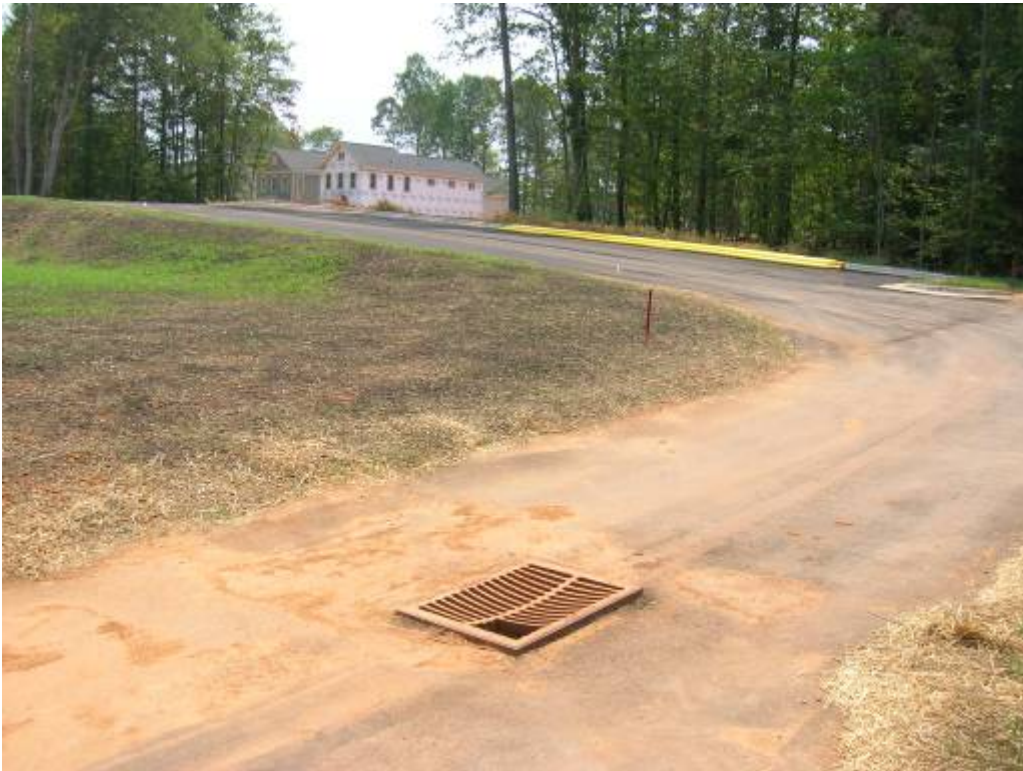
Facing south from the same location as above.

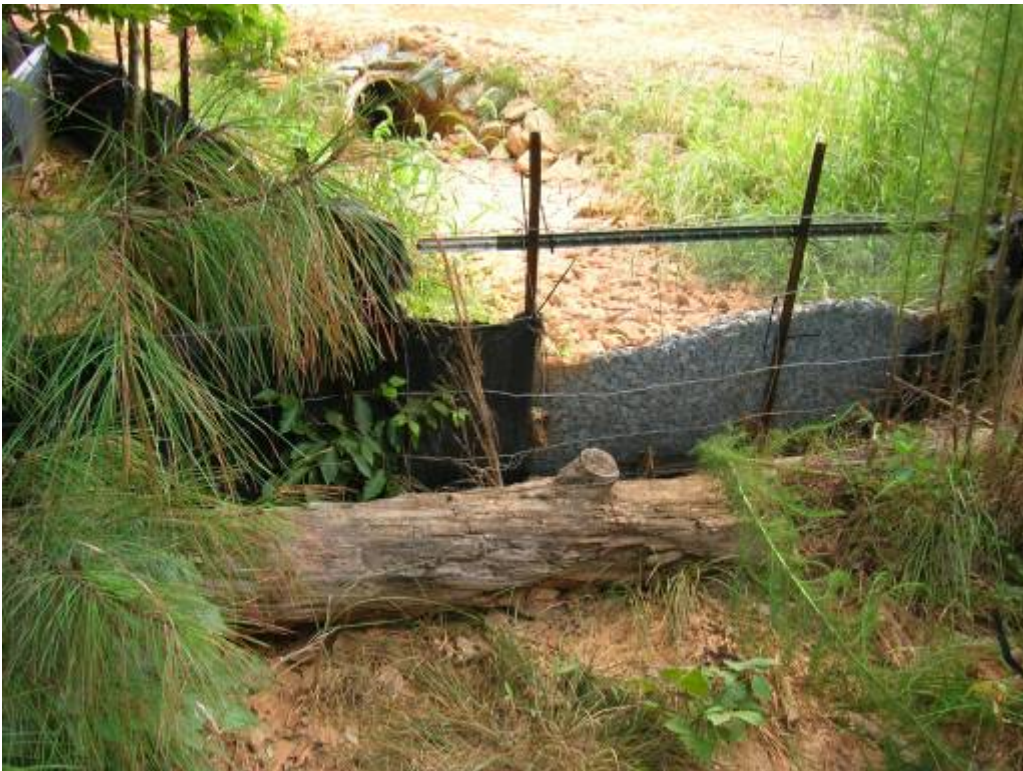
The current pipe and outlet at Site 7. Facing east.

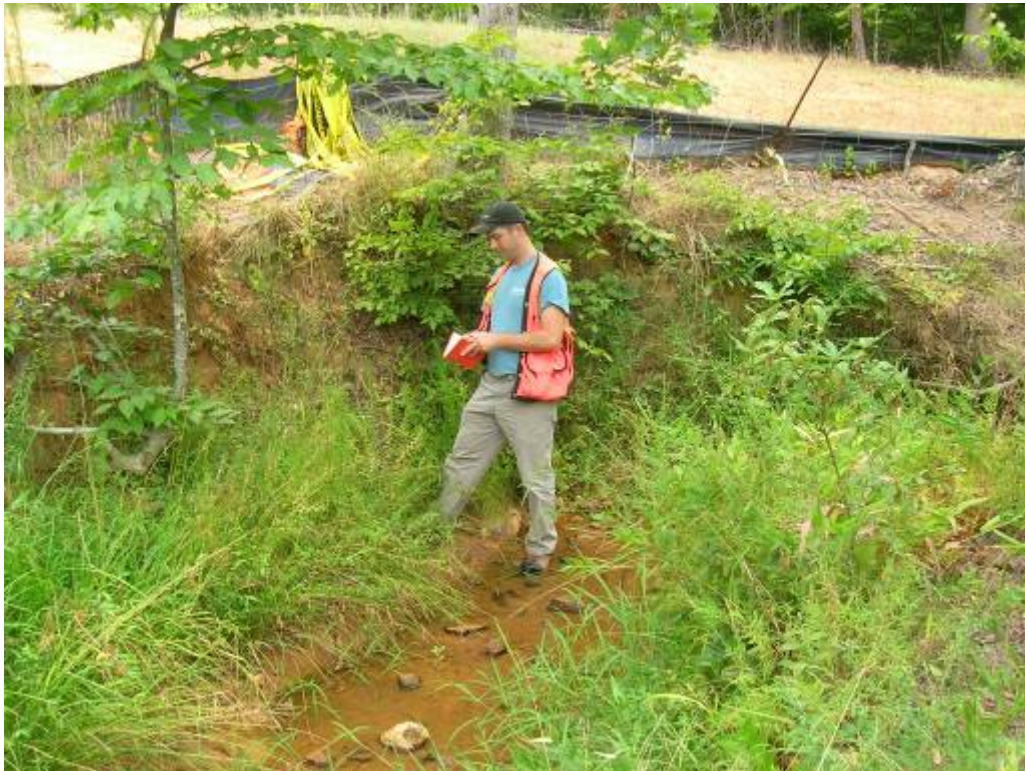
An eroding bank at Site 6. Facing north.

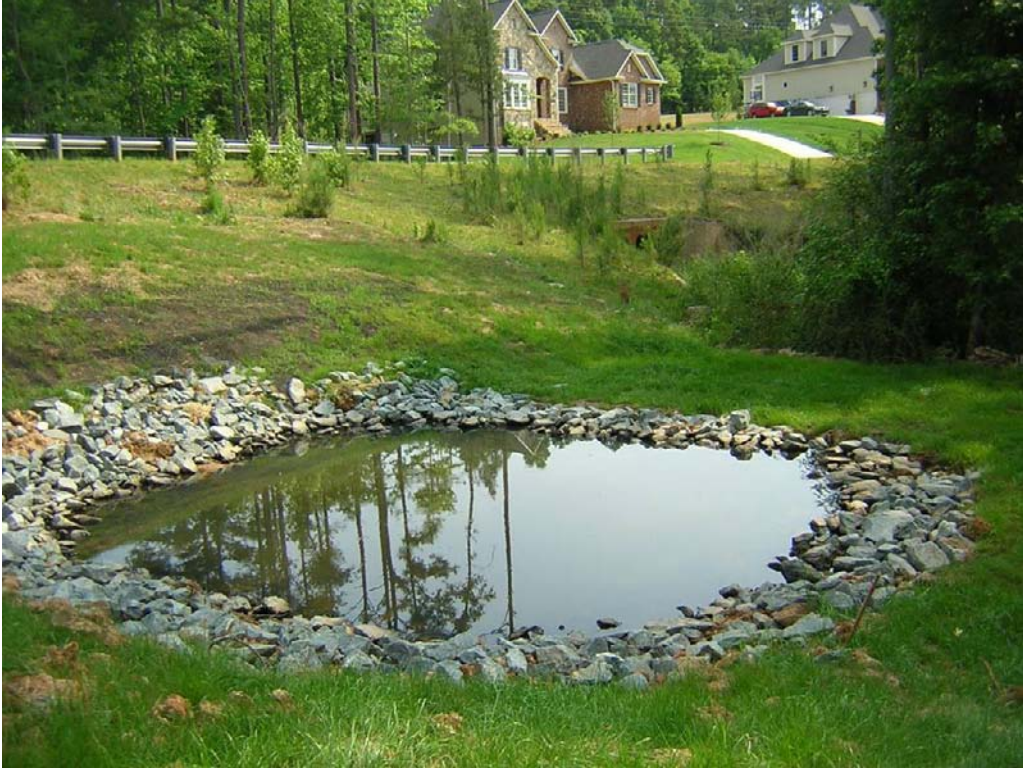
Site 8

An existing stormwater basin at Site 8. Facing northeast.

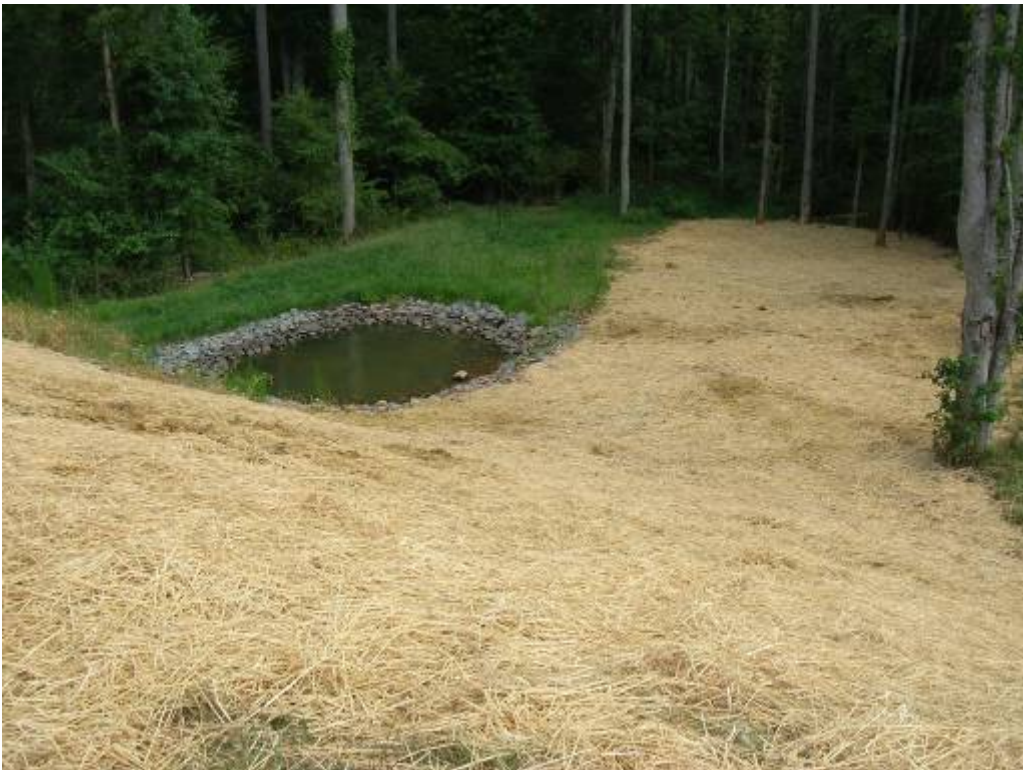
The stormwater basin one month later. The berm has been removed and the site re-seeded with grass.

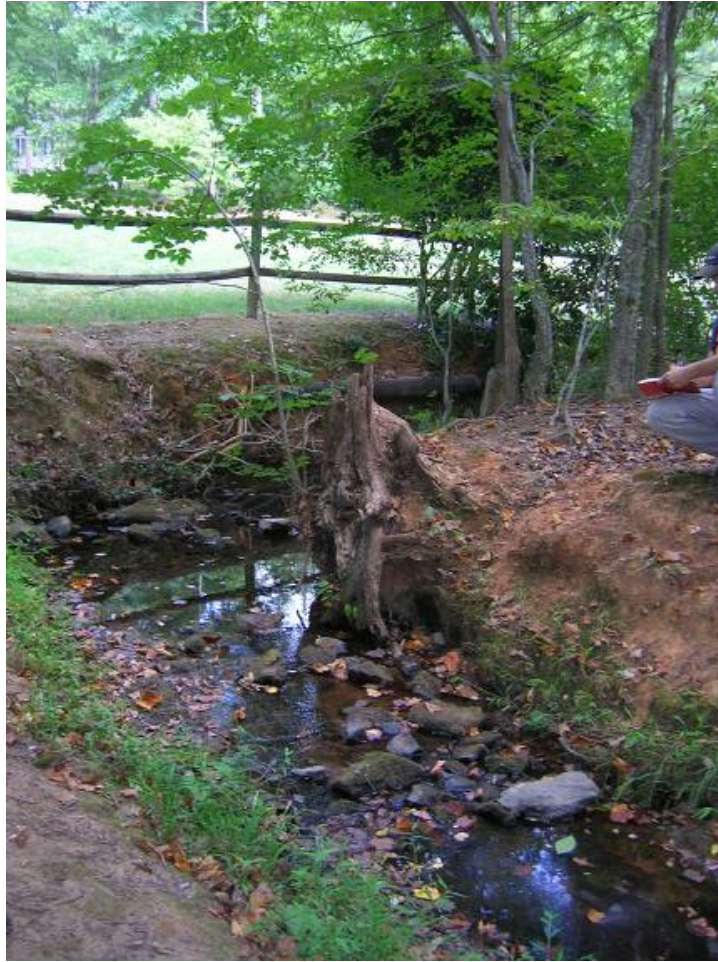
Site 9

Eroding stream banks upstream of the Cobblestone Drive crossing. Facing downstream.

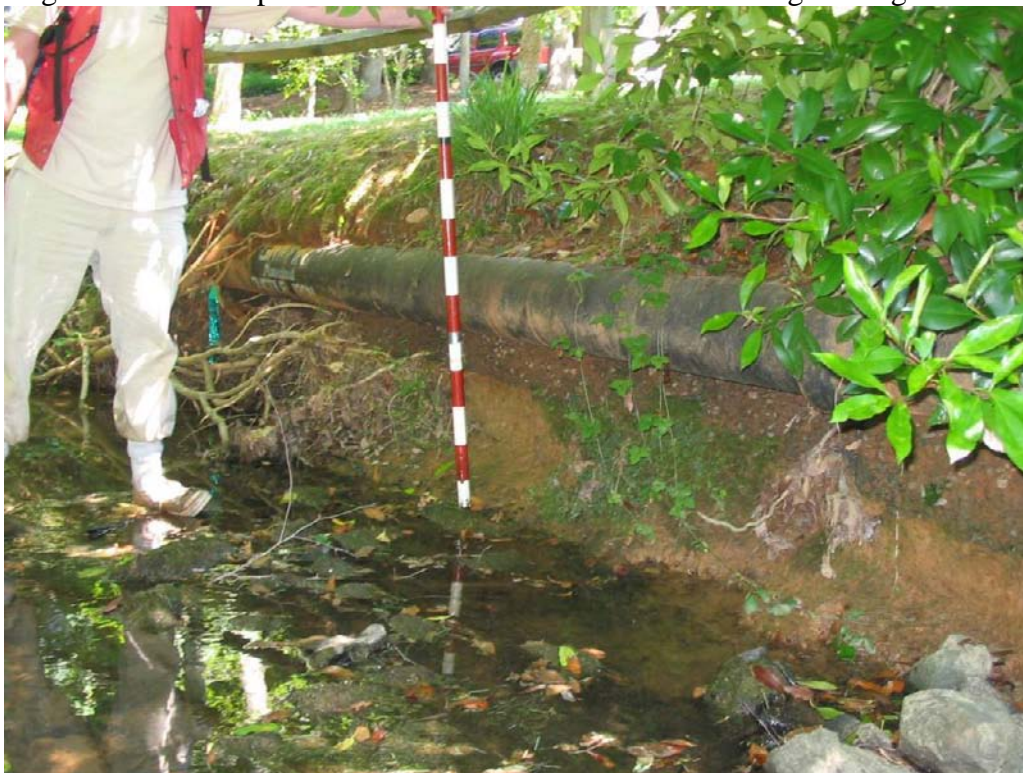
A utility line runs parallel with the streambank, just upstream of Cobblestone Drive crossing.

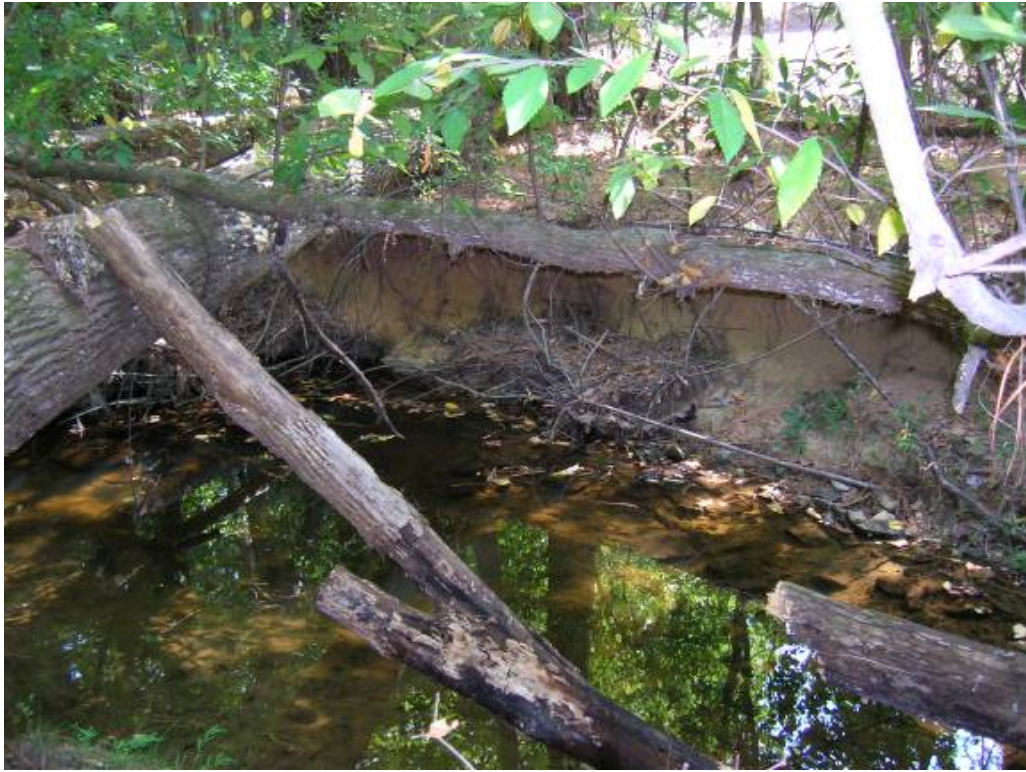
Eroding streambanks downstream of the road crossing. Facing towards right bank.

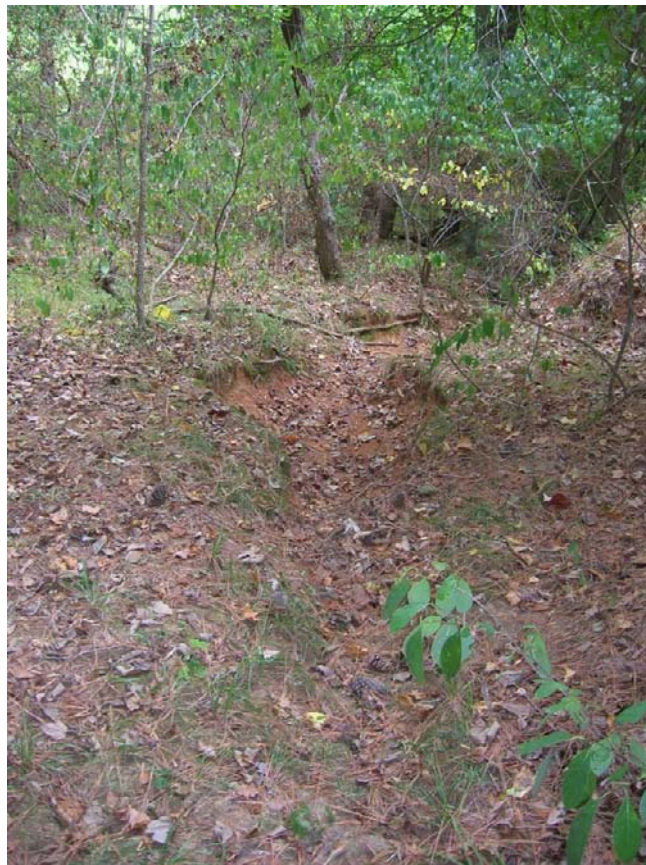
Where the flow has concentrated, an eroding channel and headcut has formed. Facing downstream.

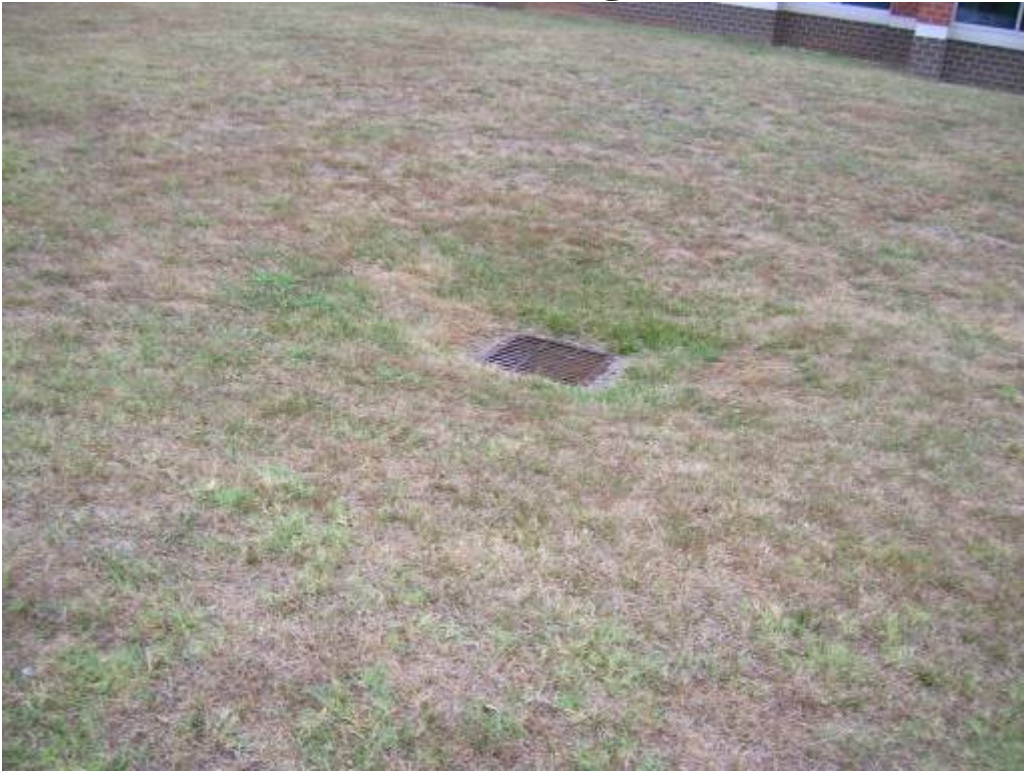
A drop inlet at the middle school. Each of these could be converted into a bioretention area.

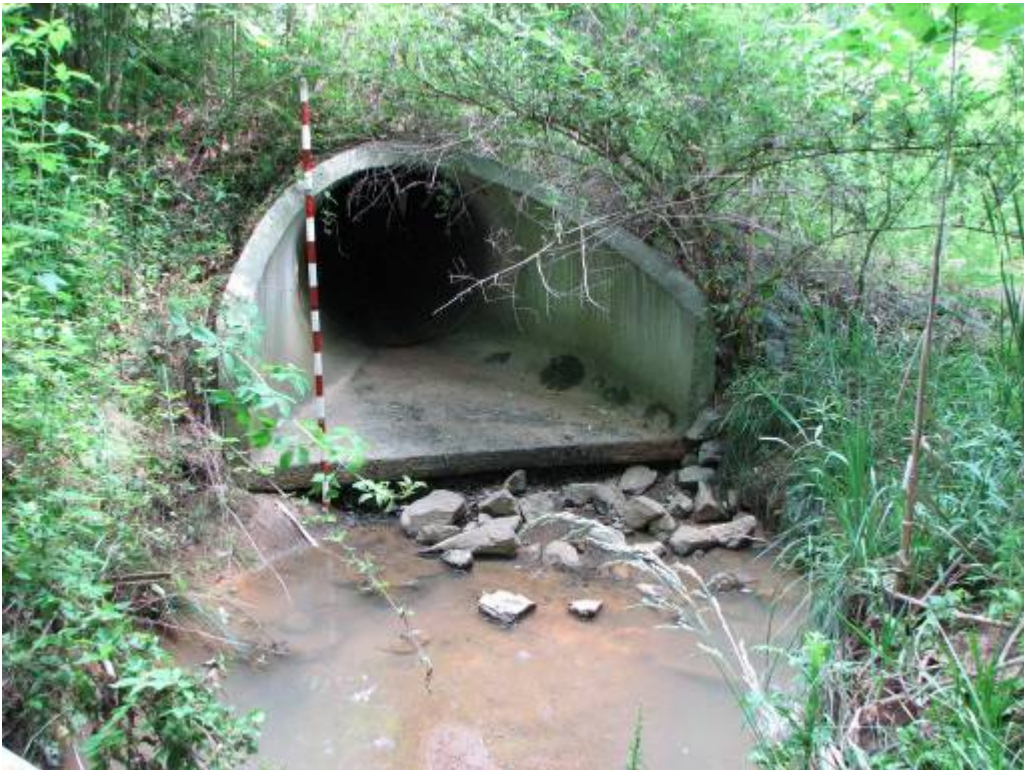
The pipe outlet discharging stormwater from the middle school. Facing south towards the middle school.

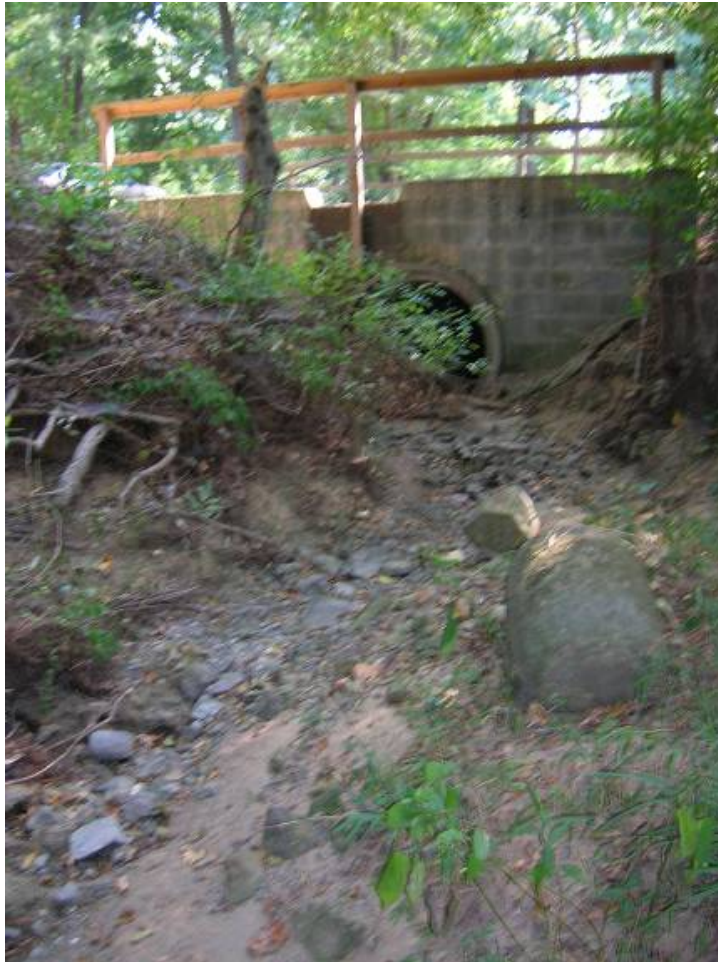
Site 16

A driveway to an apartment complex crosses the stream. Facing downstream.

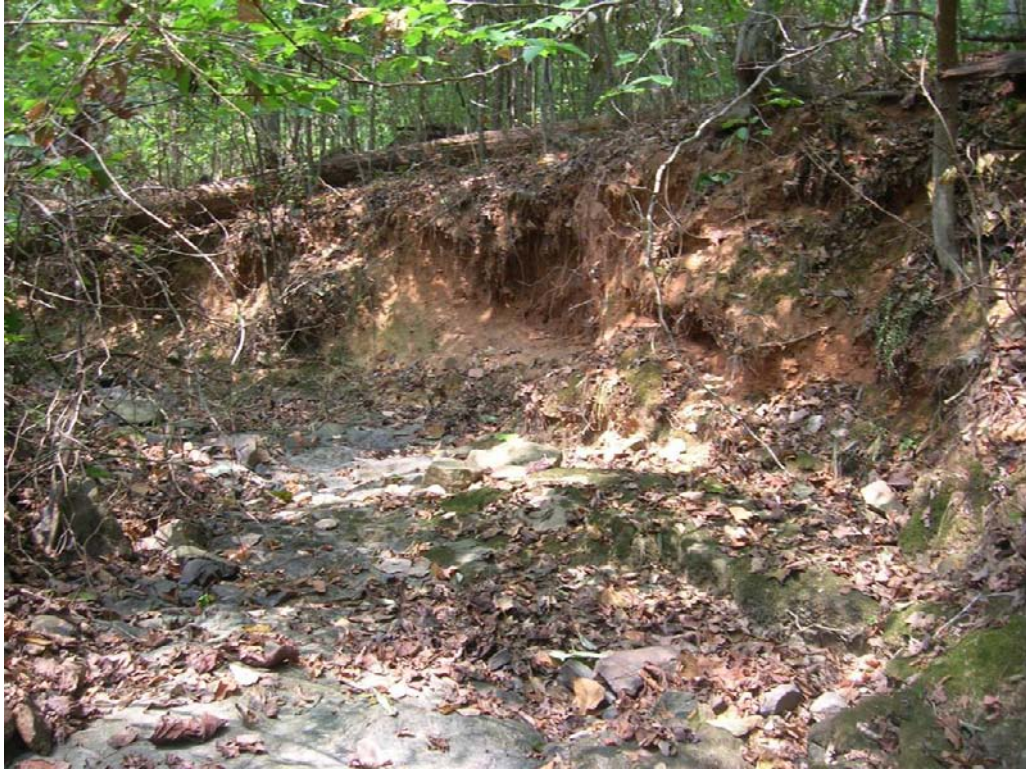
Site 17

An eroding hillside at Site 17. Facing upstream.

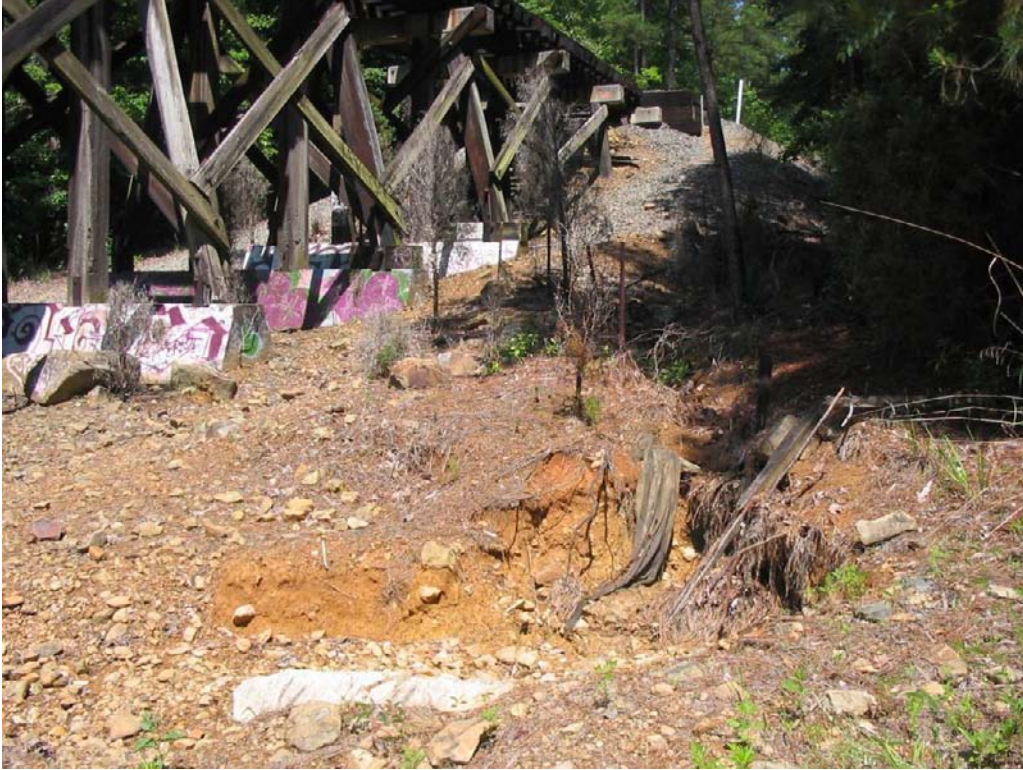
Site 18

A view of the erosion occurring adjacent to a railroad trestle. Facing north.

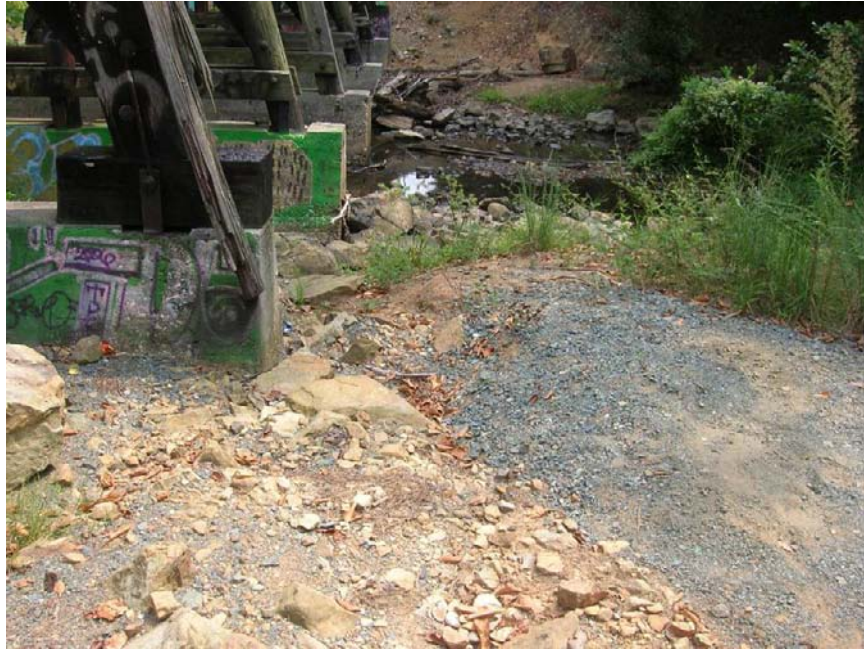
Stormwater flows past the railroad trestle footers and directly into Bolin Creek. Facing south.

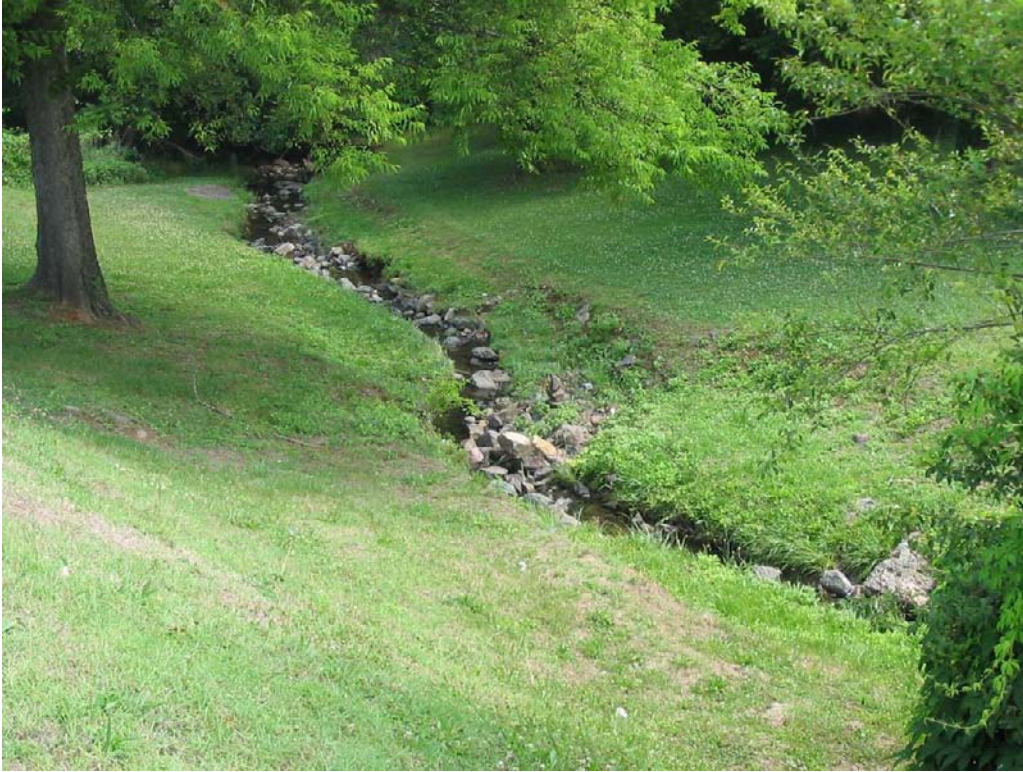
Site 19

A view of the stream and surrounding park. Note the lack of riparian vegetation. Facing downstream.

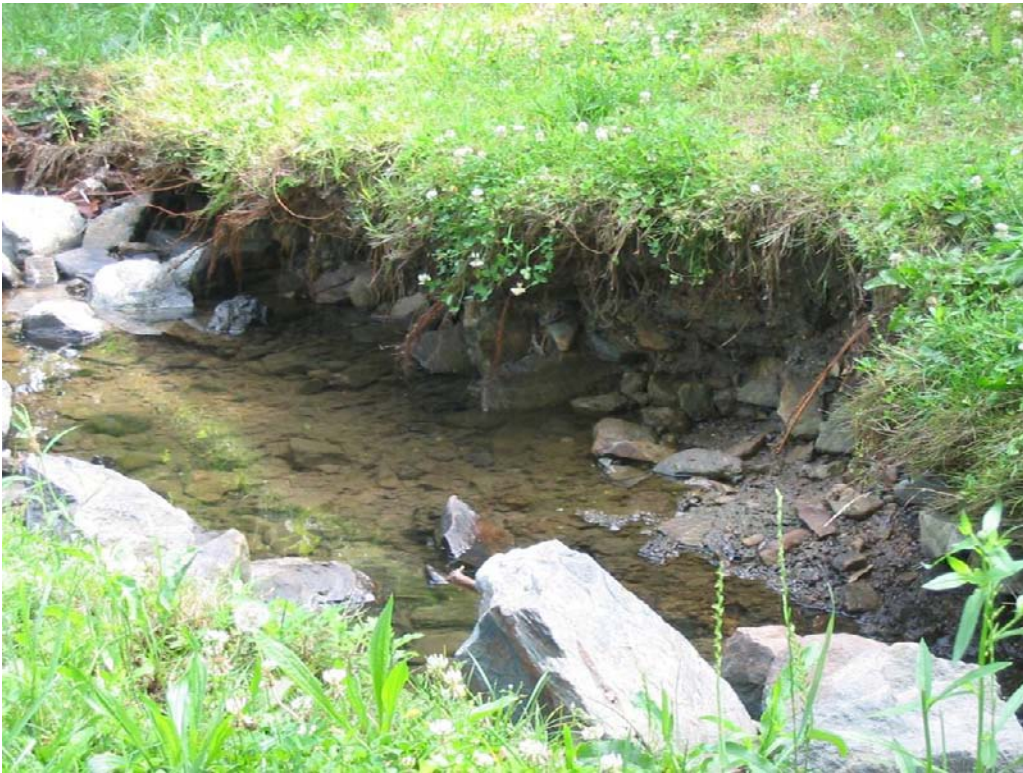
Mass wasting is occurring along this reach. Facing upstream.

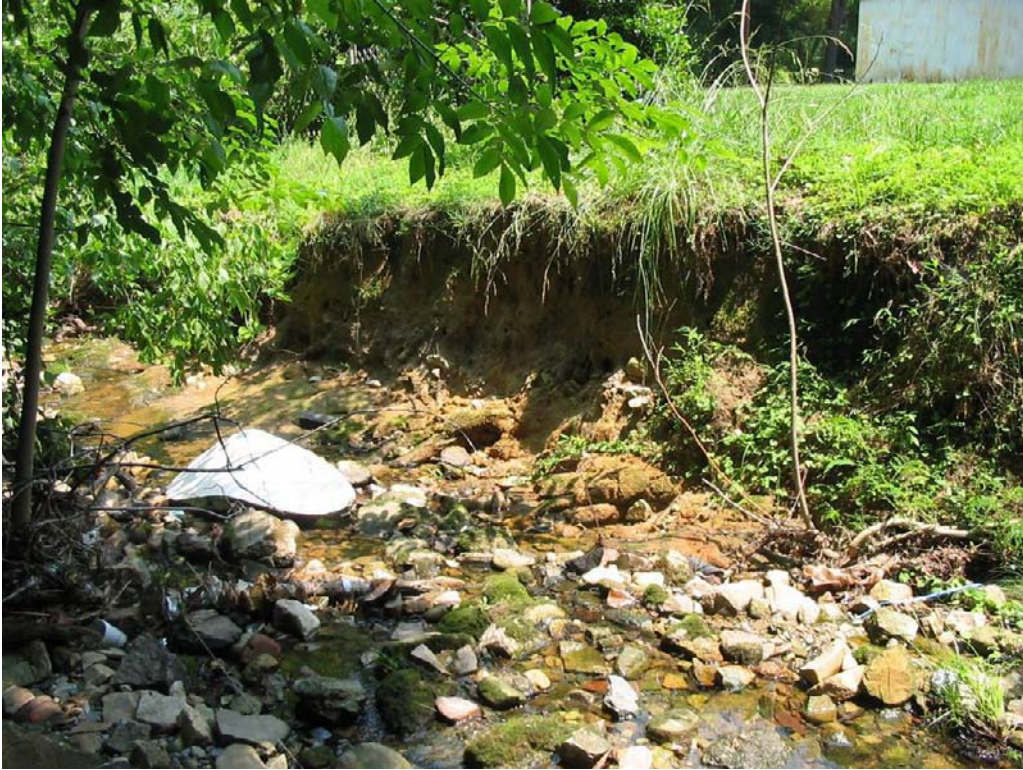
Site 20

Severe bank erosion is occurring along this reach. Facing upstream.

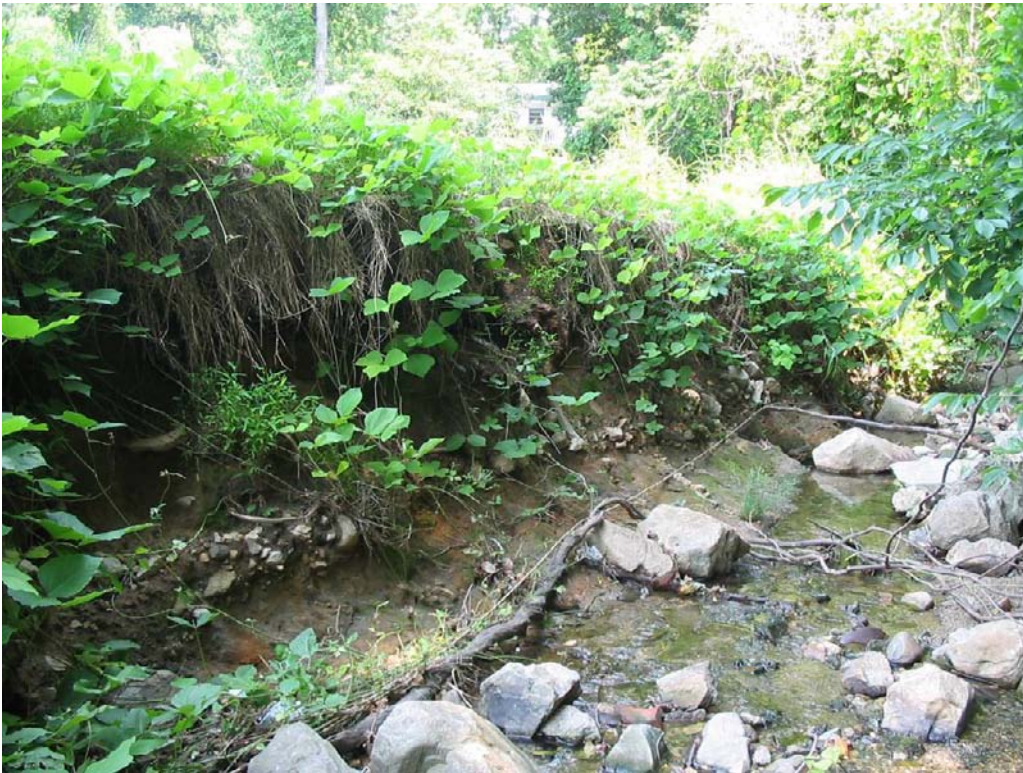
Another view of the incised channel and bank erosion. Kudzu dominates the floodplain of the stream. Facing downstream.

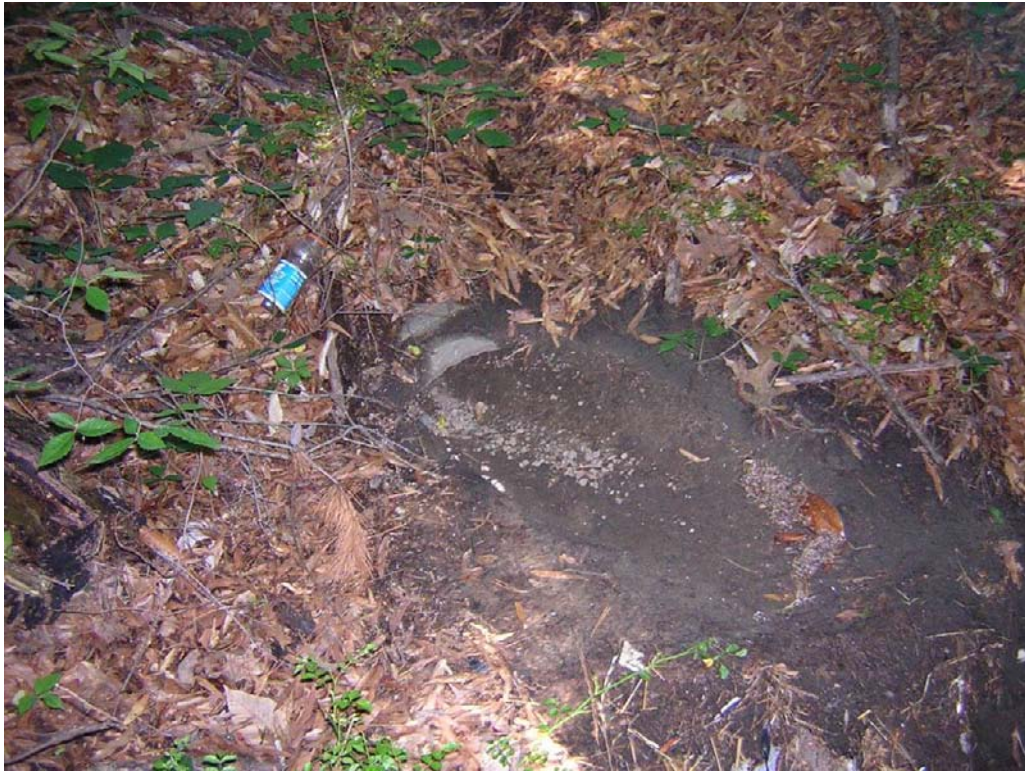
The stormwater outfall pipe from Hillsborough Street is almost completely buried. Facing northwest.

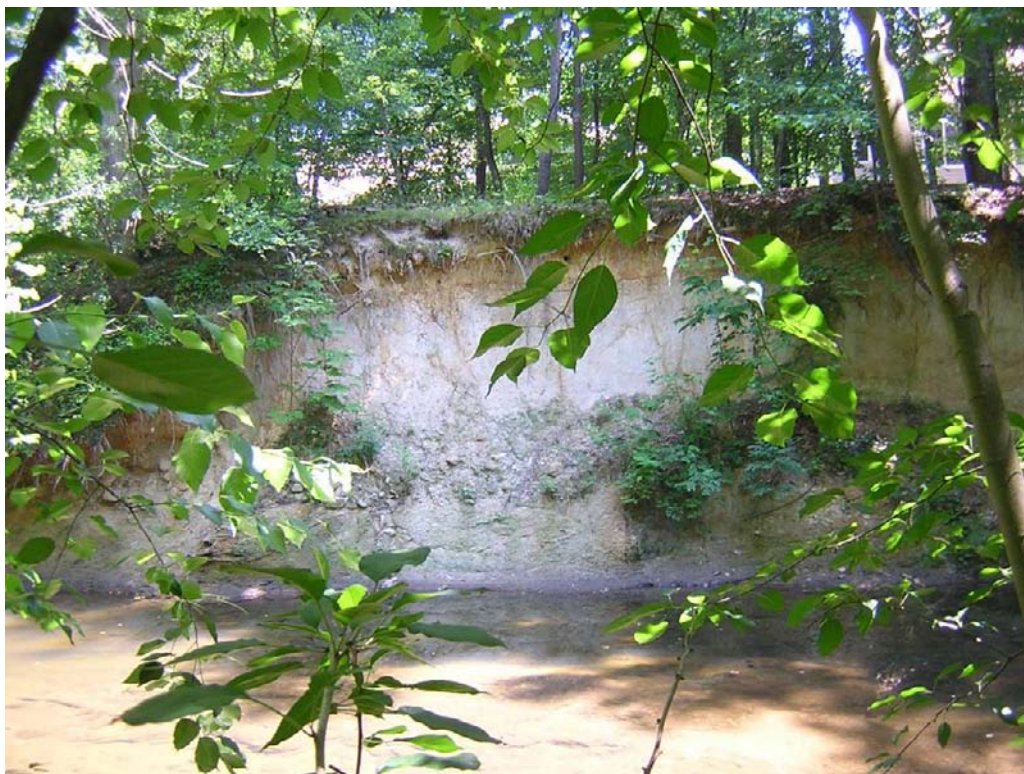
Site 22

An eroding hillside along Bolin Creek is the primary feature at Site 22. The bank is approximately 18 feet high.

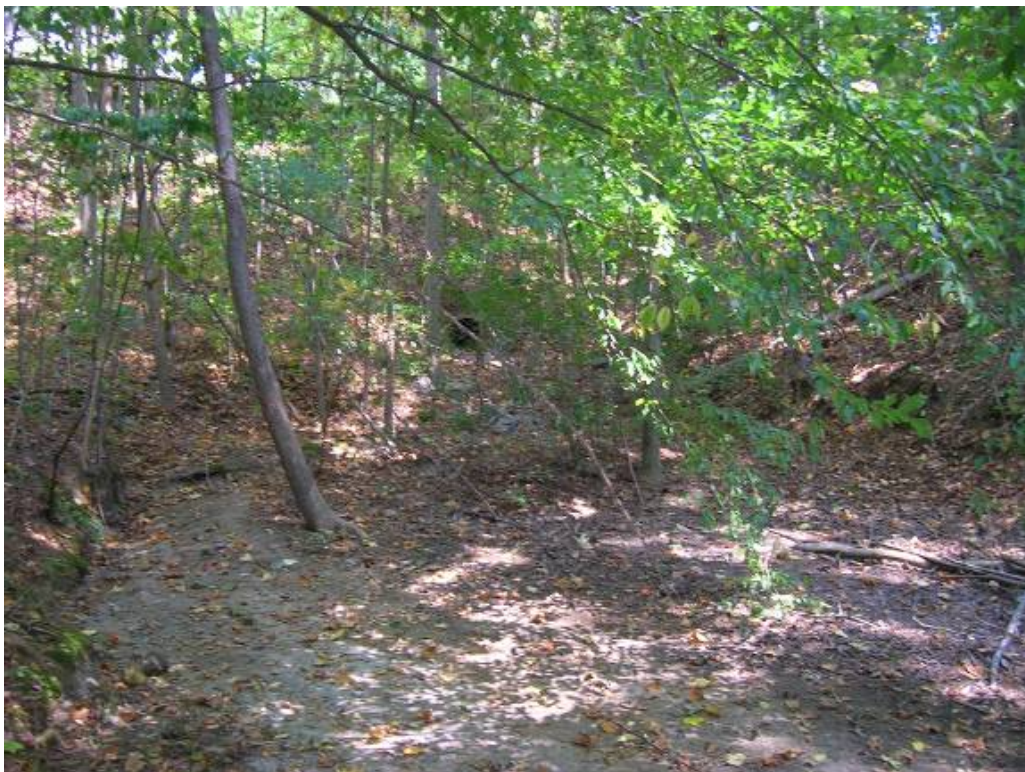
The basin provides a good location for a stormwater BMP retrofit. Facing northeast.
