BOLIN CREEK WATERSHED

Geomorphic Analysis and Potential Site Identification for Stormwater Structures and Retrofits

TOWN OF CARRBORO
NORTH CAROLINA

November 2007

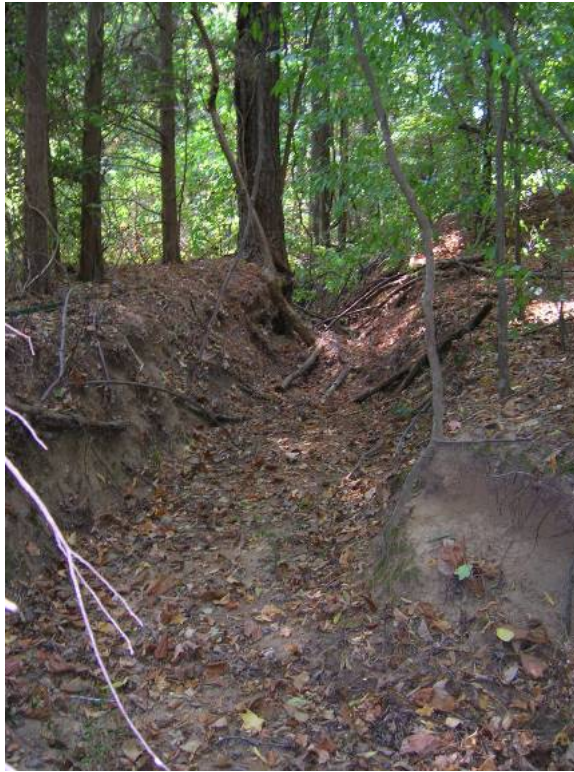
Site 24

The stream channel at site 24 is incised as it flows towards Bolin Creek and the Bolin Creek Greenway. Facing downstream.

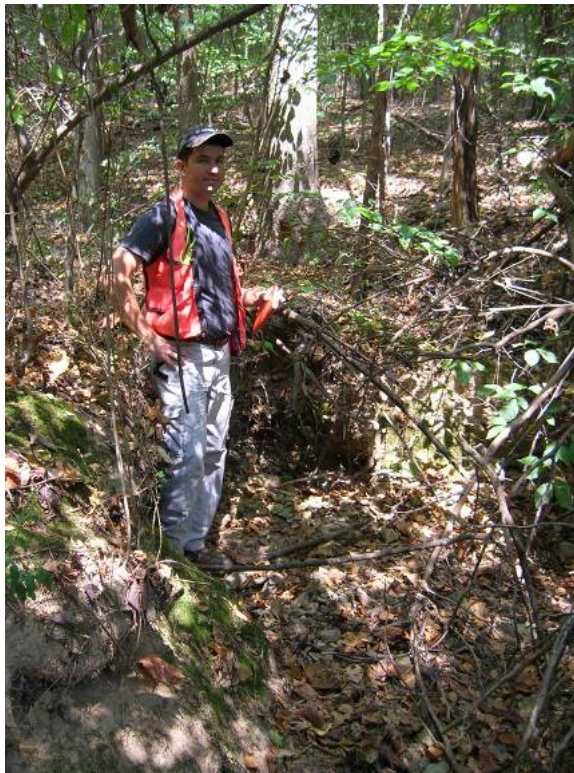
A headcut along the channel. Facing upstream.

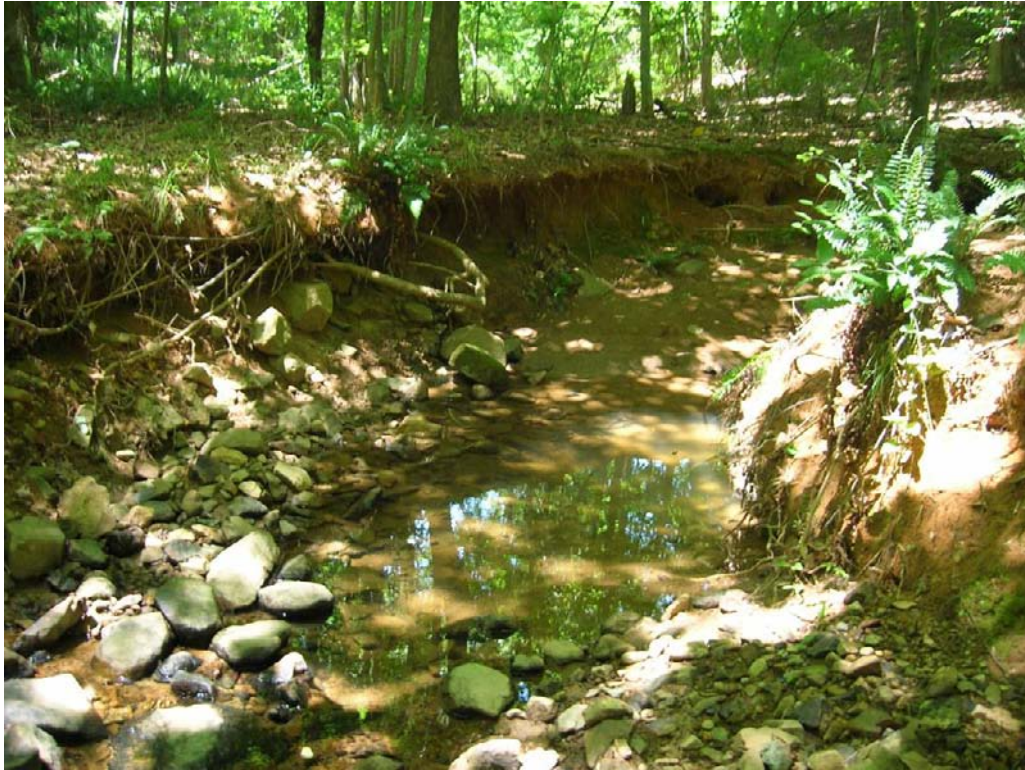
Sites 25 through 28

Cole Springs Branch is incised with undercut banks near Site 25. Facing downstream.

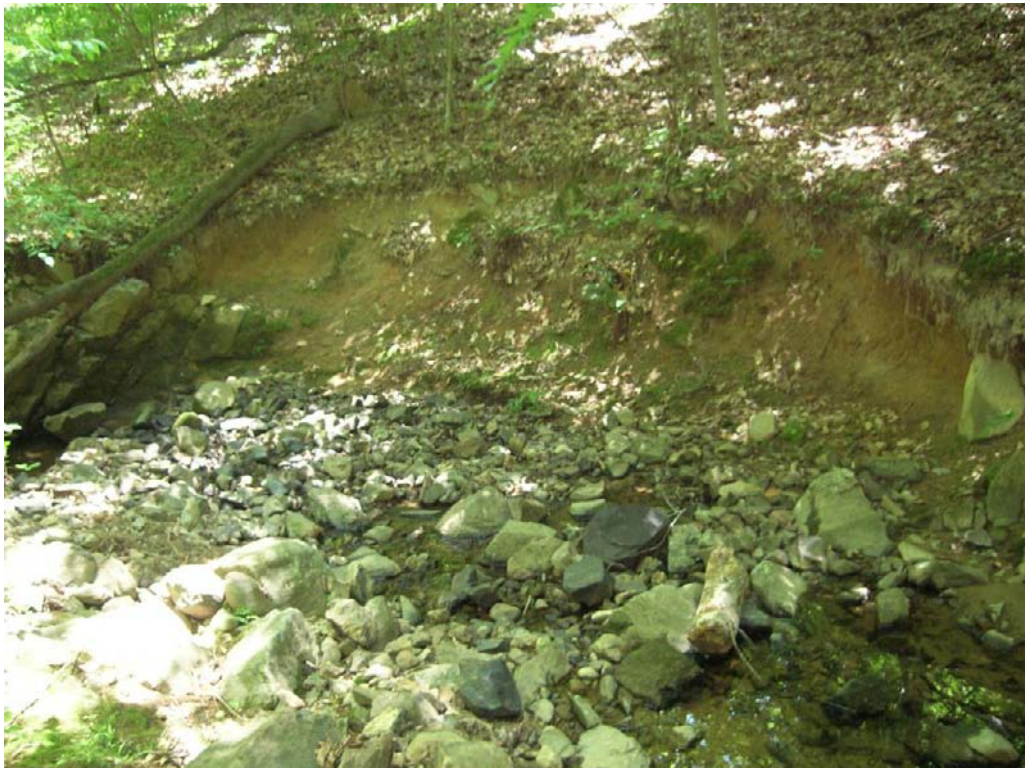
An eroding bank on Cole Springs Branch near Site 25. Facing downstream.

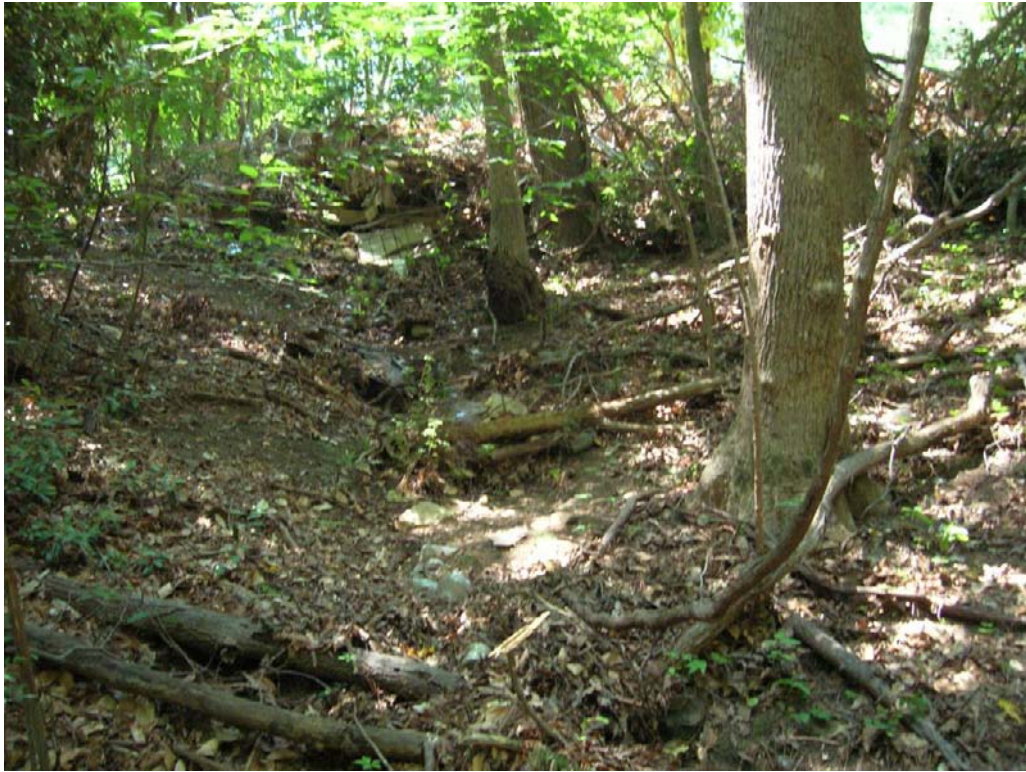
Fill has been placed in an ephemeral channel near Site 26.

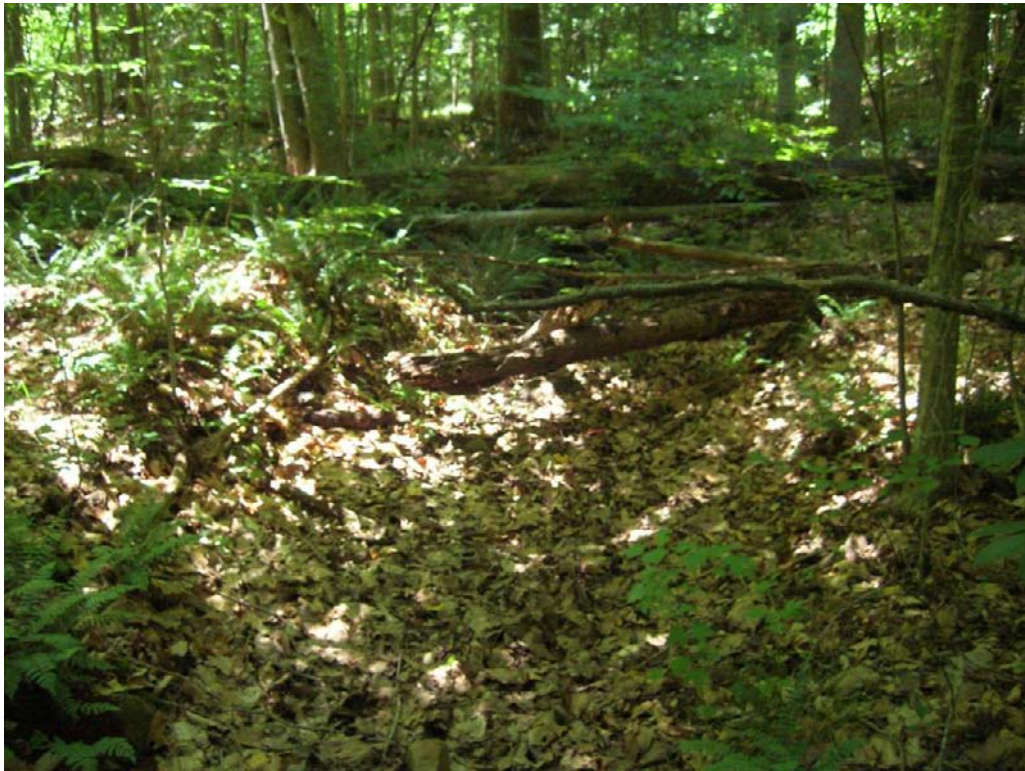
A relic stream channel in the floodplain near Site 27. This floodplain area provides a good location for side-channel BMPs.

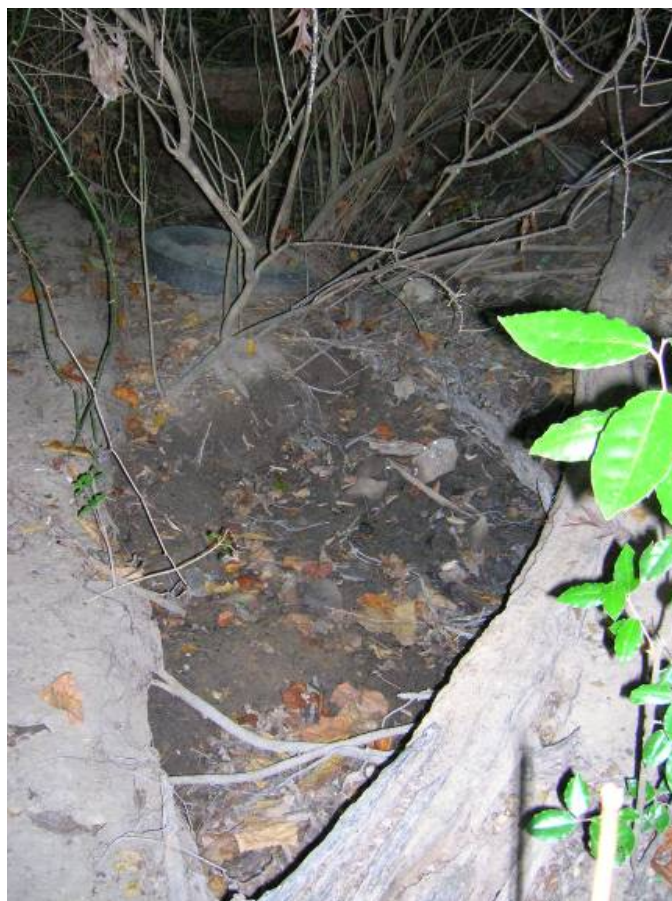
Another headcut area. Looking downstream

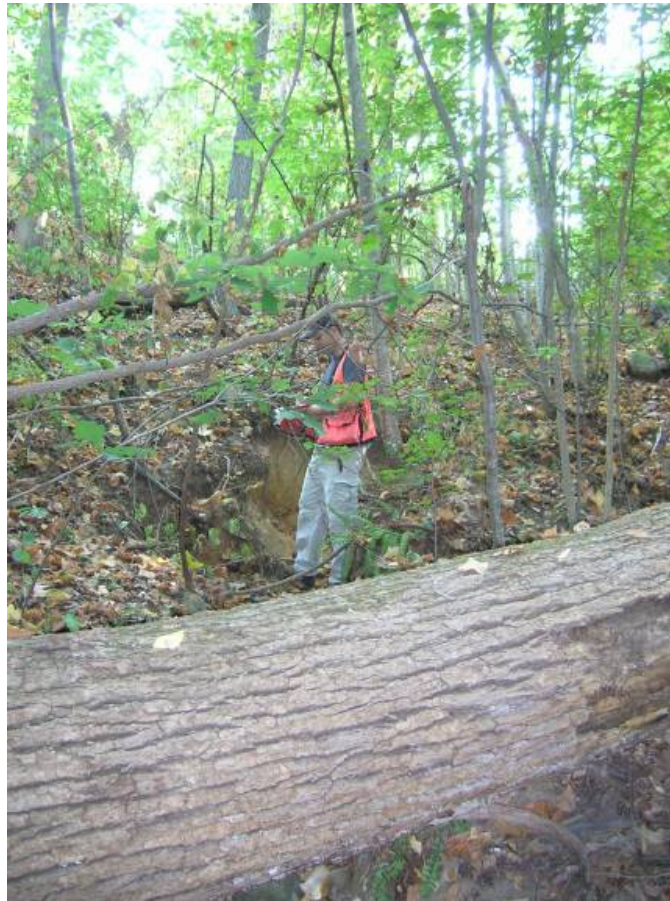
Flow from the stormwater outfall is causing hill erosion before flowing into the existing BMP. Facing northeast.

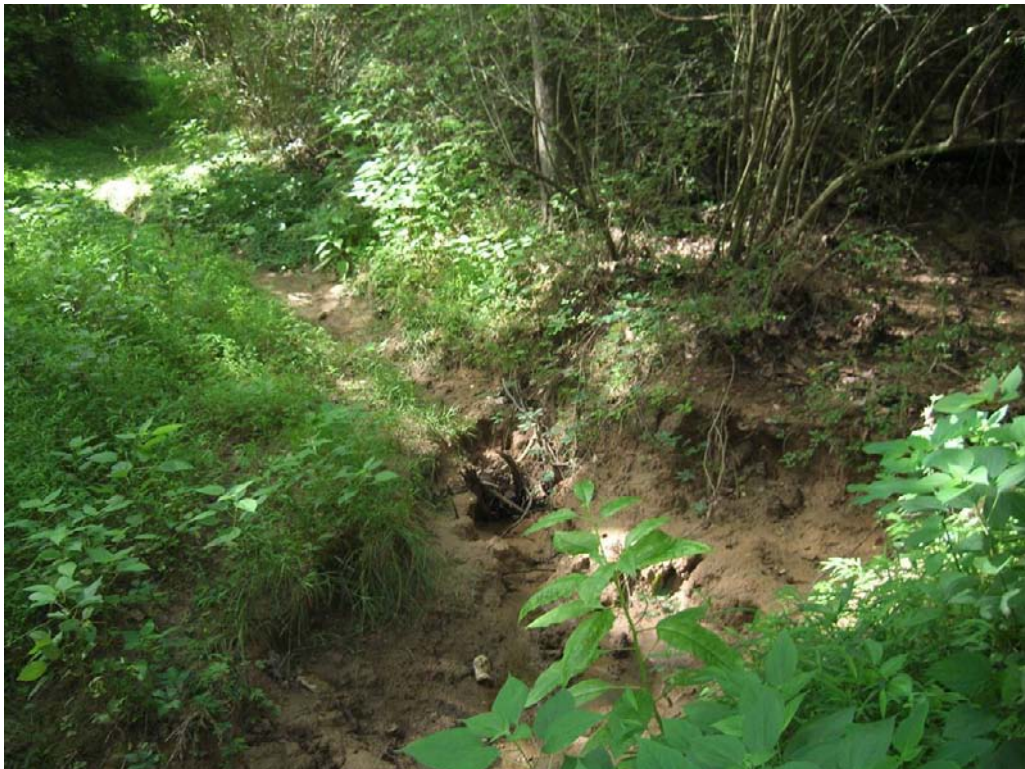
The upstream end of the floodplain ditch, where it is met by stormwater flowing from the nearby road.

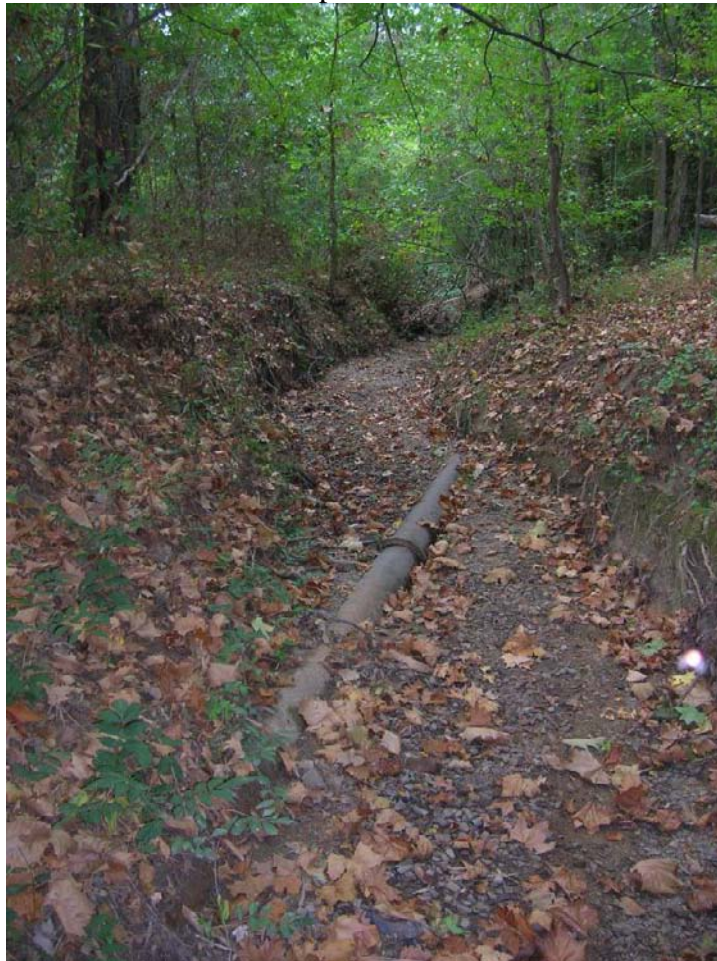
A utility line crosses the bed of the stream. Facing downstream.

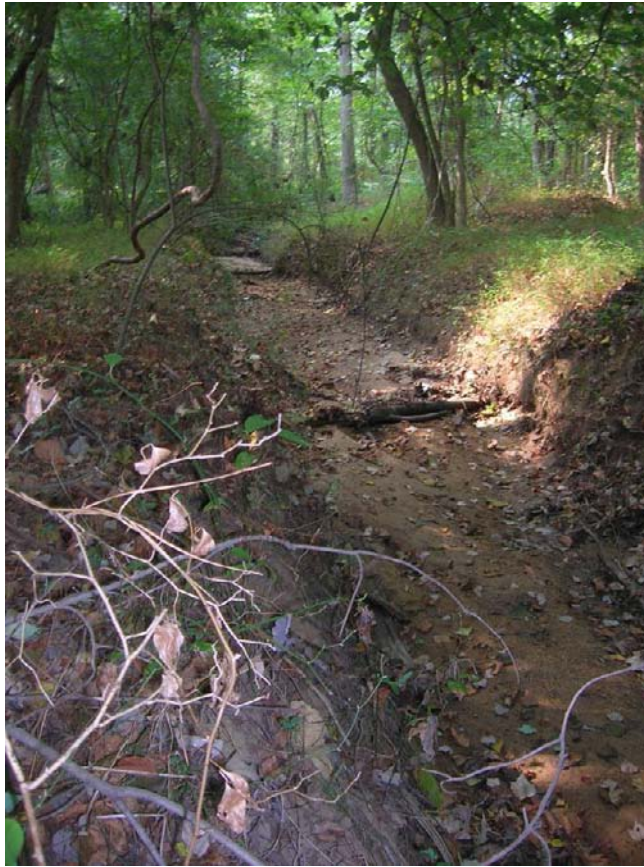
The stream has been straightened for most of its course. Spoil piles are present in the floodplain. Facing upstream.

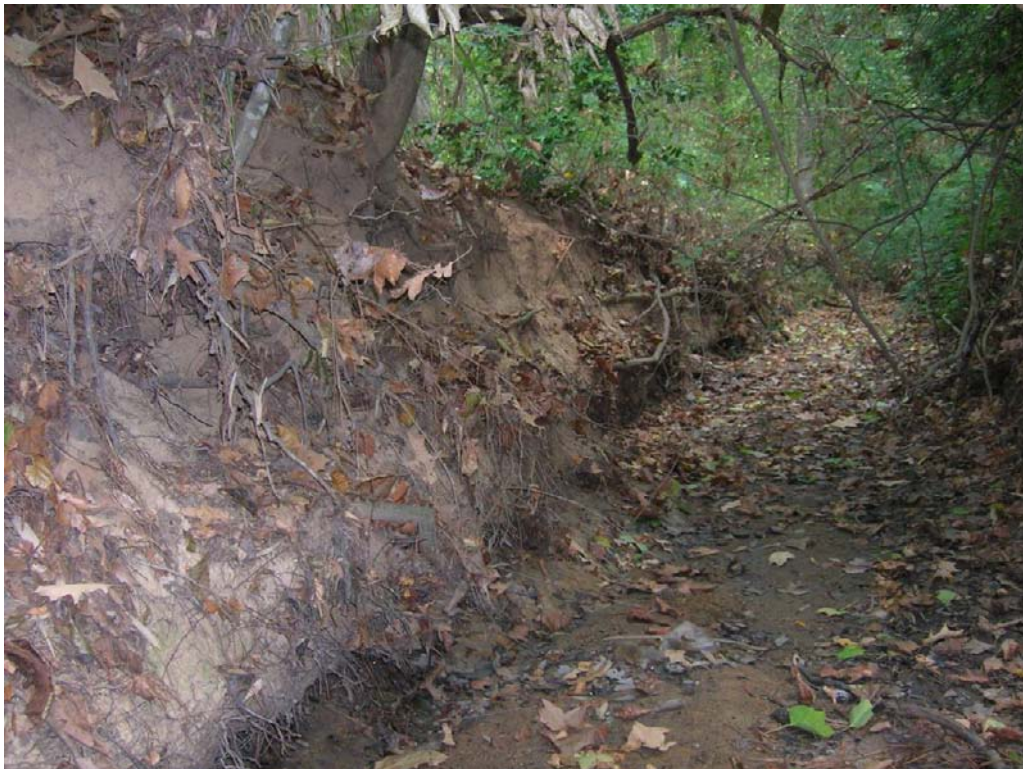
Eroding banks along the stream. Facing downstream.

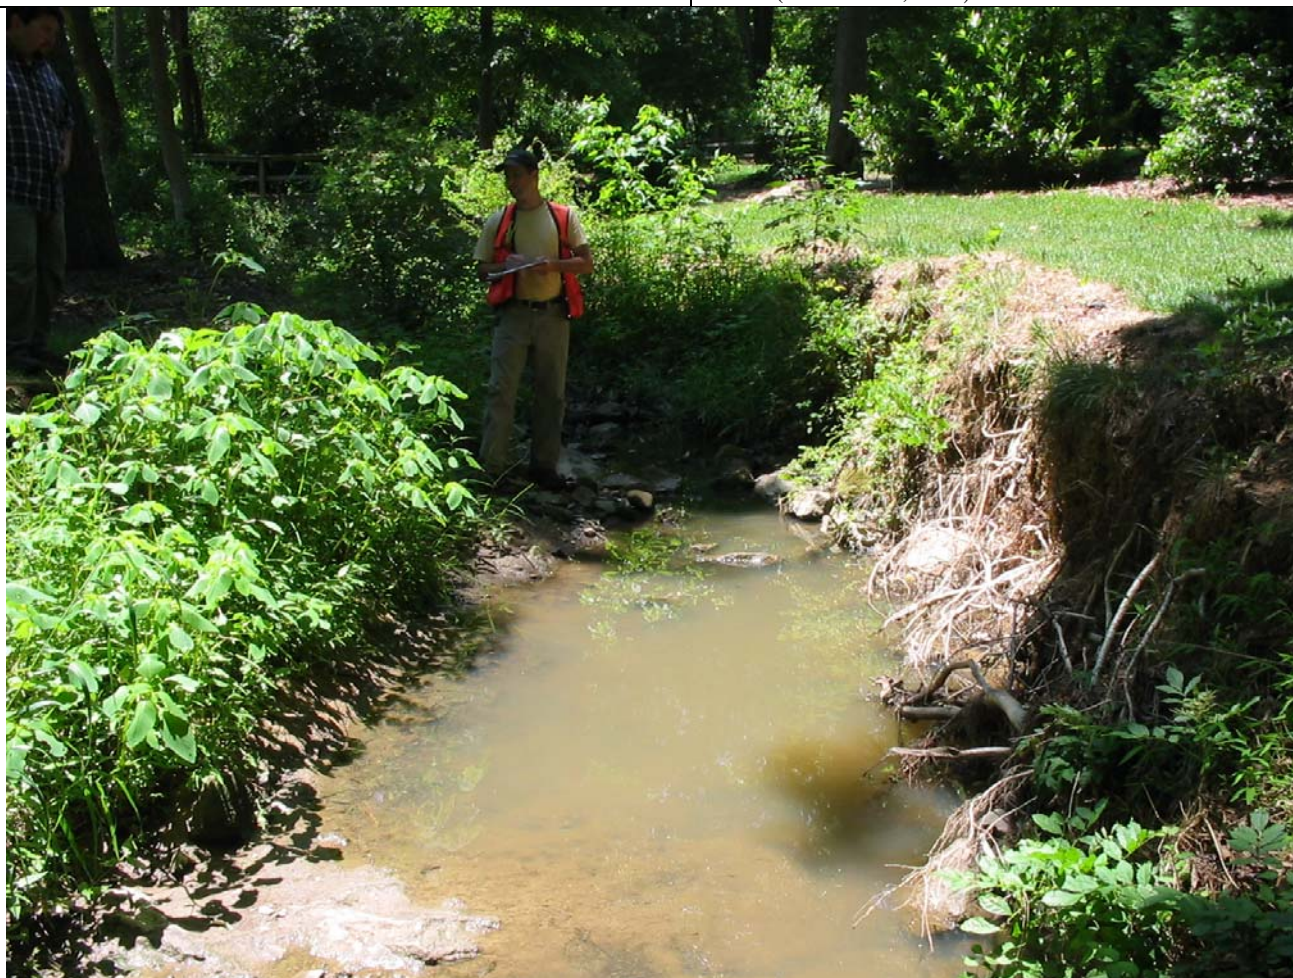
STREAM NAME: UT		DATE: 6/6/07	MAP SHEET #: 20
PHOTO NUMBERS: 1111- 1112 (TONY)		LANDMARK: ESTES	SKETCH ON BACK
GPS ID START: BD 44		GPS ID END: BD 47	
DESCRIPTION:		DESCRIPTION:	
RAIN IN LAST 24 HOURS <input type="checkbox"/> Heavy rain <input checked="" type="checkbox"/> Steady rain <input type="checkbox"/> None <input type="checkbox"/> Intermittent <input type="checkbox"/> Trace		PRESENT CONDITIONS <input type="checkbox"/> Heavy rain <input type="checkbox"/> Steady rain <input type="checkbox"/> Intermittent <input checked="" type="checkbox"/> Clear <input type="checkbox"/> Trace <input type="checkbox"/> Overcast <input type="checkbox"/> Partly cloudy	
SURROUNDING LAND USE: <input type="checkbox"/> Industrial <input type="checkbox"/> Commercial <input checked="" type="checkbox"/> Urban/Residential <input type="checkbox"/> Suburban/Res <input type="checkbox"/> Forested <input type="checkbox"/> Institutional <input type="checkbox"/> Golf course <input type="checkbox"/> Park <input type="checkbox"/> Crop <input type="checkbox"/> Pasture <input type="checkbox"/> Other:

BASE FLOW WIDTH AS % CHANNEL WIDTH <input checked="" type="checkbox"/> 0-25% <input type="checkbox"/> 25-50 % <input type="checkbox"/> 50%-75% <input type="checkbox"/> 75-100%		WATER CLARITY <input type="checkbox"/> Clear <input checked="" type="checkbox"/> Turbid (<i>suspended matter</i>) <input type="checkbox"/> Stained (<i>clear, naturally colored</i>) <input type="checkbox"/> Opaque (<i>milky</i>) <input type="checkbox"/> Other (chemicals, dyes)	
DOMINANT SUBSTRATE <input checked="" type="checkbox"/> Silt/clay (fine or slick) <input type="checkbox"/> Sand (gritty) <input checked="" type="checkbox"/> Gravel (0.1-2.5") <input type="checkbox"/> Cobble (2.5 –10") <input type="checkbox"/> Boulder (>10") <input type="checkbox"/> Bed rock	CHANNEL DIMENSIONS AT RIFFLE Height: Low bank 4.2 _____(ft) Width: Bottom 6 _____(ft) Top 10 _____(ft) Water Surface 2 _____(ft) Depth: Max BKF 1.0 _____(ft) B:H Ratio: Low bank/Max BKF=_____		OBSERVED IMPACTS <input type="checkbox"/> Outfall <input type="checkbox"/> Confluence <input checked="" type="checkbox"/> Impacted buffer- YARD WORK <input type="checkbox"/> Stream crossing <input type="checkbox"/> Channel mod <input type="checkbox"/> Utility impacts <input type="checkbox"/> Beaver <input type="checkbox"/> Other

CHANNEL DYNAMICS <input type="checkbox"/> Downcutting <input type="checkbox"/> Bed scour <input type="checkbox"/> Slope failure <input checked="" type="checkbox"/> Widening <input type="checkbox"/> Bank failure <input type="checkbox"/> Channelized <input type="checkbox"/> Headcutting <input type="checkbox"/> Bank scour <input type="checkbox"/> Unknown <input type="checkbox"/> Aggrading <input type="checkbox"/> Sed. deposition		NOTES MASS BANK FAILURE	
QUALITATIVE IMPAIRMENT RATING: <input type="checkbox"/> Low <input type="checkbox"/> Moderate <input type="checkbox"/> Severe		CHANNEL EVOLUTIUON STAGE: <input type="checkbox"/> I <input type="checkbox"/> II <input type="checkbox"/> III <input type="checkbox"/> IV <input type="checkbox"/> V <input type="checkbox"/> VI (<i>Simon et. al., 2003</i>)

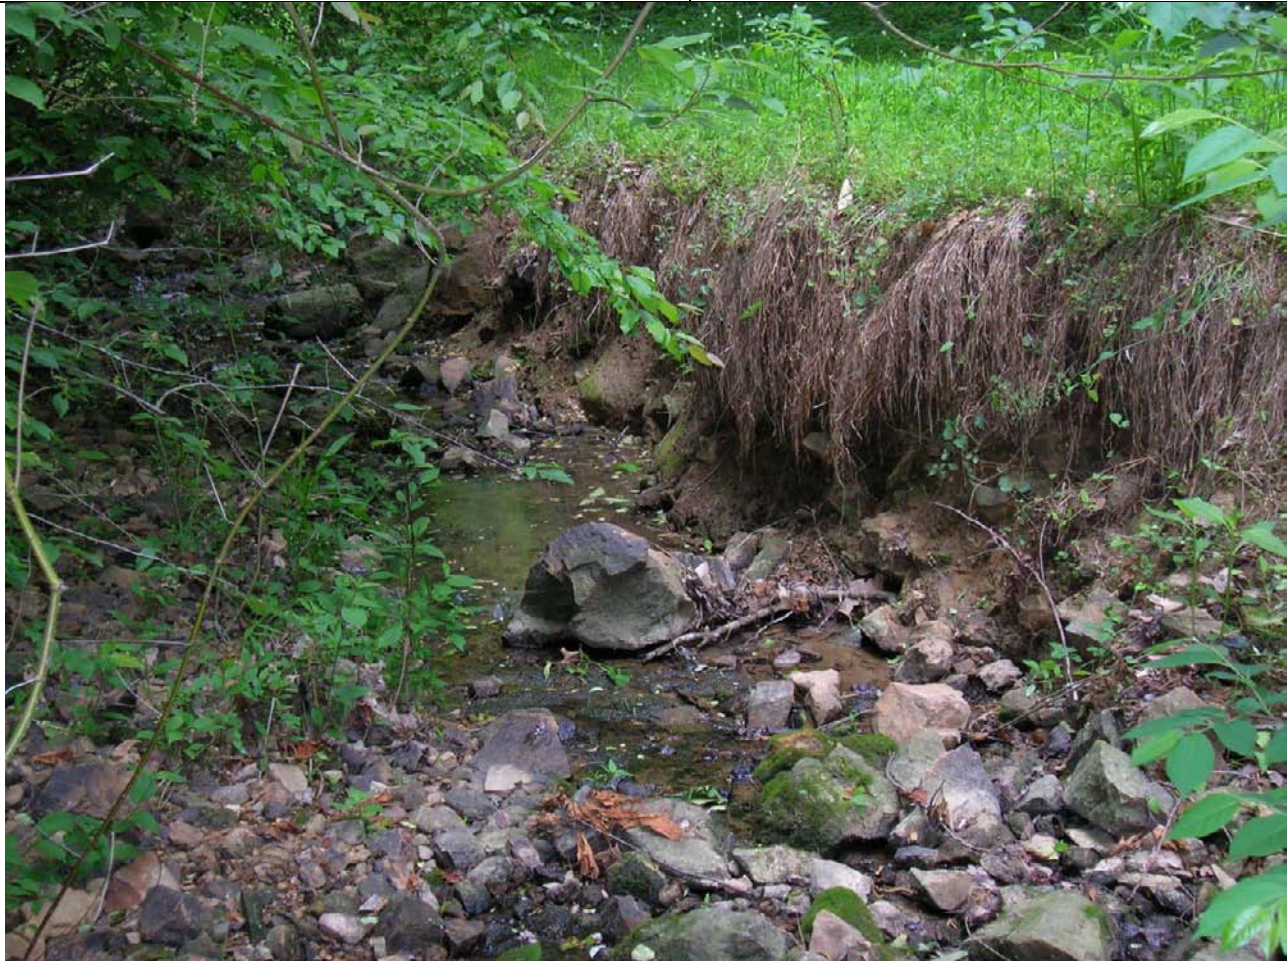
STREAM NAME: UT BOLIN		DATE: 5/8/07	MAP SHEET #: 20
PHOTO NUMBERS: 23		LANDMARK:	SKETCH ON BACK
GPS ID START: BD 11		GPS ID END:	
DESCRIPTION:		DESCRIPTION:	
RAIN IN LAST 24 HOURS <input type="checkbox"/> Heavy rain <input type="checkbox"/> Steady rain <input type="checkbox"/> None <input type="checkbox"/> Intermittent <input checked="" type="checkbox"/> Trace		PRESENT CONDITIONS <input type="checkbox"/> Heavy rain <input type="checkbox"/> Steady rain <input type="checkbox"/> Intermittent <input type="checkbox"/> Clear <input type="checkbox"/> Trace <input checked="" type="checkbox"/> Overcast <input type="checkbox"/> Partly cloudy	
SURROUNDING LAND USE: <input type="checkbox"/> Industrial <input type="checkbox"/> Commercial <input type="checkbox"/> Urban/Residential <input checked="" type="checkbox"/> Suburban/Res <input checked="" type="checkbox"/> Forested <input type="checkbox"/> Institutional <input type="checkbox"/> Golf course <input type="checkbox"/> Park <input type="checkbox"/> Crop <input type="checkbox"/> Pasture <input type="checkbox"/> Other:

BASE FLOW WIDTH AS % CHANNEL WIDTH <input checked="" type="checkbox"/> 0-25% <input type="checkbox"/> 25-50 % <input type="checkbox"/> 50%-75% <input type="checkbox"/> 75-100%		WATER CLARITY <input checked="" type="checkbox"/> Clear <input type="checkbox"/> Turbid (<i>suspended matter</i>) <input type="checkbox"/> Stained (<i>clear, naturally colored</i>) <input type="checkbox"/> Opaque (<i>milky</i>) <input type="checkbox"/> Other (chemicals, dyes)	
DOMINANT SUBSTRATE <input type="checkbox"/> Silt/clay (fine or slick) <input type="checkbox"/> Sand (gritty) <input type="checkbox"/> Gravel (0.1-2.5") <input checked="" type="checkbox"/> Cobble (2.5 –10") <input type="checkbox"/> Boulder (>10") <input type="checkbox"/> Bed rock	CHANNEL DIMENSIONS AT RIFFLE Height: Low bank ____3.2____(ft) Width: Bottom ____13____(ft) Top ____17____(ft) Water Surface ____1.4____(ft) Depth: Max BKF ____0.6____(ft) B:H Ratio: Low bank/Max BKF=_____		OBSERVED IMPACTS <input type="checkbox"/> Outfall <input type="checkbox"/> Confluence <input type="checkbox"/> Impacted buffer <input type="checkbox"/> Stream crossing <input type="checkbox"/> Channel mod <input checked="" type="checkbox"/> Utility impacts <input type="checkbox"/> Beaver <input type="checkbox"/> Other

CHANNEL DYNAMICS <input type="checkbox"/> Downcutting <input type="checkbox"/> Bed scour <input type="checkbox"/> Slope failure <input type="checkbox"/> Widening <input checked="" type="checkbox"/> Bank failure <input type="checkbox"/> Channelized <input type="checkbox"/> Headcutting <input checked="" type="checkbox"/> Bank scour <input type="checkbox"/> Unknown <input type="checkbox"/> Aggrading <input type="checkbox"/> Sed. deposition		NOTES	
QUALITATIVE IMPAIRMENT RATING: <input type="checkbox"/> Low <input checked="" type="checkbox"/> Moderate <input type="checkbox"/> Severe		CHANNEL EVOLUTIUON STAGE: <input type="checkbox"/> I <input type="checkbox"/> II <input type="checkbox"/> III <input type="checkbox"/> IV <input type="checkbox"/> V <input type="checkbox"/> VI (<i>Simon et. al., 2003</i>)

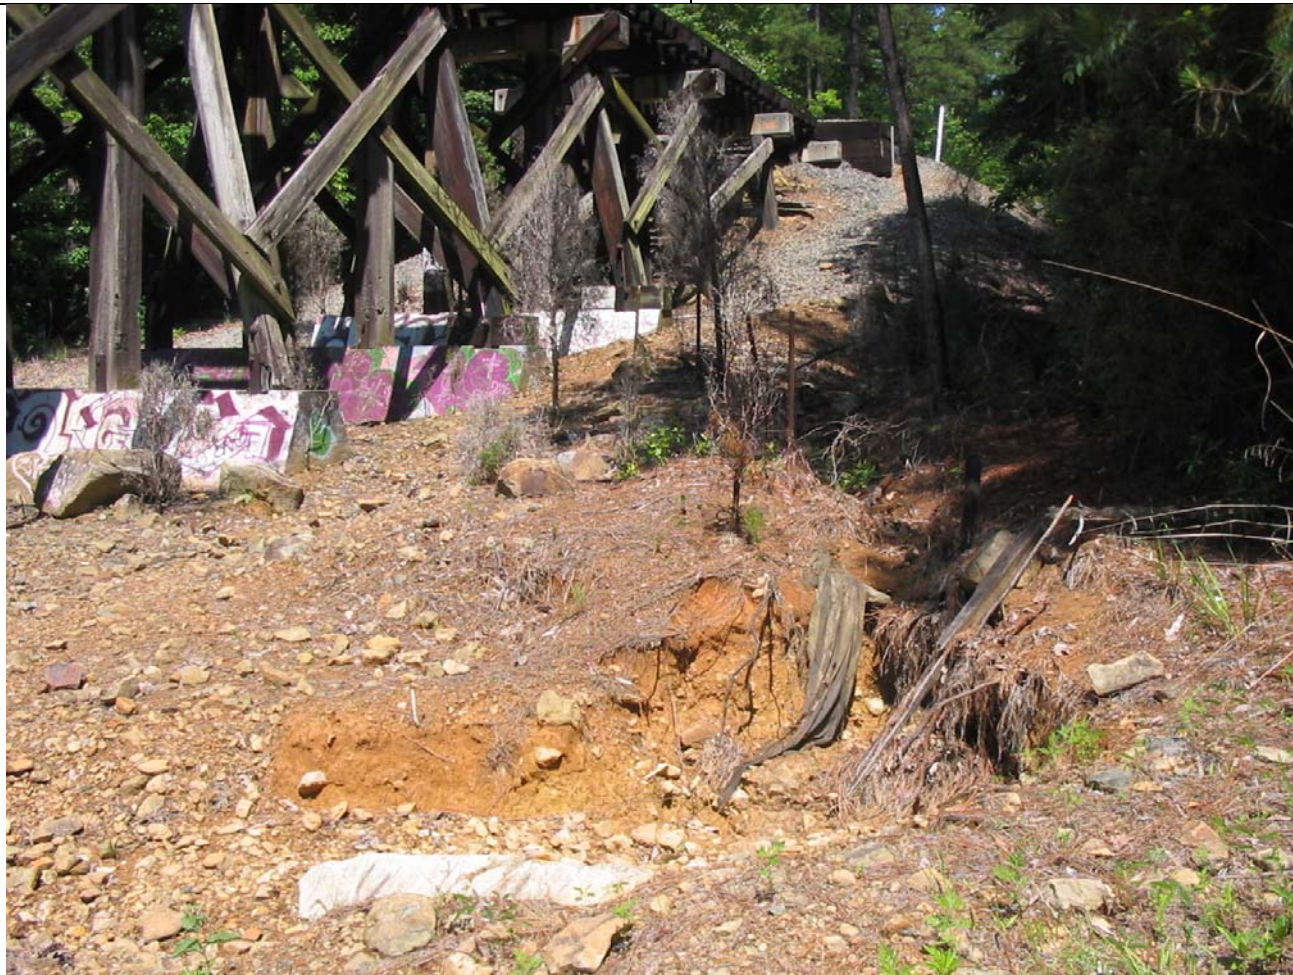
STREAM NAME: UT		DATE:	MAP SHEET #: 20
PHOTO NUMBERS: 1105		LANDMARK: OFF CARDIFF PL	SKETCH ON BACK
GPS ID START: TA 19		GPS ID END:	
DESCRIPTION: SCOUR OF RR FILL		DESCRIPTION:	
RAIN IN LAST 24 HOURS <input type="checkbox"/> Heavy rain <input checked="" type="checkbox"/> Steady rain <input type="checkbox"/> None <input type="checkbox"/> Intermittent <input type="checkbox"/> Trace		PRESENT CONDITIONS <input type="checkbox"/> Heavy rain <input type="checkbox"/> Steady rain <input type="checkbox"/> Intermittent <input checked="" type="checkbox"/> Clear <input type="checkbox"/> Trace <input type="checkbox"/> Overcast <input type="checkbox"/> Partly cloudy	
SURROUNDING LAND USE: <input type="checkbox"/> Industrial <input type="checkbox"/> Commercial <input type="checkbox"/> Urban/Residential <input checked="" type="checkbox"/> Suburban/Res <input type="checkbox"/> Forested <input type="checkbox"/> Institutional <input type="checkbox"/> Golf course <input type="checkbox"/> Park <input type="checkbox"/> Crop <input type="checkbox"/> Pasture <input type="checkbox"/> Other:

BASE FLOW WIDTH AS % CHANNEL WIDTH <input checked="" type="checkbox"/> 0-25% <input type="checkbox"/> 25-50 % <input type="checkbox"/> 50%-75% <input type="checkbox"/> 75-100%		WATER CLARITY <input type="checkbox"/> Clear <input type="checkbox"/> Turbid (<i>suspended matter</i>) <input type="checkbox"/> Stained (<i>clear, naturally colored</i>) <input type="checkbox"/> Opaque (<i>milky</i>) <input type="checkbox"/> Other (chemicals, dyes) NA-NO FLOW	
DOMINANT SUBSTRATE <input checked="" type="checkbox"/> 1 Silt/clay (fine or slick) <input type="checkbox"/> Sand (gritty) <input checked="" type="checkbox"/> 2 Gravel (0.1-2.5") <input type="checkbox"/> Cobble (2.5 -10") <input type="checkbox"/> Boulder (>10") <input type="checkbox"/> Bed rock	CHANNEL DIMENSIONS AT RIFFLE Height: Low bank _____(ft) Width: Bottom _____(ft) Top _____(ft) Water Surface _____(ft) Depth: Max BKF _____(ft) B:H Ratio: Low bank/Max BKF=_____		OBSERVED IMPACTS <input type="checkbox"/> Outfall <input type="checkbox"/> Confluence <input type="checkbox"/> Impacted buffer <input type="checkbox"/> Stream crossing <input type="checkbox"/> Channel mod <input type="checkbox"/> Utility impacts <input type="checkbox"/> Beaver <input checked="" type="checkbox"/> Other- SW r/o

CHANNEL DYNAMICS <input checked="" type="checkbox"/> Downcutting <input checked="" type="checkbox"/> Bed scour <input type="checkbox"/> Slope failure <input checked="" type="checkbox"/> Widening <input type="checkbox"/> Bank failure <input type="checkbox"/> Channelized <input checked="" type="checkbox"/> Headcutting <input checked="" type="checkbox"/> Bank scour <input type="checkbox"/> Unknown <input type="checkbox"/> Aggrading <input type="checkbox"/> Sed. deposition		NOTES SIGNIFICANT SCOUR OF RR FILL SITE FOR POTENTIAL RETENTION SEWER SMELL	
QUALITATIVE IMPAIRMENT RATING: <input type="checkbox"/> Low <input checked="" type="checkbox"/> Moderate <input type="checkbox"/> Severe		CHANNEL EVOLUTIUON STAGE: <input type="checkbox"/> I <input type="checkbox"/> II <input checked="" type="checkbox"/> III <input type="checkbox"/> IV <input type="checkbox"/> V <input type="checkbox"/> VI (<i>Simon et. al., 2003</i>)

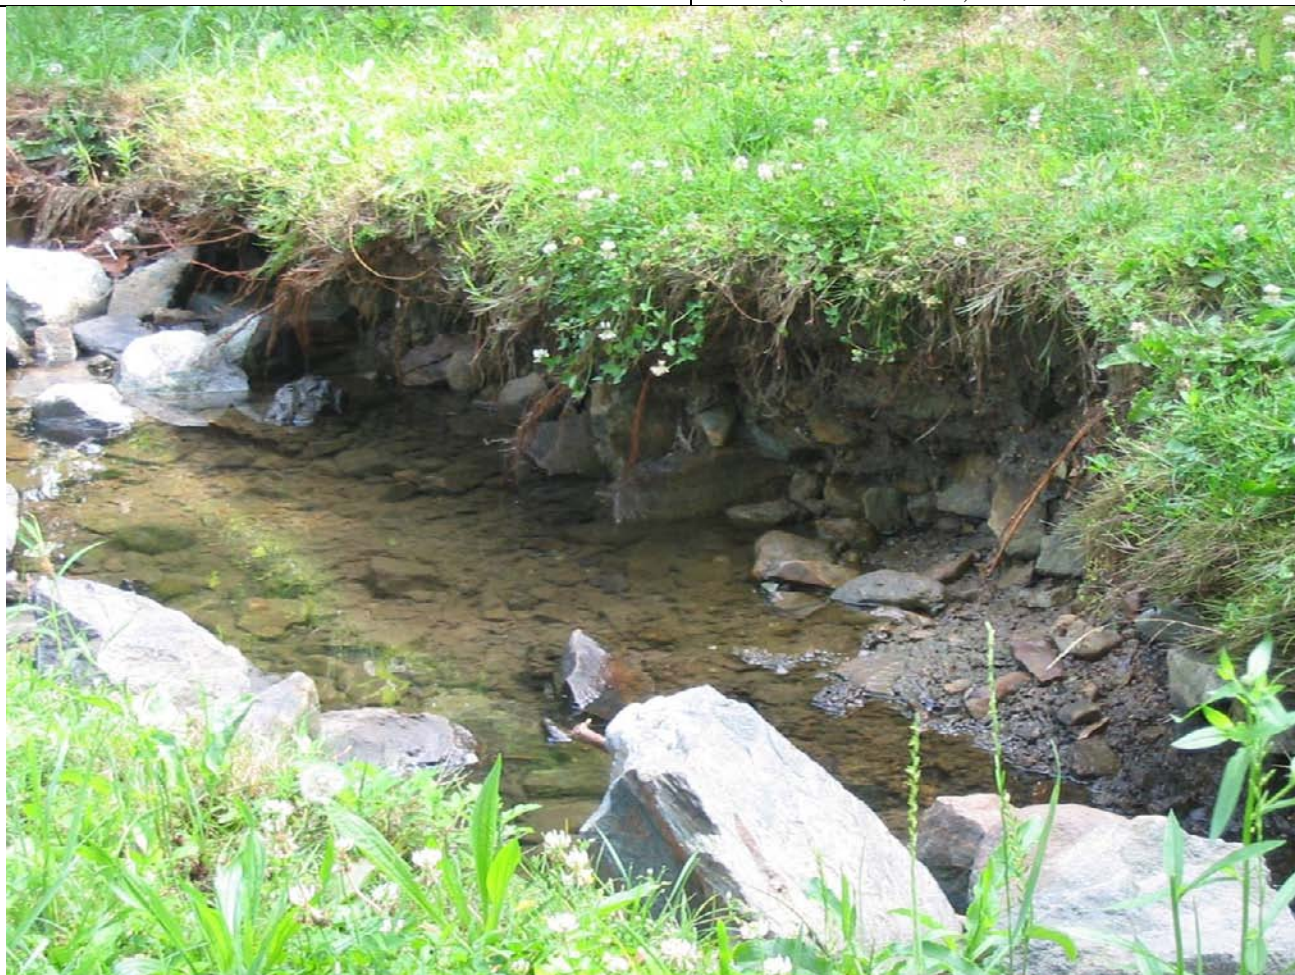
STREAM NAME: UT		DATE: 6/7/07	MAP SHEET #: 23
PHOTO NUMBERS: 1117- PIPED CH 1118-11120 DEGRADED		LANDMARK: BROAD ST.	SKETCH ON BACK
GPS ID START: TA 29		GPS ID END: TA 30	
DESCRIPTION: PIPED ST NO GPS		DESCRIPTION: DEGRADED STR NO GPS	
RAIN IN LAST 24 HOURS <input type="checkbox"/> Heavy rain <input type="checkbox"/> Steady rain <input checked="" type="checkbox"/> None <input type="checkbox"/> Intermittent <input type="checkbox"/> Trace		PRESENT CONDITIONS <input type="checkbox"/> Heavy rain <input type="checkbox"/> Steady rain <input type="checkbox"/> Intermittent <input checked="" type="checkbox"/> Clear <input type="checkbox"/> Trace <input type="checkbox"/> Overcast <input type="checkbox"/> Partly cloudy	
SURROUNDING LAND USE: <input type="checkbox"/> Industrial <input type="checkbox"/> Commercial <input checked="" type="checkbox"/> Urban/Residential <input type="checkbox"/> Suburban/Res <input type="checkbox"/> Forested <input type="checkbox"/> Institutional <input type="checkbox"/> Golf course <input checked="" type="checkbox"/> Park <input type="checkbox"/> Crop <input type="checkbox"/> Pasture <input type="checkbox"/> Other:

BASE FLOW WIDTH AS % CHANNEL WIDTH <input type="checkbox"/> 0-25% <input type="checkbox"/> 25-50 % <input checked="" type="checkbox"/> 50%-75% <input type="checkbox"/> 75-100%		WATER CLARITY <input checked="" type="checkbox"/> Clear <input type="checkbox"/> Turbid (<i>suspended matter</i>) <input type="checkbox"/> Stained (<i>clear, naturally colored</i>) <input type="checkbox"/> Opaque (<i>milky</i>) <input type="checkbox"/> Other (chemicals, dyes)	
DOMINANT SUBSTRATE <input type="checkbox"/> Silt/clay (fine or slick) <input checked="" type="checkbox"/> Sand (gritty) <input checked="" type="checkbox"/> Gravel (0.1-2.5") <input checked="" type="checkbox"/> Cobble (2.5 -10") <input type="checkbox"/> Boulder (>10") <input type="checkbox"/> Bed rock	CHANNEL DIMENSIONS AT RIFFLE Height: Low bank 1.3 (ft) Width: Bottom 4.0 (ft) Top 5.0 (ft) Water Surface 3.0 (ft) Depth: Max BKF 1.3 (ft) B:H Ratio: Low bank/Max BKF=_____		OBSERVED IMPACTS <input checked="" type="checkbox"/> Outfall <input type="checkbox"/> Confluence <input type="checkbox"/> Impacted buffer <input type="checkbox"/> Stream crossing <input type="checkbox"/> Channel mod <input type="checkbox"/> Utility impacts <input type="checkbox"/> Beaver <input type="checkbox"/> Other

CHANNEL DYNAMICS <input checked="" type="checkbox"/> Downcutting <input type="checkbox"/> Bed scour <input type="checkbox"/> Slope failure <input checked="" type="checkbox"/> Widening <input type="checkbox"/> Bank failure <input type="checkbox"/> Channelized <input type="checkbox"/> Headcutting <input checked="" type="checkbox"/> Bank scour <input type="checkbox"/> Unknown <input type="checkbox"/> Aggrading <input type="checkbox"/> Sed. deposition		NOTES- UPSTREAM OF BROAD ST STREAM IS PIPED AND COULD BE DAYLIGHTED TA 29 - DOWN STR OF BROAD ST STREAM IS DEGRADED AND COULD USE RESTORATION	
QUALITATIVE IMPAIRMENT RATING: <input type="checkbox"/> Low <input checked="" type="checkbox"/> Moderate <input type="checkbox"/> Severe		CHANNEL EVOLUTIUON STAGE: <input type="checkbox"/> I <input type="checkbox"/> II <input type="checkbox"/> III <input checked="" type="checkbox"/> IV <input type="checkbox"/> V <input type="checkbox"/> VI (<i>Simon et. al., 2003</i>)

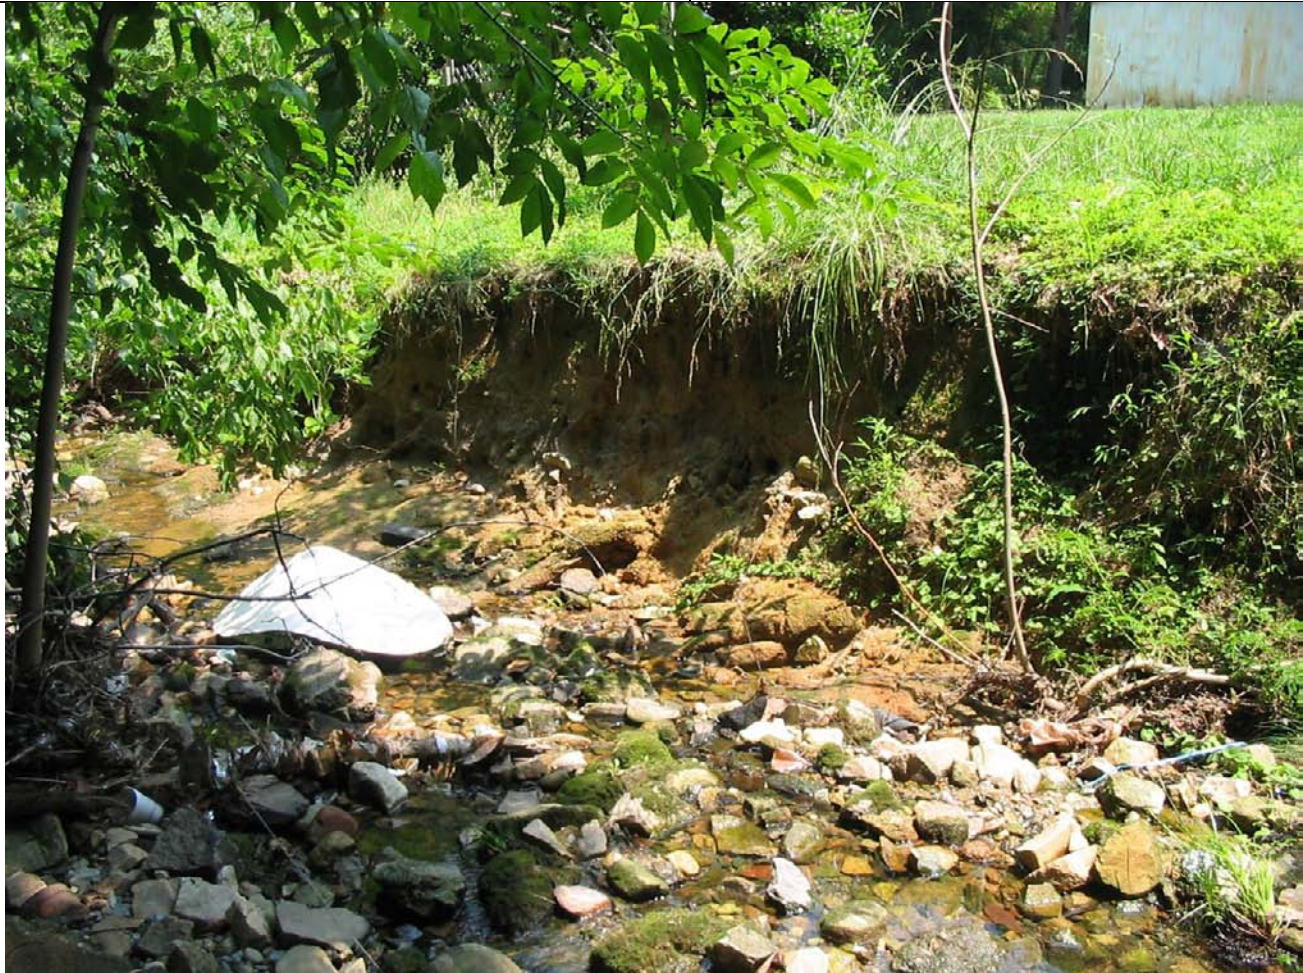
STREAM NAME: UT		DATE: 6/7/07	MAP SHEET #: 24
PHOTO NUMBERS: 1124-1125		LANDMARK:	SKETCH ON BACK
GPS ID START: TA 33		GPS ID END: TA 34	
DESCRIPTION:		DESCRIPTION:	
RAIN IN LAST 24 HOURS <input type="checkbox"/> Heavy rain <input type="checkbox"/> Steady rain <input checked="" type="checkbox"/> None <input type="checkbox"/> Intermittent <input type="checkbox"/> Trace		PRESENT CONDITIONS <input type="checkbox"/> Heavy rain <input type="checkbox"/> Steady rain <input type="checkbox"/> Intermittent <input checked="" type="checkbox"/> Clear <input type="checkbox"/> Trace <input type="checkbox"/> Overcast <input type="checkbox"/> Partly cloudy	
SURROUNDING LAND USE: <input type="checkbox"/> Industrial <input type="checkbox"/> Commercial <input checked="" type="checkbox"/> Urban/Residential <input type="checkbox"/> Suburban/Res <input type="checkbox"/> Forested <input type="checkbox"/> Institutional <input type="checkbox"/> Golf course <input type="checkbox"/> Park <input type="checkbox"/> Crop <input type="checkbox"/> Pasture <input type="checkbox"/> Other:

BASE FLOW WIDTH AS % CHANNEL WIDTH <input type="checkbox"/> 0-25% <input type="checkbox"/> 25-50 % <input checked="" type="checkbox"/> 50%-75% <input type="checkbox"/> 75-100%		WATER CLARITY <input checked="" type="checkbox"/> Clear <input type="checkbox"/> Turbid (<i>suspended matter</i>) <input type="checkbox"/> Stained (<i>clear, naturally colored</i>) <input type="checkbox"/> Opaque (<i>milky</i>) <input type="checkbox"/> Other (chemicals, dyes)	
DOMINANT SUBSTRATE <input type="checkbox"/> Silt/clay (fine or slick) <input checked="" type="checkbox"/> Sand (gritty) <input checked="" type="checkbox"/> Gravel (0.1-2.5") <input type="checkbox"/> Cobble (2.5 –10") <input type="checkbox"/> Boulder (>10") <input checked="" type="checkbox"/> Bed rock	CHANNEL DIMENSIONS AT RIFFLE Height: Low bank 10.0 (ft) Width: Bottom 10.0 (ft) Top 20.0 (ft) Water Surface 8.0 (ft) Depth: Max BKF 1.4 (ft) B:H Ratio: Low bank/Max BKF=_____		OBSERVED IMPACTS <input checked="" type="checkbox"/> Outfall <input type="checkbox"/> Confluence <input type="checkbox"/> Impacted buffer <input type="checkbox"/> Stream crossing <input type="checkbox"/> Channel mod <input checked="" type="checkbox"/> Utility impacts <input type="checkbox"/> Beaver <input checked="" type="checkbox"/> Other- SCOUR from SW

CHANNEL DYNAMICS <input checked="" type="checkbox"/> Downcutting <input type="checkbox"/> Bed scour <input type="checkbox"/> Slope failure <input checked="" type="checkbox"/> Widening <input checked="" type="checkbox"/> Bank failure <input type="checkbox"/> Channelized <input type="checkbox"/> Headcutting <input checked="" type="checkbox"/> Bank scour <input type="checkbox"/> Unknown <input type="checkbox"/> Aggrading <input type="checkbox"/> Sed. deposition		NOTES ENTIRE REACH HAS APPROX 5 TO 6 FT.ERODING VERTICAL BANK FROM SW DOWNCUTTING	
QUALITATIVE IMPAIRMENT RATING: <input type="checkbox"/> Low <input checked="" type="checkbox"/> Moderate <input type="checkbox"/> Severe		CHANNEL EVOLUTIUON STAGE: <input type="checkbox"/> I <input type="checkbox"/> II <input type="checkbox"/> III <input checked="" type="checkbox"/> IV <input type="checkbox"/> V <input type="checkbox"/> VI (<i>Simon et. al., 2003</i>)

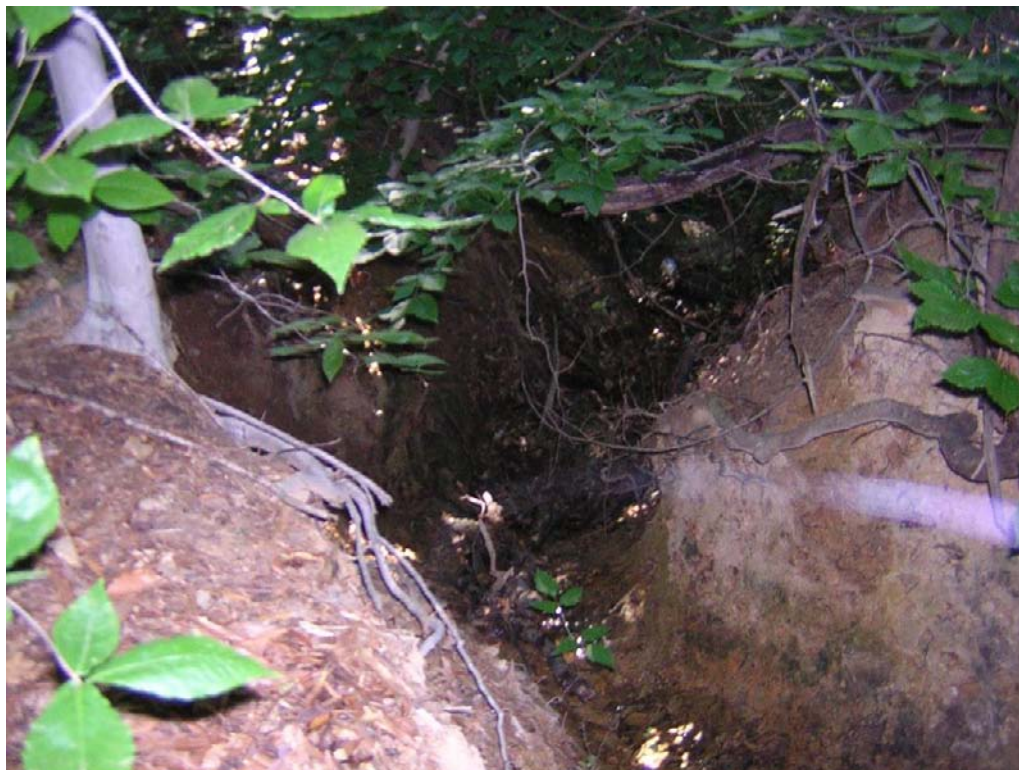
STREAM NAME: UT MILL RACE		DATE: 5/21/07	MAP SHEET #: 25-24
PHOTO NUMBERS: 2976-2979		LANDMARK: HILLSBOROUGH ST	SKETCH ON BACK
GPS ID START: IJ 43		GPS ID END: IJ 43	
DESCRIPTION:		DESCRIPTION:	
RAIN IN LAST 24 HOURS <input type="checkbox"/> Heavy rain <input type="checkbox"/> Steady rain <input type="checkbox"/> None <input checked="" type="checkbox"/> Intermittent <input type="checkbox"/> Trace		PRESENT CONDITIONS <input type="checkbox"/> Heavy rain <input type="checkbox"/> Steady rain <input type="checkbox"/> Intermittent <input checked="" type="checkbox"/> Clear <input type="checkbox"/> Trace <input type="checkbox"/> Overcast <input type="checkbox"/> Partly cloudy	
SURROUNDING LAND USE: <input type="checkbox"/> Industrial <input type="checkbox"/> Commercial <input checked="" type="checkbox"/> Urban/Residential <input checked="" type="checkbox"/> Suburban/Res <input checked="" type="checkbox"/> Forested <input type="checkbox"/> Institutional <input type="checkbox"/> Golf course <input type="checkbox"/> Park <input type="checkbox"/> Crop <input type="checkbox"/> Pasture <input type="checkbox"/> Other:

BASE FLOW WIDTH AS % CHANNEL WIDTH <input type="checkbox"/> 0-25% <input checked="" type="checkbox"/> 25-50 % <input type="checkbox"/> 50%-75% <input type="checkbox"/> 75-100%		WATER CLARITY <input type="checkbox"/> Clear <input checked="" type="checkbox"/> Turbid (<i>suspended matter</i>) <input type="checkbox"/> Stained (<i>clear, naturally colored</i>) <input type="checkbox"/> Opaque (<i>milky</i>) <input type="checkbox"/> Other (chemicals, dyes)	
DOMINANT SUBSTRATE <input checked="" type="checkbox"/> Silt/clay (fine or slick) <input type="checkbox"/> Sand (gritty) <input type="checkbox"/> Gravel (0.1-2.5") <input type="checkbox"/> Cobble (2.5 -10") <input type="checkbox"/> Boulder (>10") <input type="checkbox"/> Bed rock	CHANNEL DIMENSIONS AT RIFFLE Height: Low bank ____3-10____(ft) Width: Bottom ____3-6____(ft) Top ____3-6____(ft) Water Surface ____0.5____(ft) Depth: Max BKF ____0.2____(ft) B:H Ratio: Low bank/Max BKF=____		OBSERVED IMPACTS <input checked="" type="checkbox"/> Outfall <input type="checkbox"/> Confluence <input type="checkbox"/> Impacted buffer <input type="checkbox"/> Stream crossing <input type="checkbox"/> Channel mod <input type="checkbox"/> Utility impacts <input type="checkbox"/> Beaver <input type="checkbox"/> Other

CHANNEL DYNAMICS <input type="checkbox"/> Downcutting <input type="checkbox"/> Bed scour <input type="checkbox"/> Slope failure <input type="checkbox"/> Widening <input type="checkbox"/> Bank failure <input type="checkbox"/> Channelized <input type="checkbox"/> Headcutting <input type="checkbox"/> Bank scour <input type="checkbox"/> Unknown <input type="checkbox"/> Aggrading <input type="checkbox"/> Sed. deposition		NOTES: BURIED PIP IS CAUSING MASSIVE EROSION ON HILLSIDE DEEP GULLY FORMED POSSIBLE STEP-POOL OR ENERGY DISSIPATION EVEN CULVERT REPLACEMENT	
QUALITATIVE IMPAIRMENT RATING: <input type="checkbox"/> Low <input type="checkbox"/> Moderate <input checked="" type="checkbox"/> Severe		CHANNEL EVOLUTIUON STAGE: <input type="checkbox"/> I <input type="checkbox"/> II <input checked="" type="checkbox"/> III <input type="checkbox"/> IV <input type="checkbox"/> V <input type="checkbox"/> VI (<i>Simon et. al., 2003</i>)

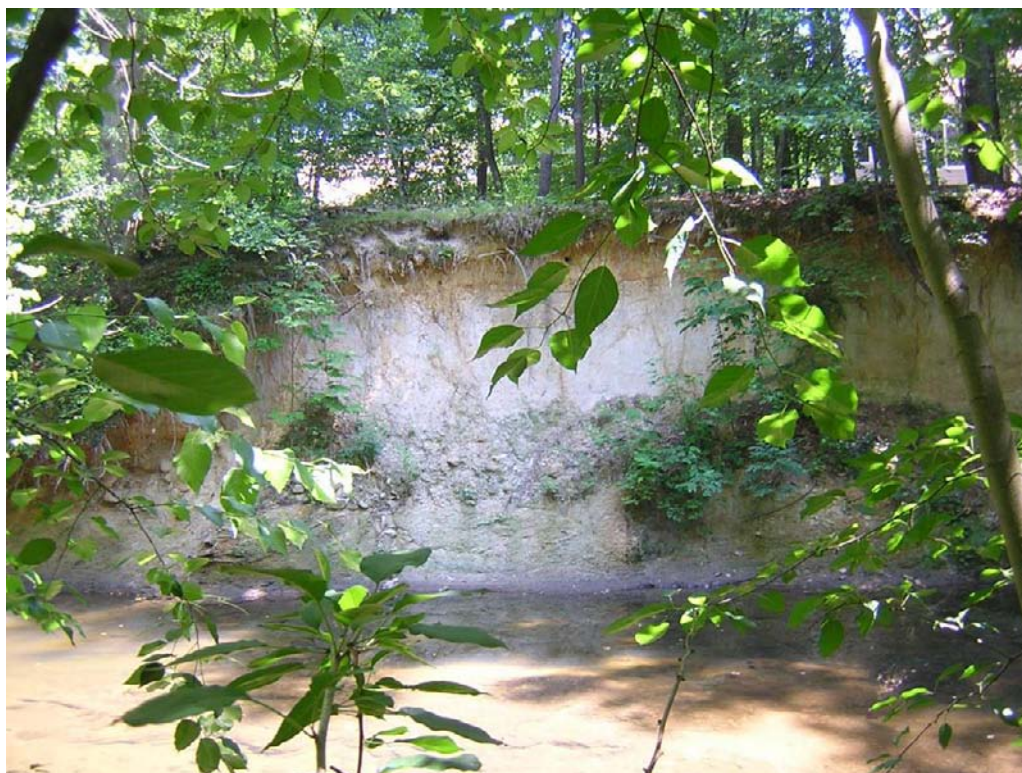
STREAM NAME: BOLIN CREEK		DATE: 2/21/07	MAP SHEET #: 25
PHOTO NUMBERS: 3015-3016		LANDMARK: BOLINWOOD DR	SKETCH ON BACK
GPS ID START: LJ53		GPS ID END: LJ53	
DESCRIPTION:		DESCRIPTION:	
RAIN IN LAST 24 HOURS <input type="checkbox"/> Heavy rain <input type="checkbox"/> Steady rain <input type="checkbox"/> None <input checked="" type="checkbox"/> Intermittent <input type="checkbox"/> Trace		PRESENT CONDITIONS <input type="checkbox"/> Heavy rain <input type="checkbox"/> Steady rain <input type="checkbox"/> Intermittent <input checked="" type="checkbox"/> Clear <input type="checkbox"/> Trace <input type="checkbox"/> Overcast <input type="checkbox"/> Partly cloudy	
SURROUNDING LAND USE: <input type="checkbox"/> Industrial <input type="checkbox"/> Commercial <input checked="" type="checkbox"/> Urban/Residential <input type="checkbox"/> Suburban/Res <input checked="" type="checkbox"/> Forested <input type="checkbox"/> Institutional <input type="checkbox"/> Golf course <input type="checkbox"/> Park <input type="checkbox"/> Crop <input type="checkbox"/> Pasture <input type="checkbox"/> Other:

BASE FLOW WIDTH AS % CHANNEL WIDTH <input type="checkbox"/> 0-25% <input type="checkbox"/> 25-50 % <input type="checkbox"/> 50%-75% <input checked="" type="checkbox"/> 75-100%		WATER CLARITY <input checked="" type="checkbox"/> Clear <input type="checkbox"/> Turbid (<i>suspended matter</i>) <input type="checkbox"/> Stained (<i>clear, naturally colored</i>) <input type="checkbox"/> Opaque (<i>milky</i>) <input type="checkbox"/> Other (chemicals, dyes)	
DOMINANT SUBSTRATE <input checked="" type="checkbox"/> Silt/clay (fine or slick) <input checked="" type="checkbox"/> Sand (gritty) <input checked="" type="checkbox"/> Gravel (0.1-2.5") <input type="checkbox"/> Cobble (2.5 –10") <input type="checkbox"/> Boulder (>10") <input checked="" type="checkbox"/> Bed rock	CHANNEL DIMENSIONS AT RIFFLE Height: Low bank ____5-20__(ft) Width: Bottom ____20__(ft) Top ____20__(ft) Water Surface ____20__(ft) Depth: Max BKF ____2.5__(ft) B:H Ratio: Low bank/Max BKF=_____		OBSERVED IMPACTS <input type="checkbox"/> Outfall <input type="checkbox"/> Confluence <input checked="" type="checkbox"/> Impacted buffer <input type="checkbox"/> Stream crossing <input type="checkbox"/> Channel mod <input type="checkbox"/> Utility impacts <input type="checkbox"/> Beaver <input type="checkbox"/> Other

CHANNEL DYNAMICS <input type="checkbox"/> Downcutting <input type="checkbox"/> Bed scour <input type="checkbox"/> Slope failure <input type="checkbox"/> Widening <input checked="" type="checkbox"/> Bank failure <input type="checkbox"/> Channelized <input type="checkbox"/> Headcutting <input type="checkbox"/> Bank scour <input type="checkbox"/> Unknown <input type="checkbox"/> Aggrading <input type="checkbox"/> Sed. deposition		NOTES MAJOR BANK FAILURE ON BOLIN CREEK POSSIBLE BANK STABILIZATION	
QUALITATIVE IMPAIRMENT RATING: <input type="checkbox"/> Low <input type="checkbox"/> Moderate <input type="checkbox"/> Severe		CHANNEL EVOLUTIUON STAGE: <input type="checkbox"/> I <input type="checkbox"/> II <input type="checkbox"/> III <input type="checkbox"/> IV <input type="checkbox"/> V <input type="checkbox"/> VI (<i>Simon et. al., 2003</i>)
