BOLIN CREEK WATERSHED

Geomorphic Analysis and Potential Site Identification for Stormwater Structures and Retrofits

TOWN OF CARRBORO
NORTH CAROLINA

November 2007

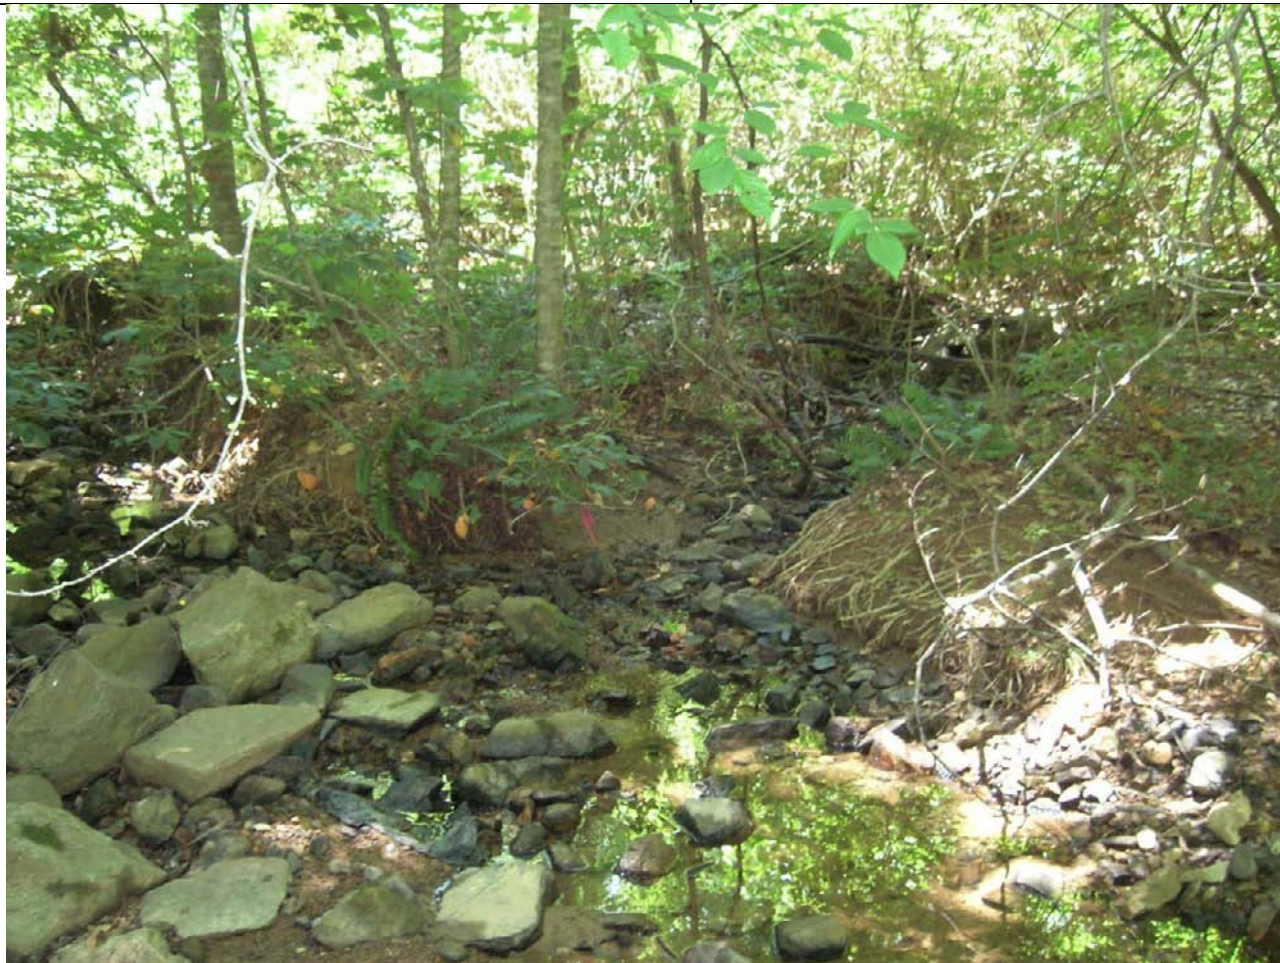
STREAM NAME: UT		DATE: 6/21/07	MAP SHEET #: 26
PHOTO NUMBERS: 1162-1165		LANDMARK: YMCA	SKETCH ON BACK
GPS ID START: BD 58		GPS ID END: BD 59	
DESCRIPTION:		DESCRIPTION:	
RAIN IN LAST 24 HOURS <input type="checkbox"/> Heavy rain <input checked="" type="checkbox"/> Steady rain <input type="checkbox"/> None <input type="checkbox"/> Intermittent <input type="checkbox"/> Trace		PRESENT CONDITIONS <input type="checkbox"/> Heavy rain <input type="checkbox"/> Steady rain <input type="checkbox"/> Intermittent <input checked="" type="checkbox"/> Clear <input type="checkbox"/> Trace <input type="checkbox"/> Overcast <input type="checkbox"/> Partly cloudy	
SURROUNDING LAND USE: <input type="checkbox"/> Industrial <input checked="" type="checkbox"/> Commercial <input checked="" type="checkbox"/> Urban/Residential <input type="checkbox"/> Suburban/Res <input type="checkbox"/> Forested <input type="checkbox"/> Institutional <input type="checkbox"/> Golf course <input type="checkbox"/> Park <input type="checkbox"/> Crop <input type="checkbox"/> Pasture <input type="checkbox"/> Other:

BASE FLOW WIDTH AS % CHANNEL WIDTH <input checked="" type="checkbox"/> 0-25% <input type="checkbox"/> 25-50 % <input type="checkbox"/> 50%-75% <input type="checkbox"/> 75-100%		WATER CLARITY <input checked="" type="checkbox"/> Clear <input type="checkbox"/> Turbid (<i>suspended matter</i>) <input type="checkbox"/> Stained (<i>clear, naturally colored</i>) <input type="checkbox"/> Opaque (<i>milky</i>) <input type="checkbox"/> Other (chemicals, dyes)	
DOMINANT SUBSTRATE <input type="checkbox"/> Silt/clay (fine or slick) <input checked="" type="checkbox"/> Sand (gritty) <input type="checkbox"/> Gravel (0.1-2.5") <input checked="" type="checkbox"/> Cobble (2.5 –10") <input type="checkbox"/> Boulder (>10") <input type="checkbox"/> Bed rock	CHANNEL DIMENSIONS AT RIFFLE Height: Low bank ____2.1____(ft) Width: Bottom ____7.1____(ft) Top ____9____(ft) Water Surface ____2____(ft) Depth: Max BKF ____0.5____(ft) B:H Ratio: Low bank/Max BKF=_____		OBSERVED IMPACTS <input type="checkbox"/> Outfall <input type="checkbox"/> Confluence <input type="checkbox"/> Impacted buffer <input type="checkbox"/> Stream crossing <input type="checkbox"/> Channel mod <input type="checkbox"/> Utility impacts <input type="checkbox"/> Beaver <input type="checkbox"/> Other

CHANNEL DYNAMICS <input checked="" type="checkbox"/> Downcutting <input type="checkbox"/> Bed scour <input type="checkbox"/> Slope failure <input type="checkbox"/> Widening <input type="checkbox"/> Bank failure <input type="checkbox"/> Channelized <input type="checkbox"/> Headcutting <input checked="" type="checkbox"/> Bank scour <input type="checkbox"/> Unknown <input type="checkbox"/> Aggrading <input type="checkbox"/> Sed. deposition		NOTES THIS NEEDS HELP. ACTIVE, GETS WORSE DS. SEE BD 59-60.	
QUALITATIVE IMPAIRMENT RATING: <input type="checkbox"/> Low <input checked="" type="checkbox"/> Moderate <input type="checkbox"/> Severe		CHANNEL EVOLUTIUON STAGE: <input type="checkbox"/> I <input checked="" type="checkbox"/> II <input type="checkbox"/> III <input type="checkbox"/> IV <input type="checkbox"/> V <input type="checkbox"/> VI (<i>Simon et. al., 2003</i>)

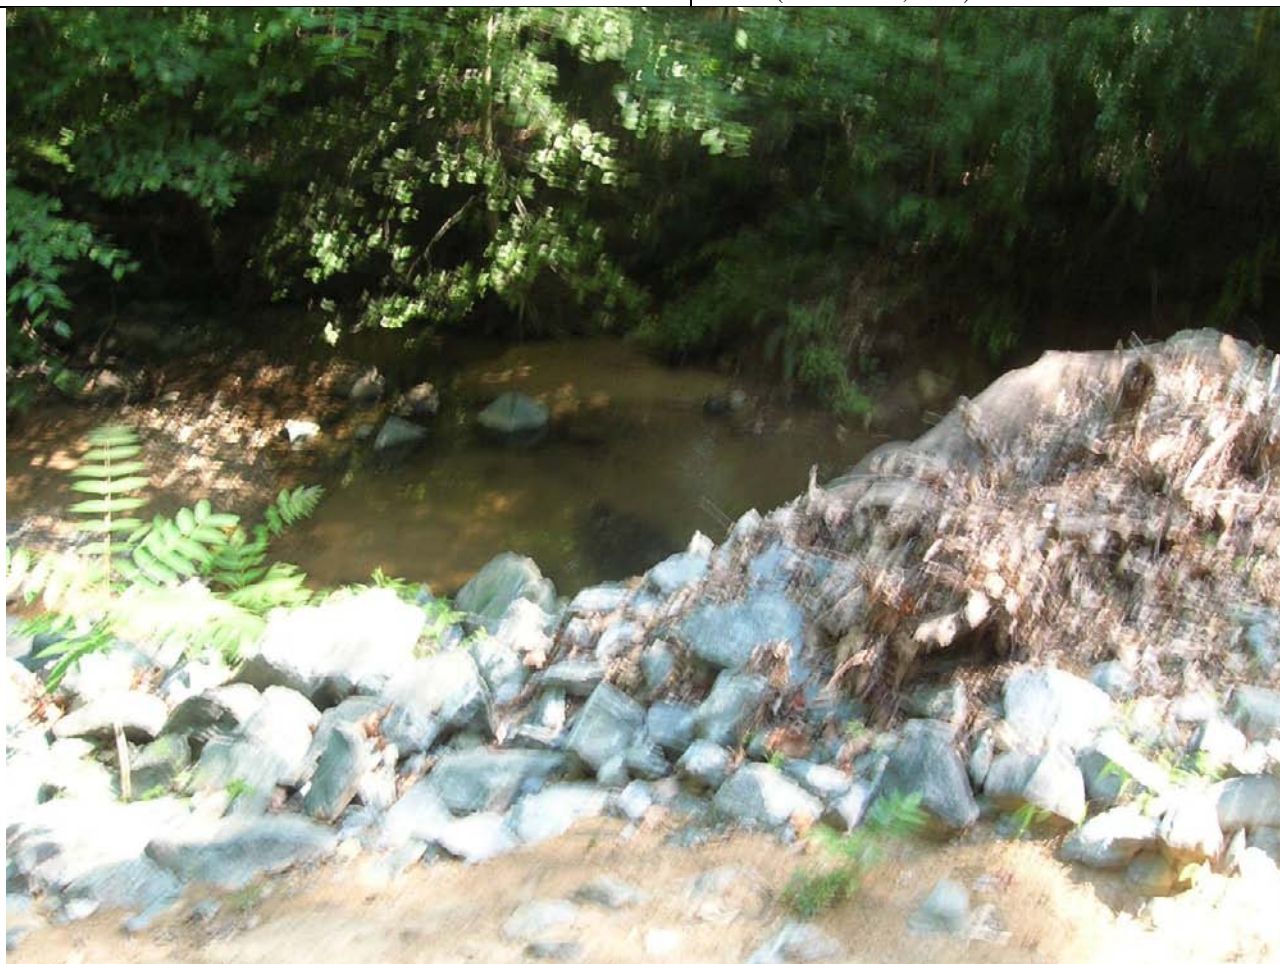
STREAM NAME: COLE SPRINGS BR.		DATE: 6/21/07	MAP SHEET #: 26
PHOTO NUMBERS: 1231,1232		LANDMARK:	SKETCH ON BACK
GPS ID START: BD 75		GPS ID END:	
DESCRIPTION:		DESCRIPTION:	
RAIN IN LAST 24 HOURS <input type="checkbox"/> Heavy rain <input checked="" type="checkbox"/> Steady rain <input type="checkbox"/> None <input type="checkbox"/> Intermittent <input type="checkbox"/> Trace		PRESENT CONDITIONS <input type="checkbox"/> Heavy rain <input type="checkbox"/> Steady rain <input type="checkbox"/> Intermittent <input checked="" type="checkbox"/> Clear <input type="checkbox"/> Trace <input type="checkbox"/> Overcast <input type="checkbox"/> Partly cloudy	
SURROUNDING LAND USE: <input type="checkbox"/> Industrial <input type="checkbox"/> Commercial <input checked="" type="checkbox"/> Urban/Residential <input type="checkbox"/> Suburban/Res <input type="checkbox"/> Forested <input type="checkbox"/> Institutional <input type="checkbox"/> Golf course <input type="checkbox"/> Park <input type="checkbox"/> Crop <input type="checkbox"/> Pasture <input type="checkbox"/> Other:

BASE FLOW WIDTH AS % CHANNEL WIDTH <input type="checkbox"/> 0-25% <input checked="" type="checkbox"/> 25-50 % <input type="checkbox"/> 50%-75% <input type="checkbox"/> 75-100%		WATER CLARITY <input type="checkbox"/> Clear <input type="checkbox"/> Turbid (<i>suspended matter</i>) <input type="checkbox"/> Stained (<i>clear, naturally colored</i>) <input type="checkbox"/> Opaque (<i>milky</i>) <input type="checkbox"/> Other (chemicals, dyes)	
DOMINANT SUBSTRATE <input type="checkbox"/> Silt/clay (fine or slick) <input type="checkbox"/> Sand (gritty) <input type="checkbox"/> Gravel (0.1-2.5") <input type="checkbox"/> Cobble (2.5 –10") <input type="checkbox"/> Boulder (>10") <input type="checkbox"/> Bed rock	CHANNEL DIMENSIONS AT RIFFLE Height: Low bank 4 _____(ft) Width: Bottom 4 _____(ft) Top 14 _____(ft) Water Surface 2 _____(ft) Depth: Max BKF 1.8 _____(ft) B:H Ratio: Low bank/Max BKF=_____		OBSERVED IMPACTS <input type="checkbox"/> Outfall <input type="checkbox"/> Confluence <input type="checkbox"/> Impacted buffer <input type="checkbox"/> Stream crossing <input type="checkbox"/> Channel mod <input type="checkbox"/> Utility impacts <input type="checkbox"/> Beaver <input type="checkbox"/> Other

CHANNEL DYNAMICS <input checked="" type="checkbox"/> Downcutting <input type="checkbox"/> Bed scour <input type="checkbox"/> Slope failure <input checked="" type="checkbox"/> Widening <input checked="" type="checkbox"/> Bank failure <input type="checkbox"/> Channelized <input type="checkbox"/> Headcutting <input checked="" type="checkbox"/> Bank scour <input type="checkbox"/> Unknown <input type="checkbox"/> Aggrading <input type="checkbox"/> Sed. deposition		NOTES CULVERT FOR UTILITY ROADWAY ALONG SS LINE CAUSES CONTRACTION	
QUALITATIVE IMPAIRMENT RATING: <input type="checkbox"/> Low <input checked="" type="checkbox"/> Moderate <input type="checkbox"/> Severe		CHANNEL EVOLUTIUON STAGE: <input type="checkbox"/> I <input type="checkbox"/> II <input checked="" type="checkbox"/> III <input type="checkbox"/> IV <input type="checkbox"/> V <input type="checkbox"/> VI (<i>Simon et. al., 2003</i>)

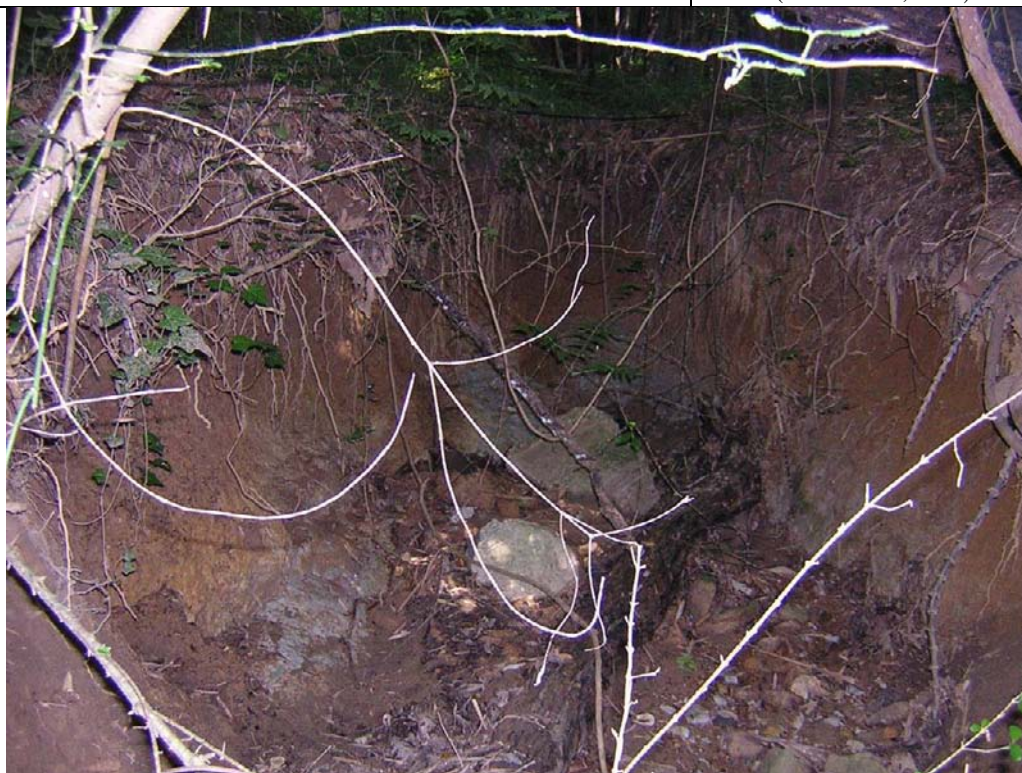
STREAM NAME: UT BATTLE BRANCH		DATE: 6/22/07	MAP SHEET #: 30
PHOTO NUMBERS:NO PHOTO		LANDMARK:	SKETCH ON BACK
GPS ID START: IJ 64		GPS ID END: IJ 64	
DESCRIPTION:		DESCRIPTION:	
RAIN IN LAST 24 HOURS <input type="checkbox"/> Heavy rain <input type="checkbox"/> Steady rain <input type="checkbox"/> None <input checked="" type="checkbox"/> Intermittent <input type="checkbox"/> Trace		PRESENT CONDITIONS <input type="checkbox"/> Heavy rain <input type="checkbox"/> Steady rain <input type="checkbox"/> Intermittent <input checked="" type="checkbox"/> Clear <input type="checkbox"/> Trace <input type="checkbox"/> Overcast <input type="checkbox"/> Partly cloudy	
SURROUNDING LAND USE: <input type="checkbox"/> Industrial <input type="checkbox"/> Commercial <input checked="" type="checkbox"/> Urban/Residential <input checked="" type="checkbox"/> Suburban/Res <input checked="" type="checkbox"/> Forested <input type="checkbox"/> Institutional <input type="checkbox"/> Golf course <input type="checkbox"/> Park <input type="checkbox"/> Crop <input type="checkbox"/> Pasture <input type="checkbox"/> Other:

BASE FLOW WIDTH AS % CHANNEL WIDTH <input checked="" type="checkbox"/> 0-25% <input type="checkbox"/> 25-50 % <input type="checkbox"/> 50%-75% <input type="checkbox"/> 75-100%		WATER CLARITY <input type="checkbox"/> Clear <input checked="" type="checkbox"/> Turbid (<i>suspended matter</i>) <input type="checkbox"/> Stained (<i>clear, naturally colored</i>) <input type="checkbox"/> Opaque (<i>milky</i>) <input type="checkbox"/> Other (chemicals, dyes)	
DOMINANT SUBSTRATE <input checked="" type="checkbox"/> Silt/clay (fine or slick) <input type="checkbox"/> Sand (gritty) <input type="checkbox"/> Gravel (0.1-2.5") <input type="checkbox"/> Cobble (2.5 –10") <input type="checkbox"/> Boulder (>10") <input type="checkbox"/> Bed rock	CHANNEL DIMENSIONS AT RIFFLE Height: Low bank ____3-4____(ft) Width: Bottom ____3____(ft) Top ____5____(ft) Water Surface ____NA____(ft) Depth: Max BKF ____NA____(ft) B:H Ratio: Low bank/Max BKF=____NA____		OBSERVED IMPACTS <input type="checkbox"/> Outfall <input type="checkbox"/> Confluence <input type="checkbox"/> Impacted buffer <input type="checkbox"/> Stream crossing <input type="checkbox"/> Channel mod <input type="checkbox"/> Utility impacts <input type="checkbox"/> Beaver <input checked="" type="checkbox"/> Other

CHANNEL DYNAMICS <input checked="" type="checkbox"/> Downcutting <input type="checkbox"/> Widening <input checked="" type="checkbox"/> Headcutting <input type="checkbox"/> Aggrading		NOTES SERIES OF HEADCUTS PROGRESSING UP STEEP CHANNEL LOTS OF SILT AND SEDIMENT FROM BANK FAILURE ORIGINATES AT PARTIALLY BURIED PIPE UPSTREAM	
QUALITATIVE IMPAIRMENT RATING: <input type="checkbox"/> Low <input type="checkbox"/> Moderate <input checked="" type="checkbox"/> Severe		CHANNEL EVOLUTIUON STAGE: <input type="checkbox"/> I <input type="checkbox"/> II <input type="checkbox"/> III <input type="checkbox"/> IV <input type="checkbox"/> V <input type="checkbox"/> VI (<i>Simon et. al., 2003</i>)

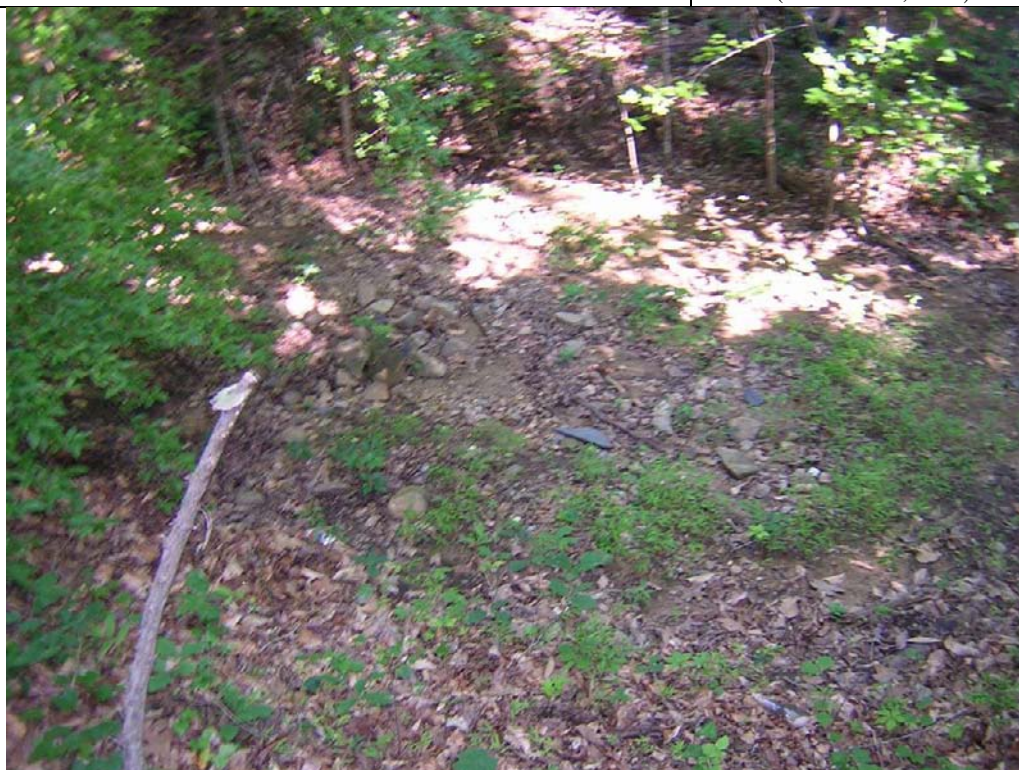
STREAM NAME: UT TO BOLIN CR		DATE: 6/21/07	MAP SHEET #: 30
PHOTO NUMBERS: 3032-3034		LANDMARK: STEEP HILLSIDE	SKETCH ON BACK
GPS ID START: IJ 60		GPS ID END: IJ 60	
DESCRIPTION:		DESCRIPTION:	
RAIN IN LAST 24 HOURS <input type="checkbox"/> Heavy rain <input type="checkbox"/> Steady rain <input type="checkbox"/> None <input checked="" type="checkbox"/> Intermittent <input type="checkbox"/> Trace		PRESENT CONDITIONS <input type="checkbox"/> Heavy rain <input type="checkbox"/> Steady rain <input type="checkbox"/> Intermittent <input checked="" type="checkbox"/> Clear <input type="checkbox"/> Trace <input type="checkbox"/> Overcast <input type="checkbox"/> Partly cloudy	
SURROUNDING LAND USE: <input type="checkbox"/> Industrial <input type="checkbox"/> Commercial <input type="checkbox"/> Urban/Residential <input checked="" type="checkbox"/> Suburban/Res <input checked="" type="checkbox"/> Forested <input type="checkbox"/> Institutional <input type="checkbox"/> Golf course <input type="checkbox"/> Park <input type="checkbox"/> Crop <input type="checkbox"/> Pasture <input type="checkbox"/> Other:

BASE FLOW WIDTH AS % CHANNEL WIDTH <input type="checkbox"/> 0-25% <input checked="" type="checkbox"/> NA-hillside <input type="checkbox"/> 25-50 % <input type="checkbox"/> 50%-75% <input type="checkbox"/> 75-100%		WATER CLARITY <input type="checkbox"/> Clear <input type="checkbox"/> Turbid (<i>suspended matter</i>) <input type="checkbox"/> Stained (<i>clear, naturally colored</i>) <input type="checkbox"/> Opaque (<i>milky</i>) <input type="checkbox"/> Other (chemicals, dyes) <input checked="" type="checkbox"/> NA	
DOMINANT SUBSTRATE <input checked="" type="checkbox"/> 2 Silt/clay (fine or slick) <input checked="" type="checkbox"/> 1 Sand (gritty) <input type="checkbox"/> Gravel (0.1-2.5") <input type="checkbox"/> Cobble (2.5 –10") <input type="checkbox"/> Boulder (>10") <input type="checkbox"/> Bed rock	CHANNEL DIMENSIONS AT RIFFLE Height: Low bank _____(ft) Width: Bottom _____(ft) Top _____(ft) Water Surface _____(ft) Depth: Max BKF _____(ft) B:H Ratio: Low bank/Max BKF=_____		OBSERVED IMPACTS <input checked="" type="checkbox"/> Outfall <input type="checkbox"/> Confluence <input type="checkbox"/> Impacted buffer <input type="checkbox"/> Stream crossing <input type="checkbox"/> Channel mod <input type="checkbox"/> Utility impacts <input type="checkbox"/> Beaver <input checked="" type="checkbox"/> Other- old BMP

CHANNEL DYNAMICS <input type="checkbox"/> Downcutting <input type="checkbox"/> Bed scour <input checked="" type="checkbox"/> Slope failure <input type="checkbox"/> Widening <input type="checkbox"/> Bank failure <input type="checkbox"/> Channelized <input type="checkbox"/> Headcutting <input type="checkbox"/> Bank scour <input type="checkbox"/> Unknown <input checked="" type="checkbox"/> Aggrading <input type="checkbox"/> Sed. deposition		NOTES OLD BMP – MAYBE LEVEL SPREADER ;COULD EASILY RETROFIT GULLY FORMATION ABOVE ROCK CHECK DAMS BELOW	
QUALITATIVE IMPAIRMENT RATING: <input type="checkbox"/> Low <input checked="" type="checkbox"/> Moderate <input type="checkbox"/> Severe		CHANNEL EVOLUTIUON STAGE: <input type="checkbox"/> I <input type="checkbox"/> II <input type="checkbox"/> III <input type="checkbox"/> IV <input type="checkbox"/> V <input type="checkbox"/> VI (<i>Simon et. al., 2003</i>)
